Rehabilitation of Stone Arch Culverts Henry County US 24 and State Route 424

Mike Benton, P.E. – ODOT District 2
Matt Schroeder – Miller Bros. Construction

ODOT PID 88197 Scope

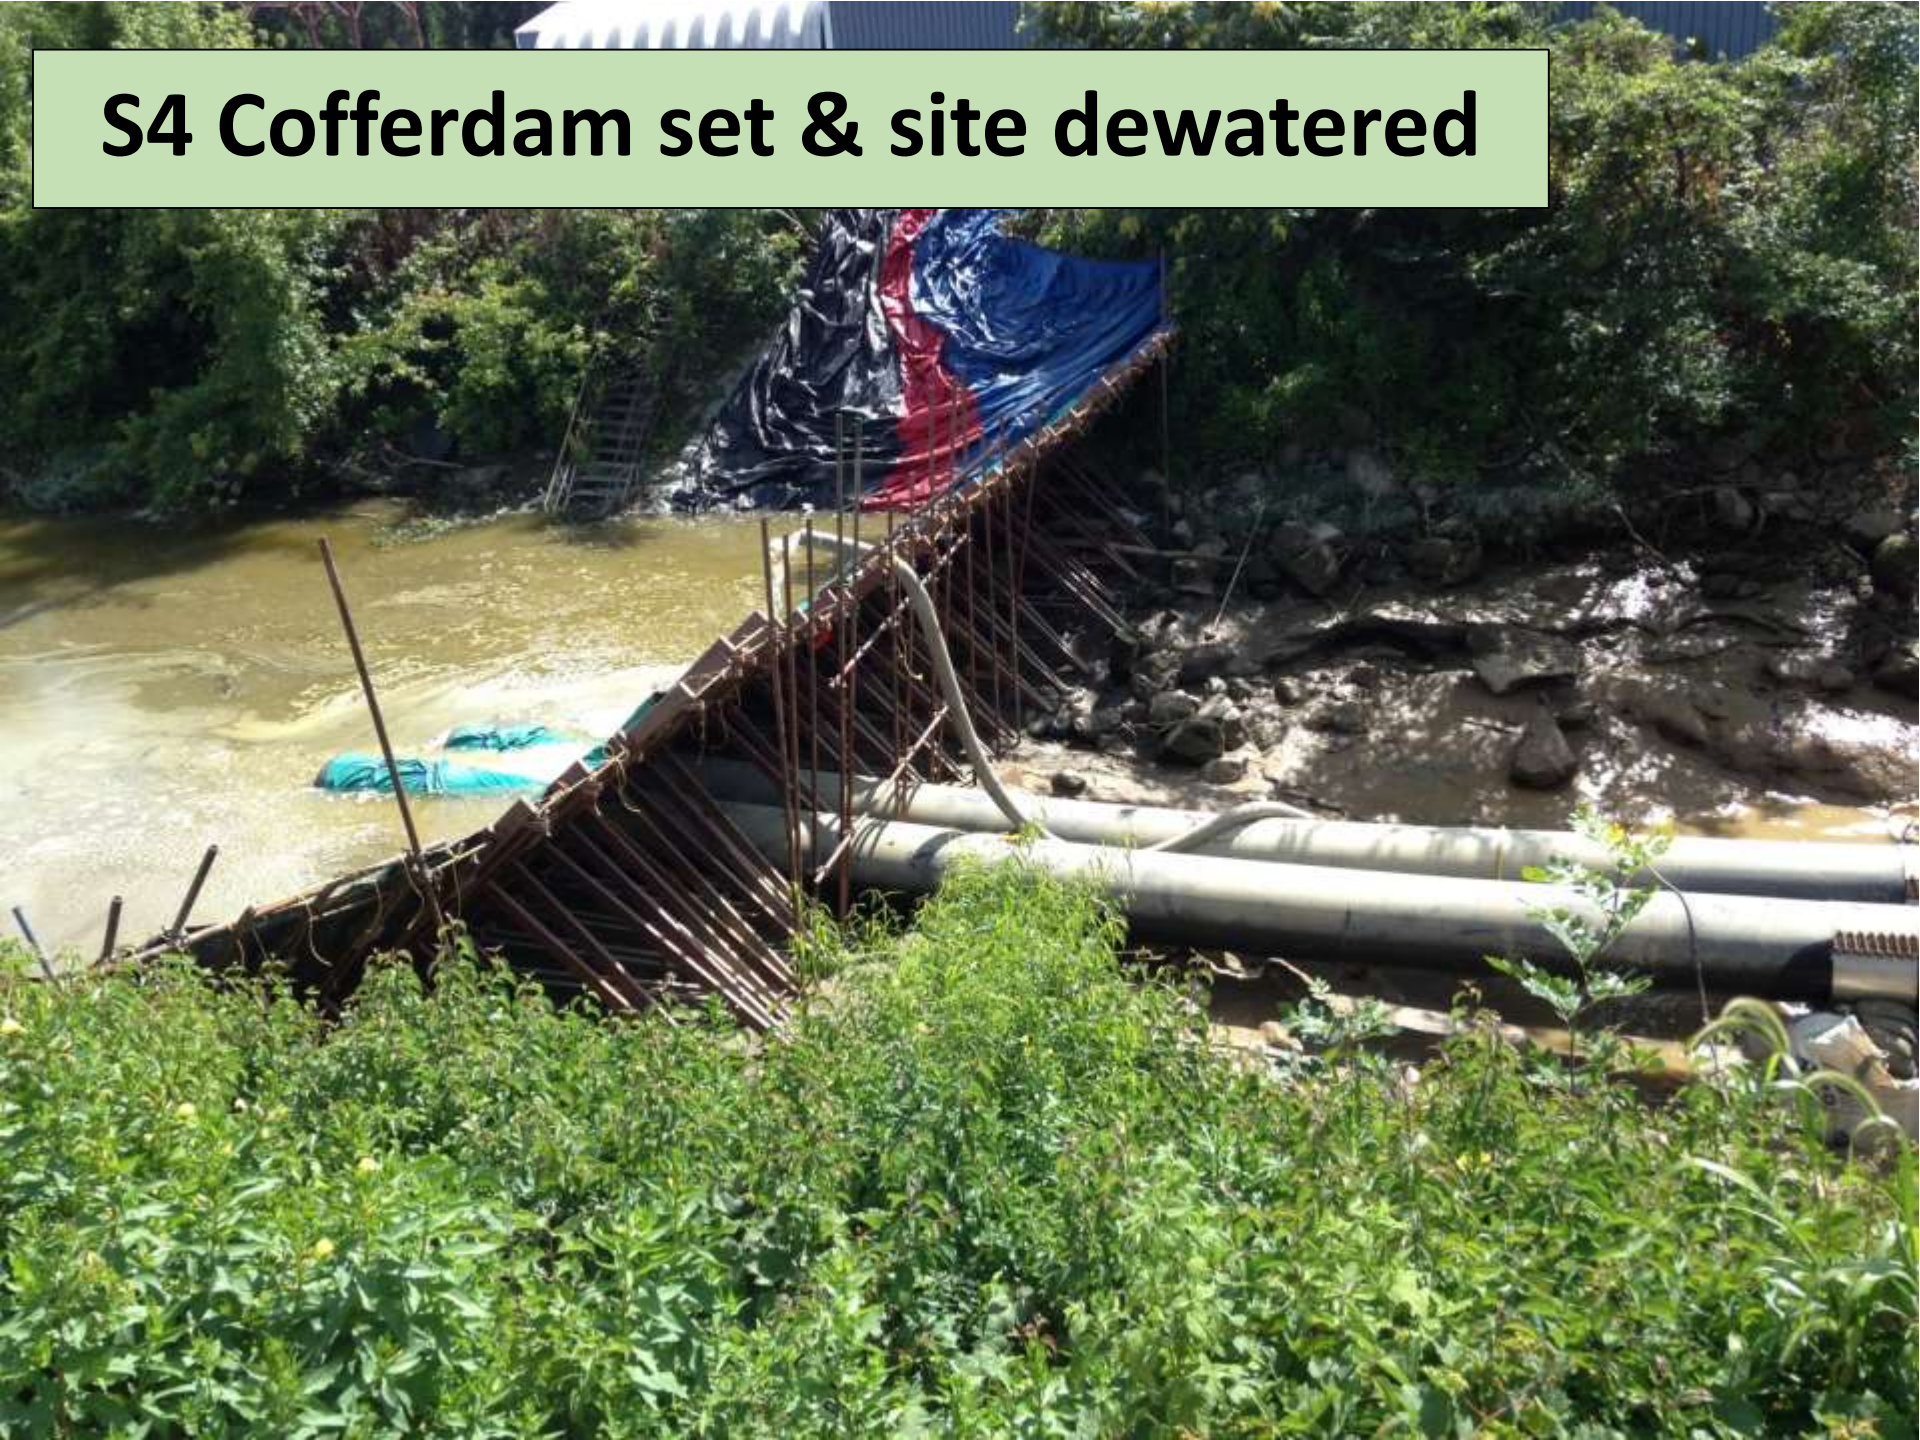
S4 Timbers

Plans indicated the blocks were sitting on 2' of stone base. Once the work area was dewatered it was discovered that the entire structure (headwalls, wingwalls and arch) are sitting on large wooded timbers. At that point ODOT was notified of change of existing conditions and work was suspended until an alternate plan was developed. The existing timbers were tested and the results indicated that they were in good condition.

- Install 18'x7'8" CMP arch liner inside existing arch.
 - Liner sat on CIP footings placed on top of existing timbers.
 - Footings were doweled into existing blocks.
 - Liner was assembled outside the arch and pulled into place with steel cable block & tackle and dozer.
 - Void between the existing arch and liner was filled with LSM. Special procedure so as not to damage the liner
- Pour a new CIP arch ring to match the previous.
- Install wire MSE walls.
- Remove and reassemble headwalls & wingwalls.

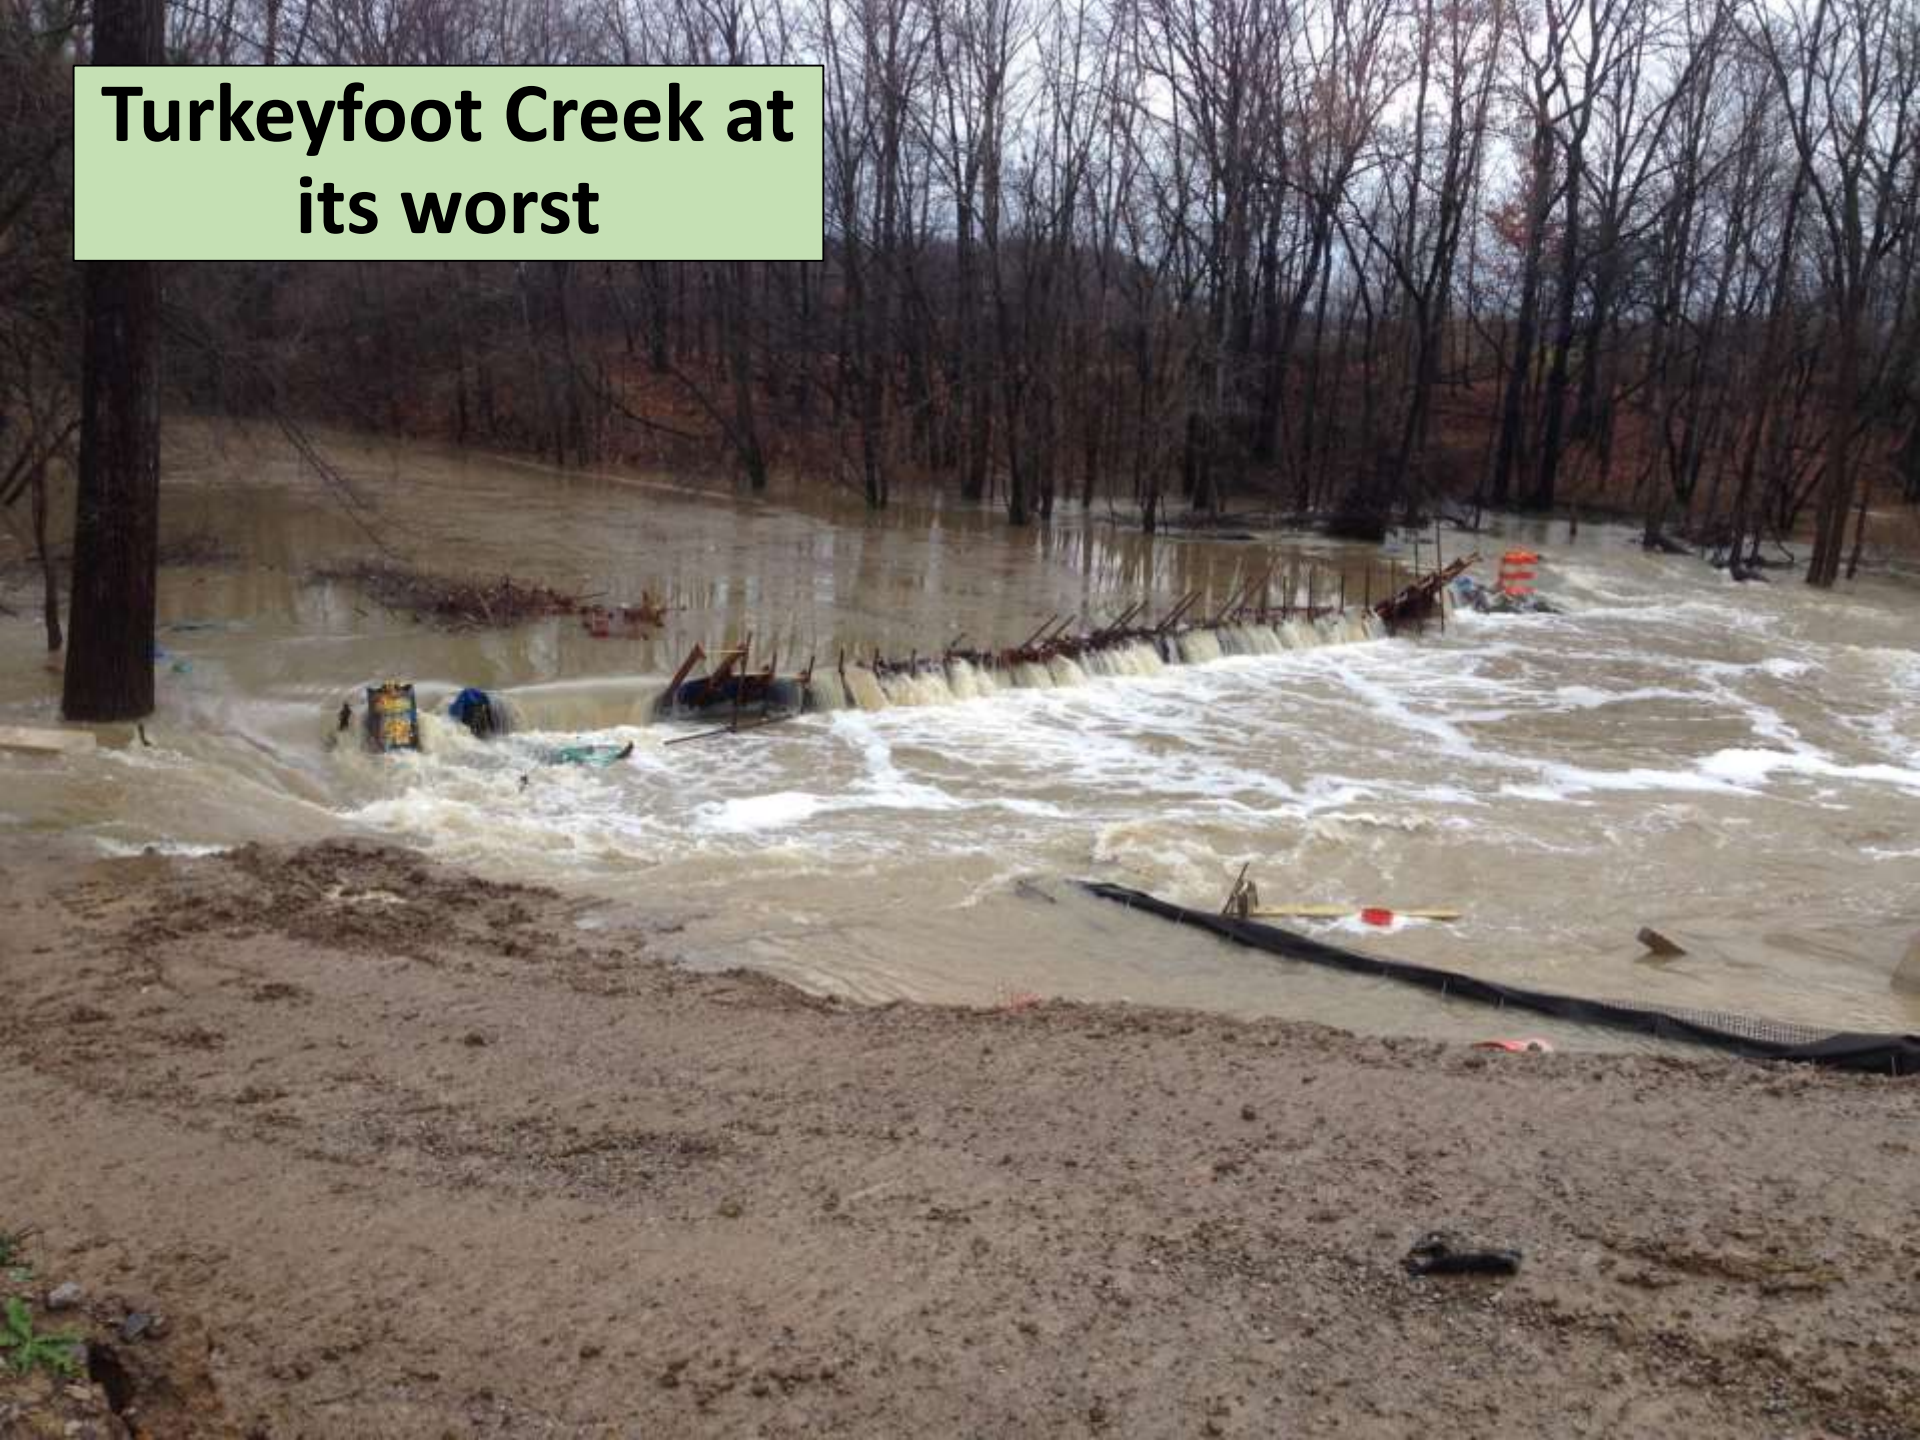
Turkeyfoot Creek at its worst
