Hamilton Eaton Bridge 7.449

Butler County Engineers

- Pre-stressed Box Beam structure built in 1994

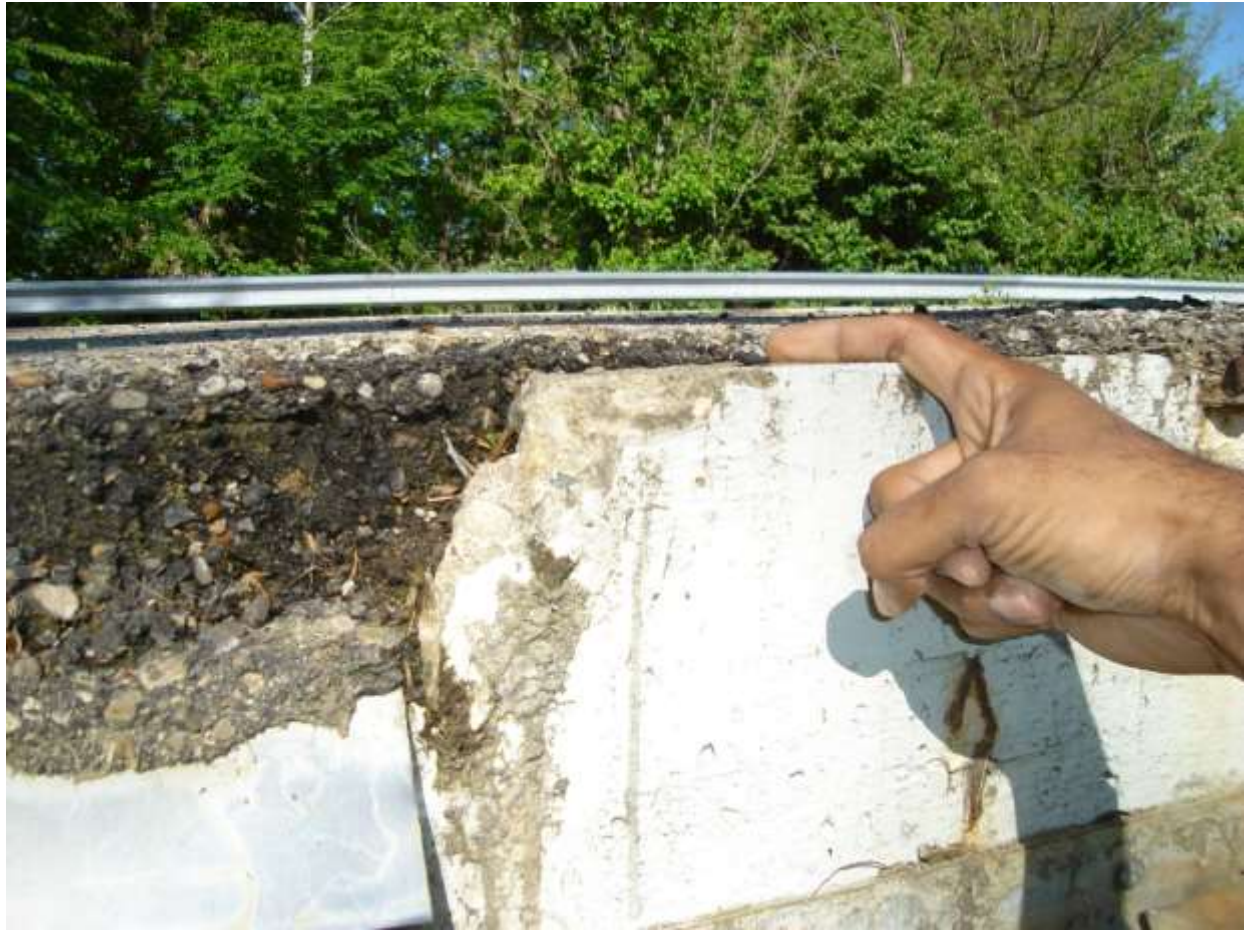
- Abutment Seat
 - Leaking from top of abutment
 - Back Wall Rotted
- Wearing surface
 - Asphalt separating at edge of bridge
- Floor
 - Spalling on top of beam #1, leakage between beam 5-6 entire span

- Scope
 - Do as much in-house as possible
 - Plane bad asphalt from bridge and approach slabs
 - Repair bad concrete and rebar
 - Install drip edge
 - Prep and install Type 3 waterproofing
 - Resurface bridge and approach slabs
