Morgan County Engineer's Office

Stevan Hook, P.E., P.S.

Stevan Hook, P.E., P.S. County Engineer

Making our bridge dollars go further,

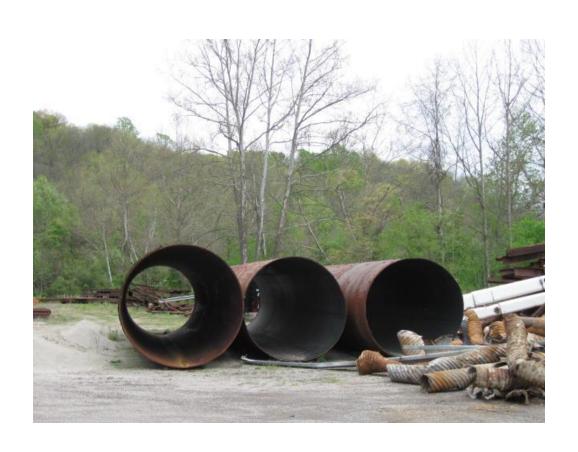
Tanker cars laying in the yard

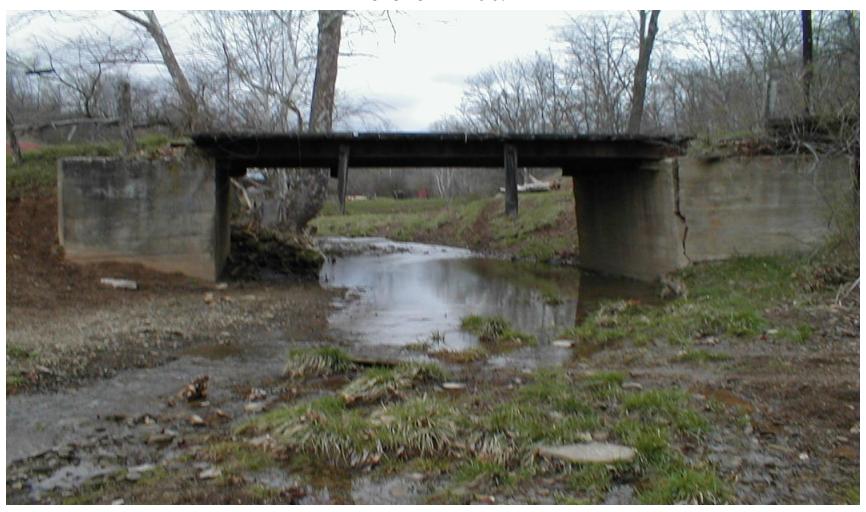
Before in 2009

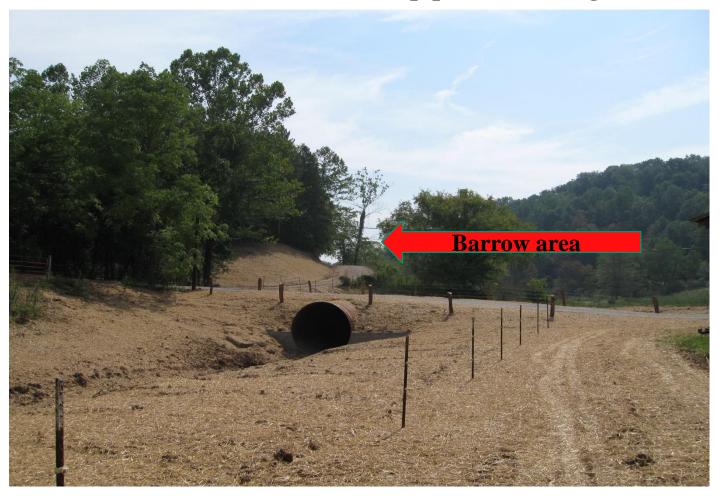
The barrow area was used to fill over pipe & create sight distance.

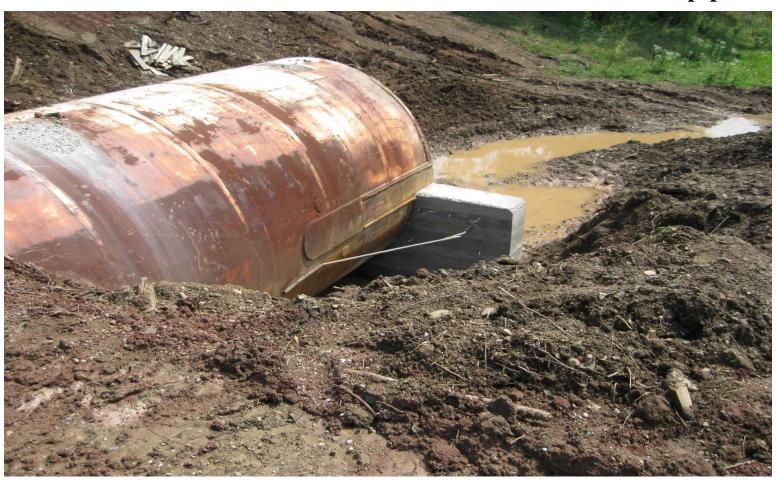
Downstream headwall is 12" thick and 3' below bottom of pipe.

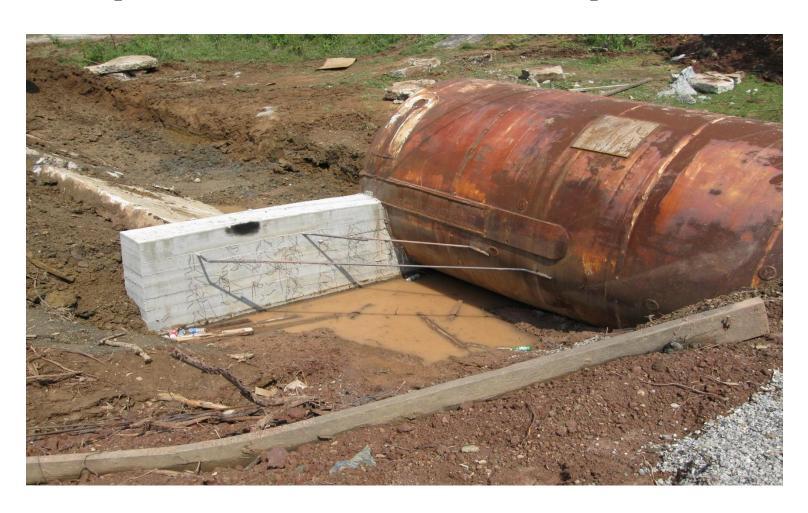
Upstream is the same but wider for erosion protection.

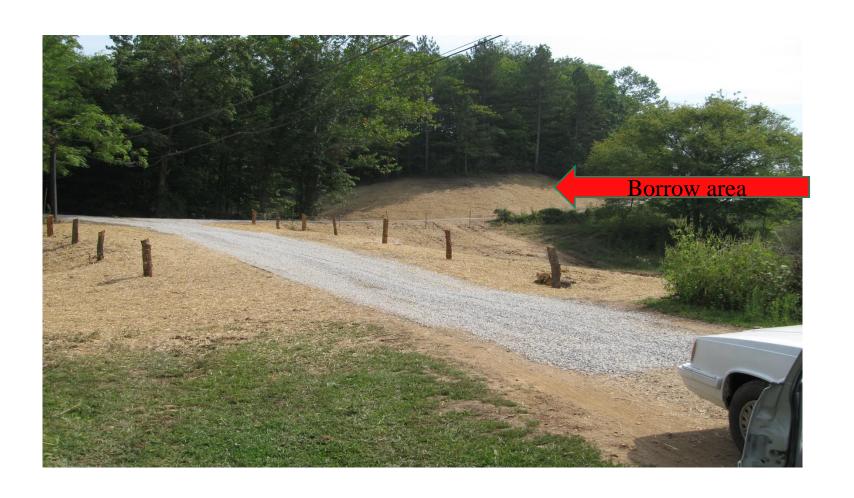
Finished project

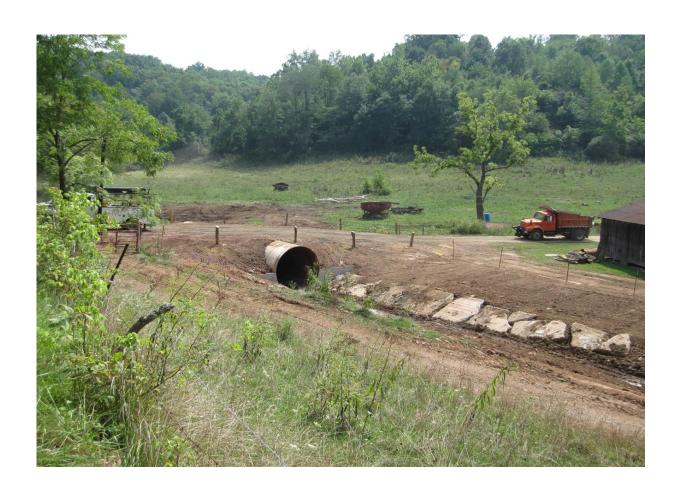
Old concrete abutments were utilized as rock slope protection.

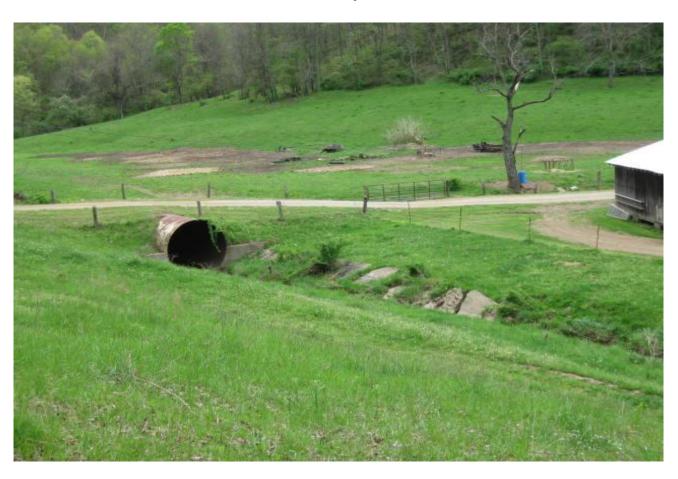
How it looks 9 years later

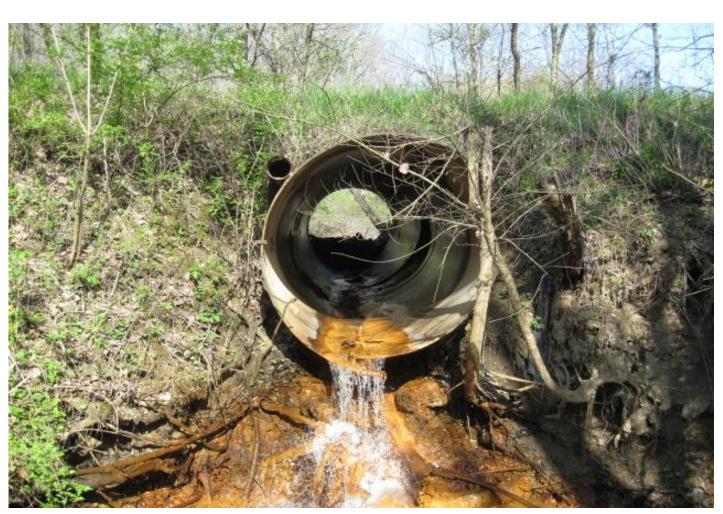
What not to do!! -with acid water

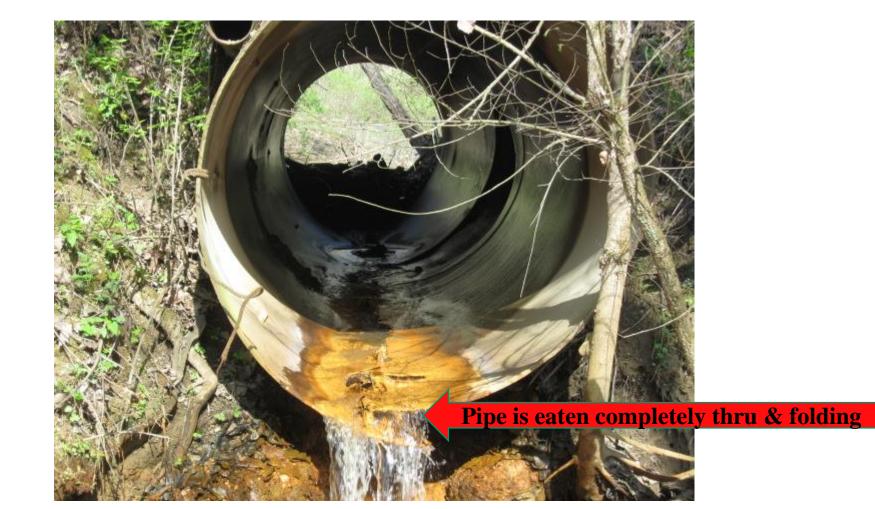
This will have to be replaced, not sure with what!!!

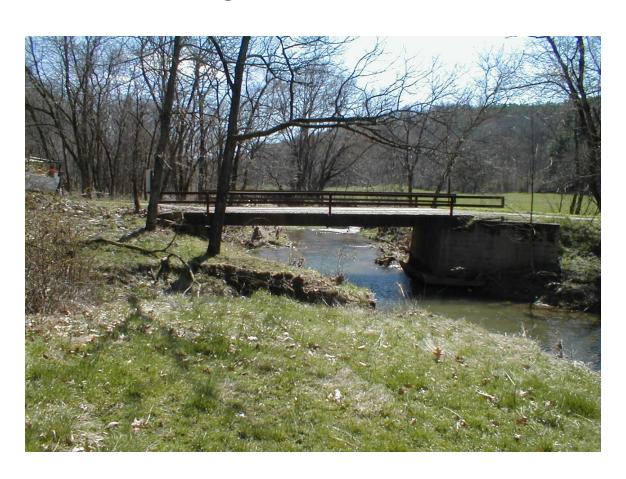
View prior to abutment failure due to scour. 5,000 acre drainage & on an outside bend of creek.

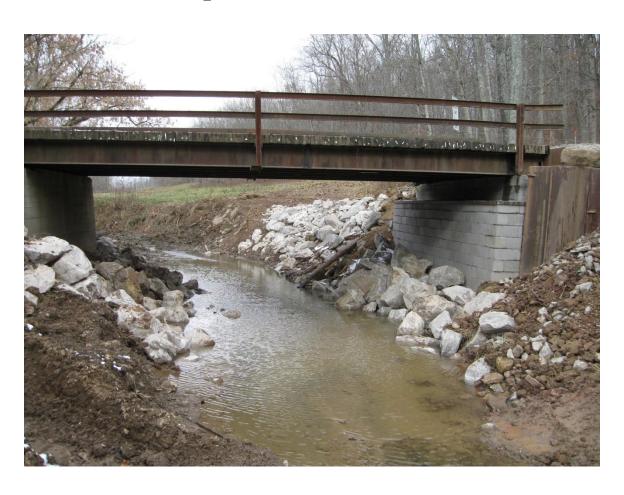
Completed in the fall of 2008

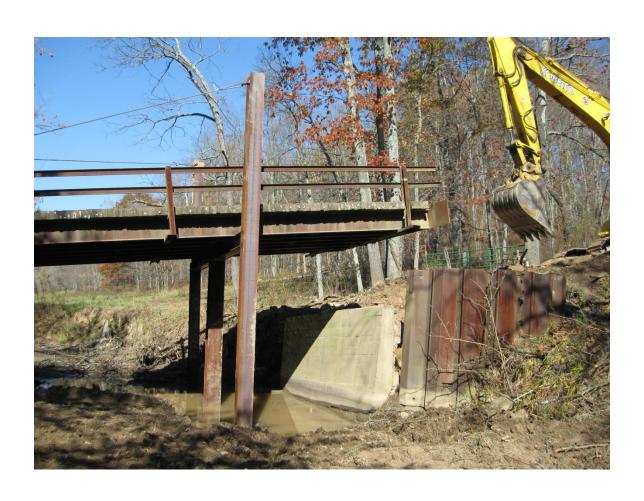
We raised bridge above old abutment & anchored back

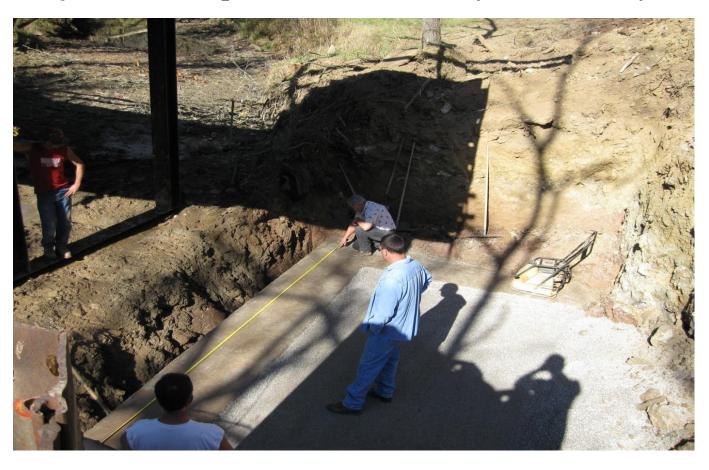
Poured footer to get a level surface, would not do this next time. Would just use a compacted stone base & lay block directly on it.

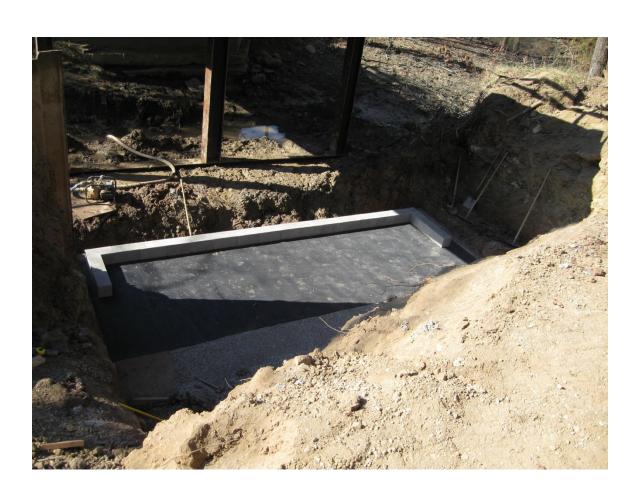
First course of block and fabric

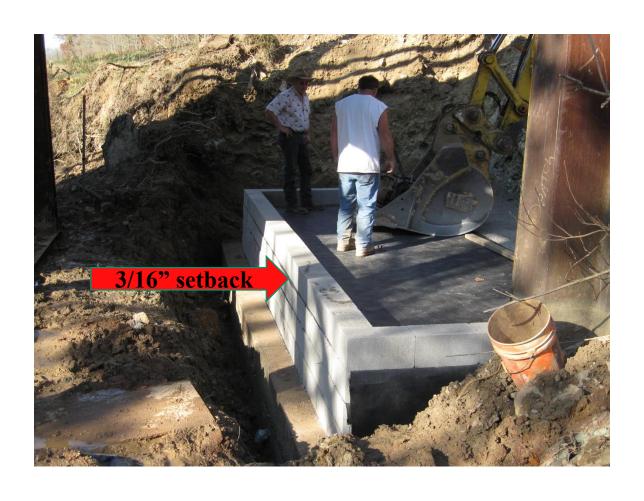
At the 4th tier

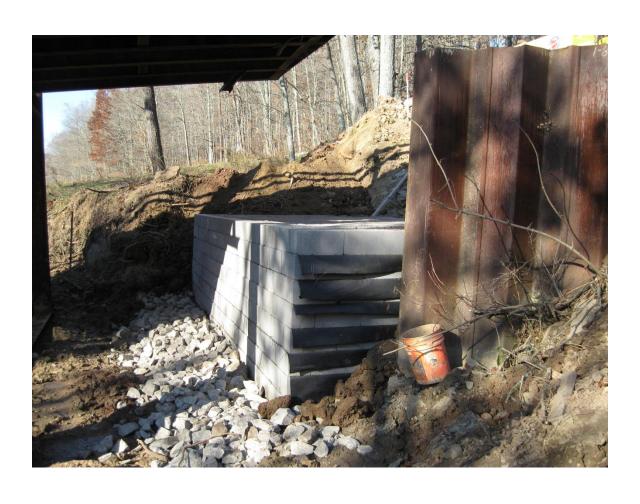
At the 10th tier

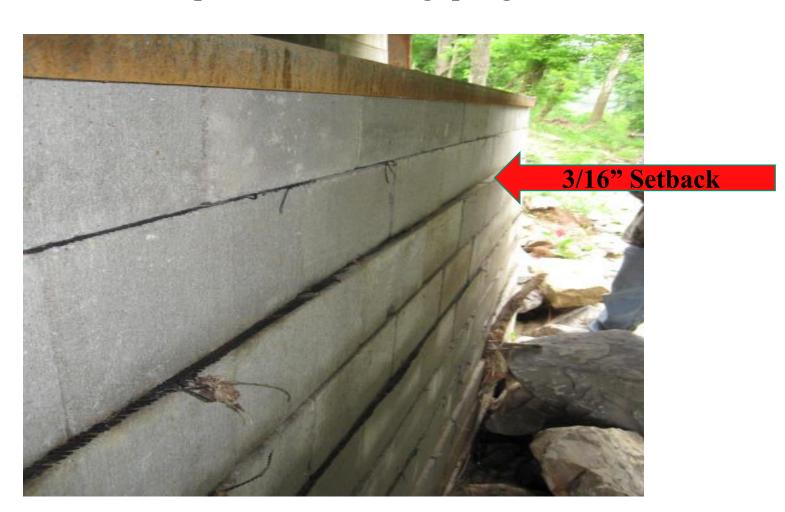
April 2009 – Following spring

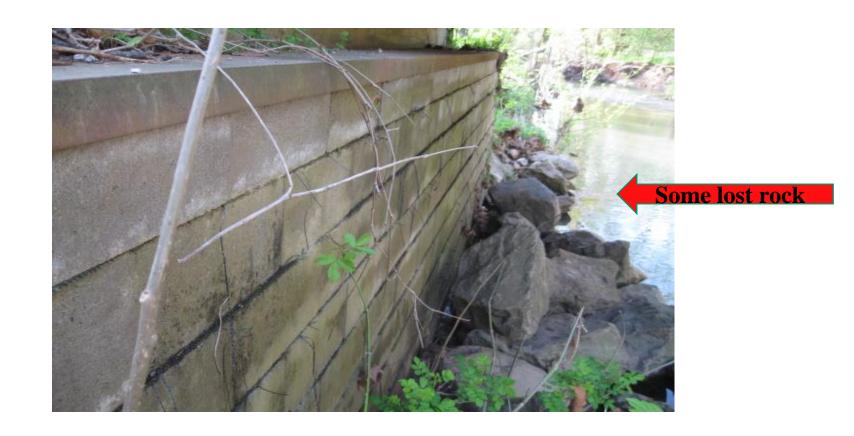
April 2017 - Wall still straight

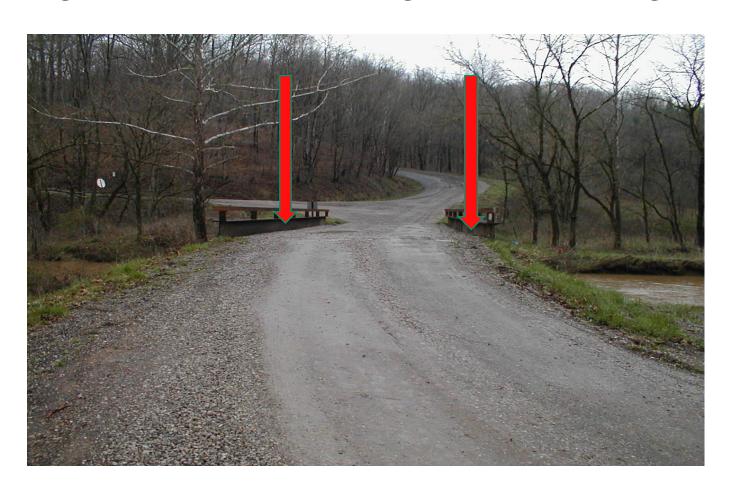
Bridge has a load limit due to stringer section loss at the girders.

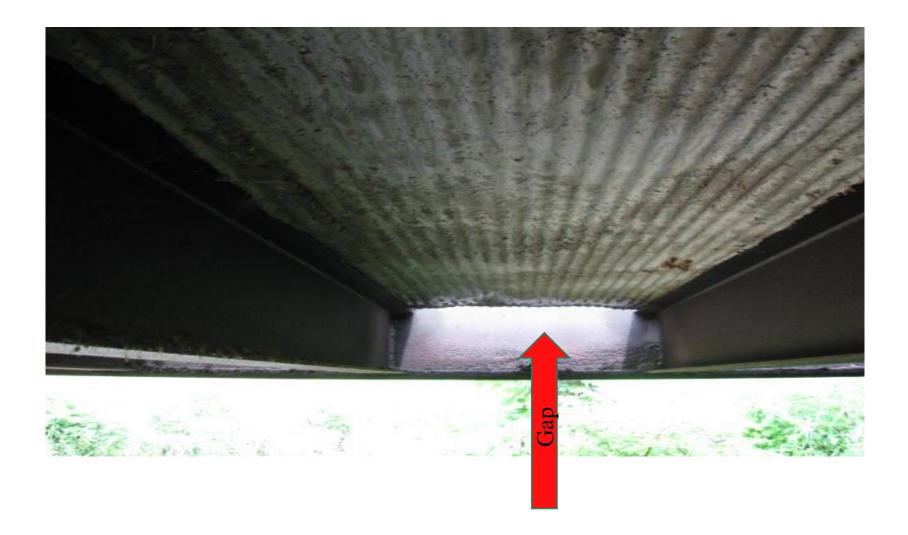
Sun light shining thru gap.

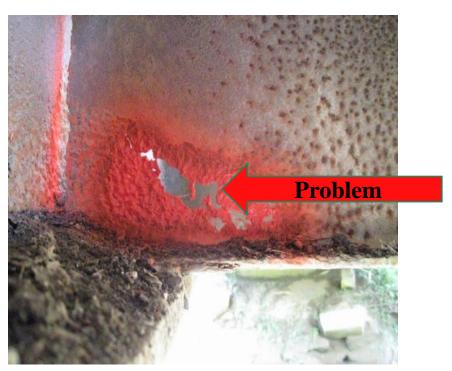
Here is the result.

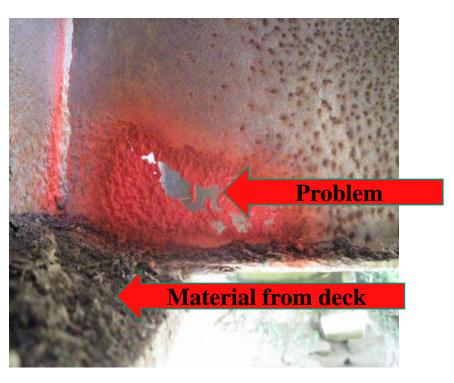
Section loss in web
 of stringer as a
 result of,

This is the controlling condition for the load rating problems.

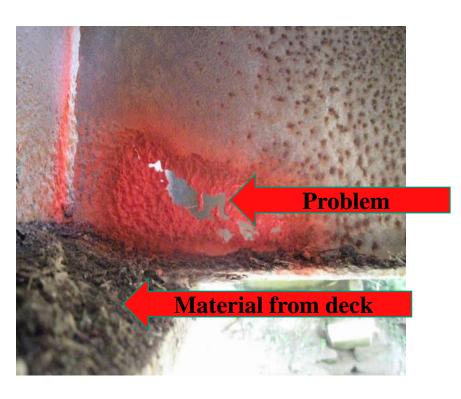
- Section loss in web of stringer as a result of,
- Material build-up on bottom girder flange.

Here is the main load rating problem & cause.

- Section loss in web of stringer
- Material build-up on bottom girder flange.
- Began a bridge washing program to buy time.

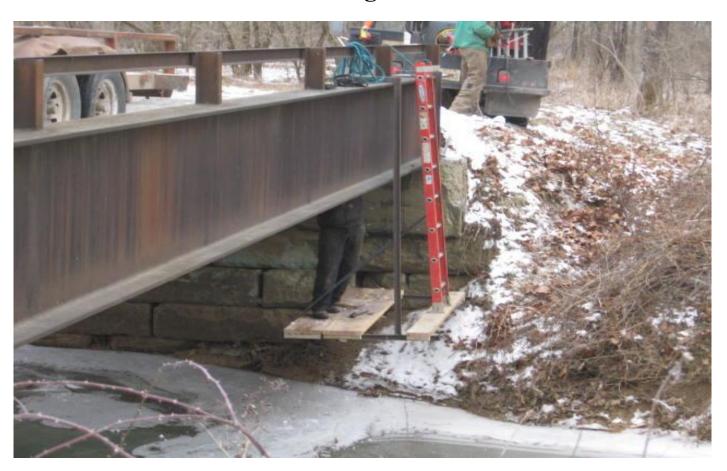
Access to work area under the bridge was a big problem. This was the bridge crew's solution.
