National Bridge Inspection Standards & Bridge Maintenance Program Review

Miami County

April 27, 2021

By: Mark Sherman, PE

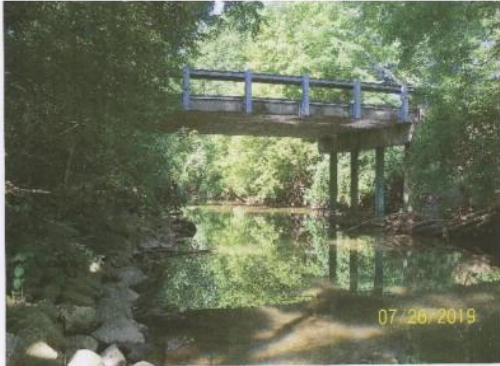
Channel photo could have better visibility of abutments. Fortunately the channel is narrow enough here to see the abutments are set well back from the channel.

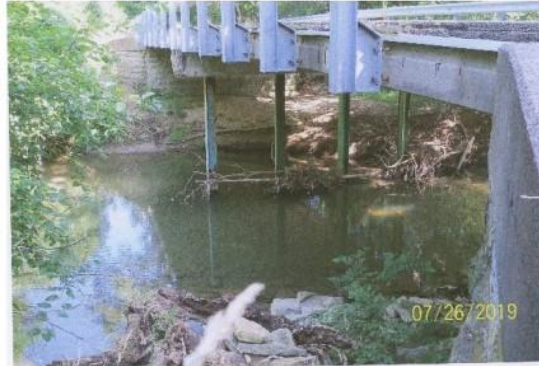
Channel Photo is not acceptable, due to sharp angle. Cannot see channel relative to abutment on the right, or the channel immediately upstream of the bridge.
