# OTWAY COVERED BRIDGE (35-73-15) SCIOTO COUNTY

County Engineer's Association of Ohio

# **Otway Covered Bridge History**

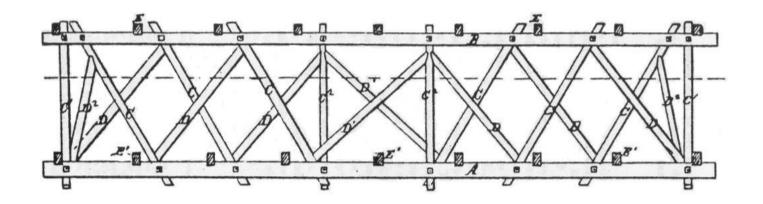
"Type 1" Smith Truss, from patent drawings of 1867

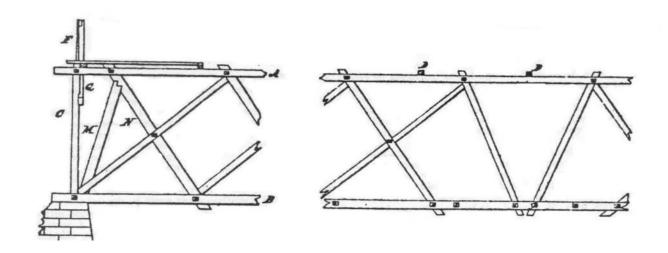
"Type 2" Smith Truss, from patent drawings of 1869

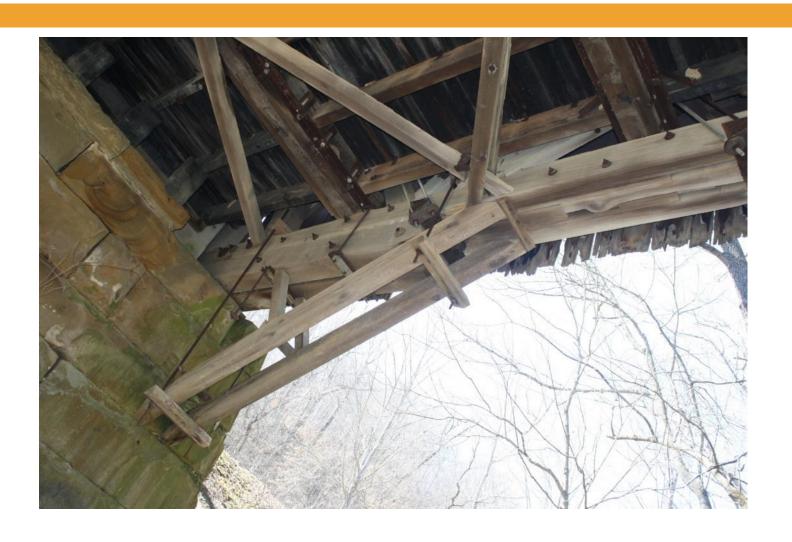
- After the steel bridge and walkway built, the siding was removed and contractor began to straighten the bridge and to Jack it up to get camber back in the bridge
- The lower Chord was out of alignment by nearly 6"
- Deck was sagging ~ 5 ½"
- Straightened bridge using cables and come-a-longs and placed blocking under the lower chord and slowly began jacking the bridge
- Jacked up to +9" of camber (bridge would settle after making all repairs and new roof and siding. The bridge was jacked 14+ inches at the center

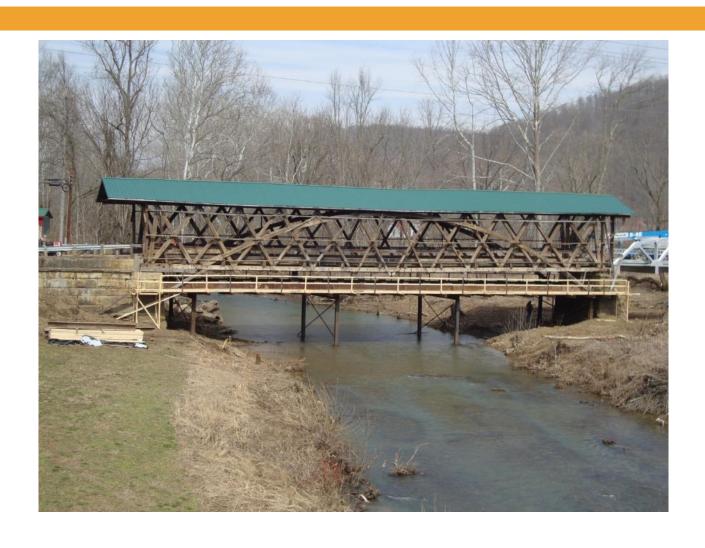
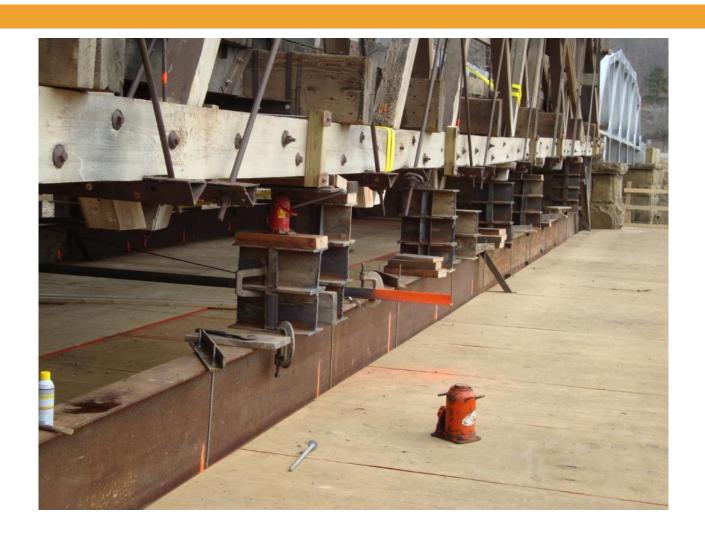
- Once bridge was straight and camber placed, began replacing and repairing members along the lower chords. This is where most of the deterioration of the bridge was located. Took right around 2 months for this work
- Originally planned to replace 7 lower chord members
- Total replaced 13. Other members were discovered when removing members scheduled for replacement.
   Once we could see in inside face of these members, they had to be replaced
- Additionally 3 upper chord members were replaced

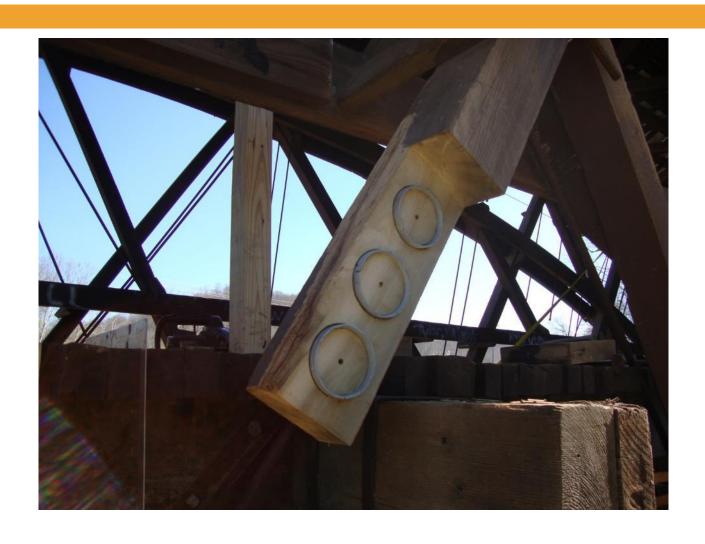
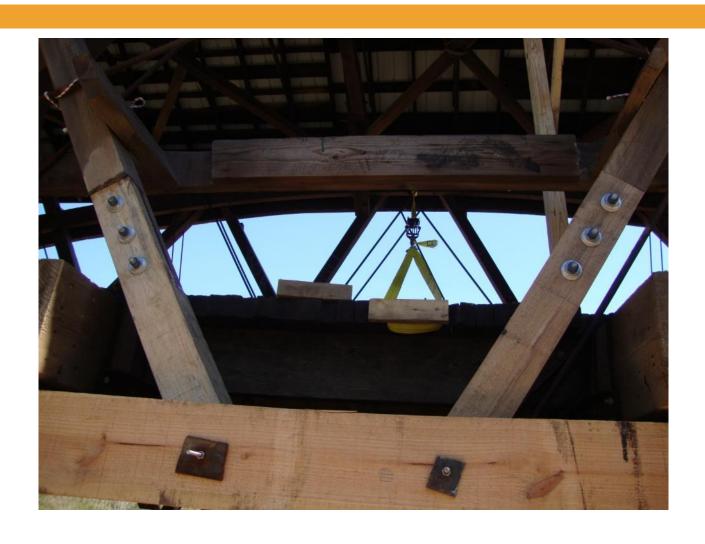
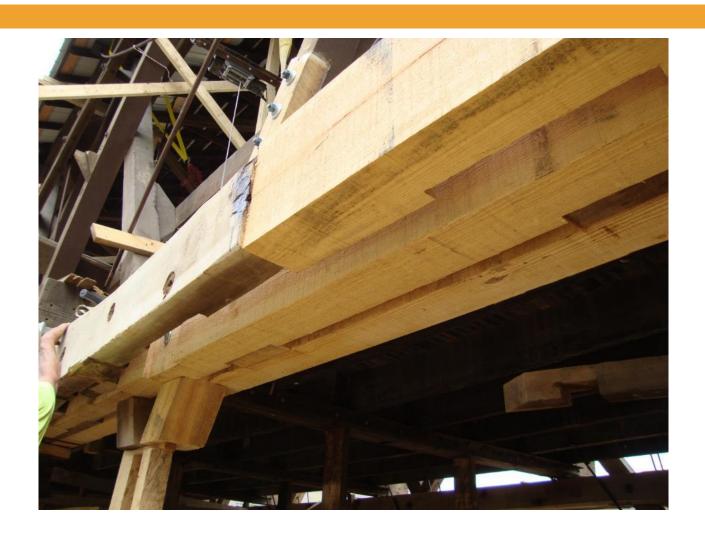
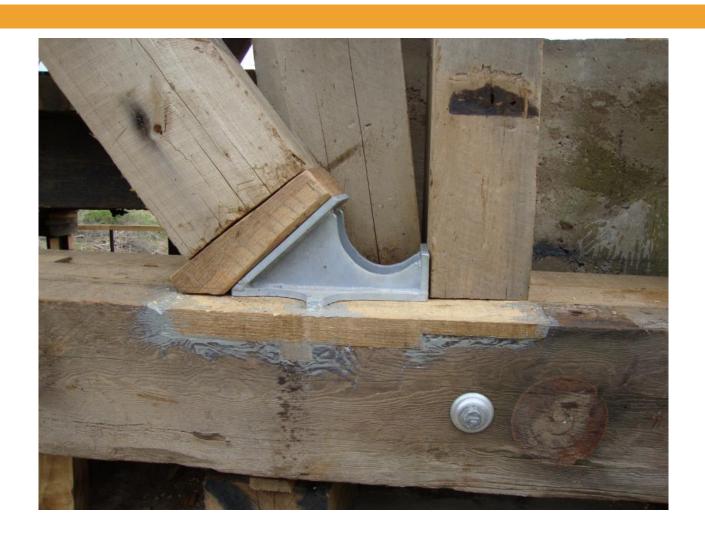
- Overall total 29 members replaced includes X braces, spacer blocks, fish plates arch pieces, 1 tension member, and the upper and lower chords
- Also discovered that the lower chord bolts that hold the 3 members together were failing. We had to replace nearly all of these bolts. Total of 132
- Another unique portion of this bridge is the tension rods.
  The contractor had a time with these!! Replaced 31 of these rods. Took nearly 3 week s to install and tighten

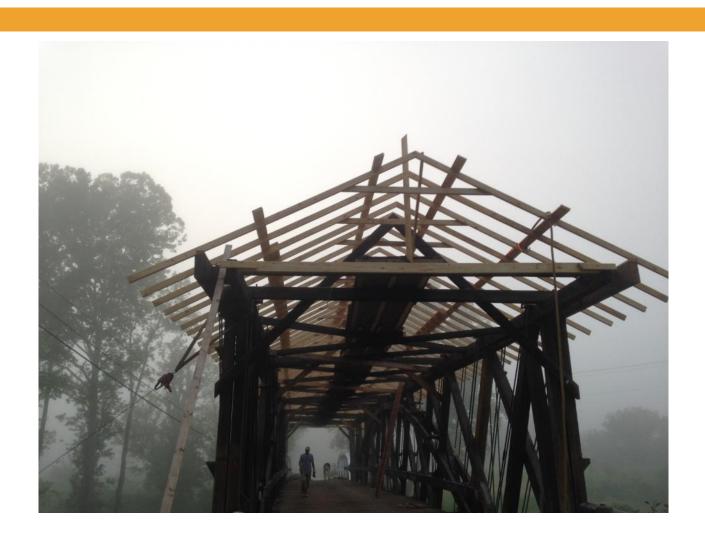
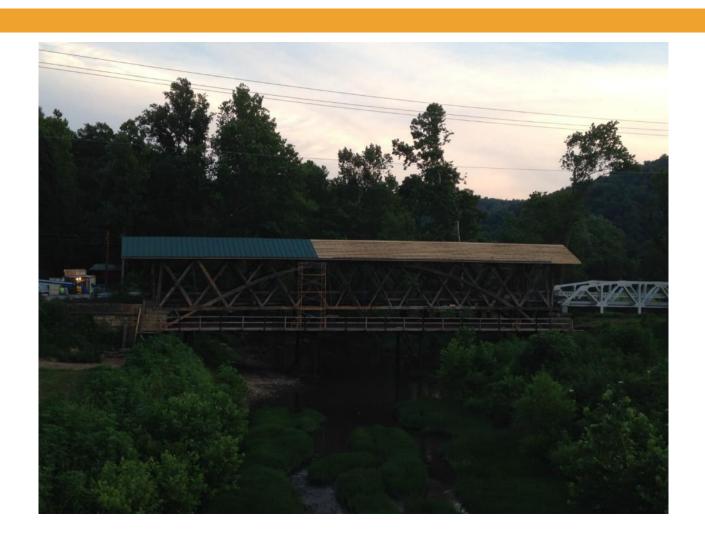
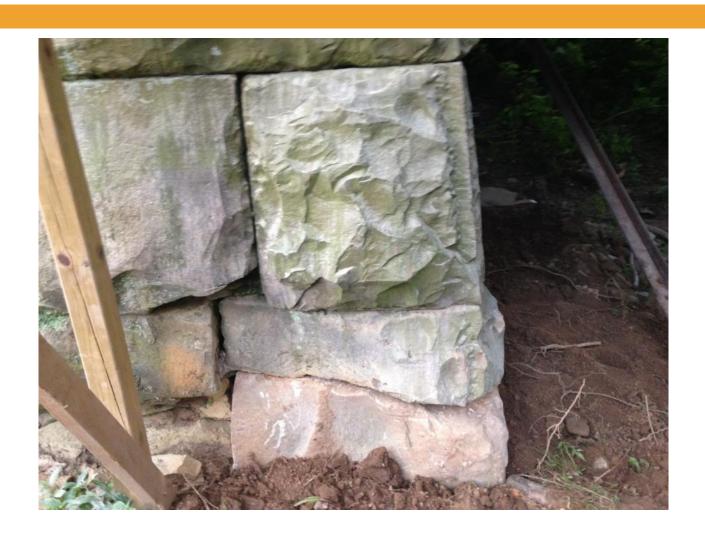
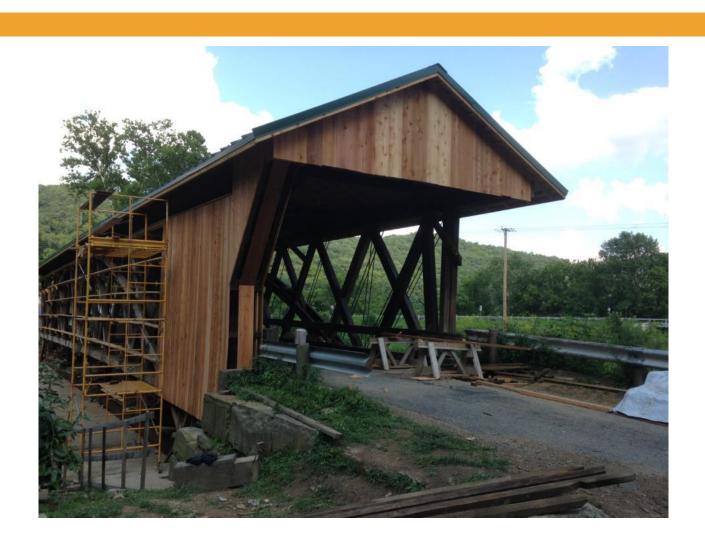
- New roofing system and new timber support system underneath was part of the project
- New siding on the bridge is western red cedar taking about 2 ½ weeks to install
- No windows were installed
- 125 gallons of fire retardant was added covered everything
- Safety LED Rope lighting was installed along the top chord to allow for indirect lighting of the bridge when it's dark out
