2015 Ohio Bridge Conference

Anthony Wayne Bridge

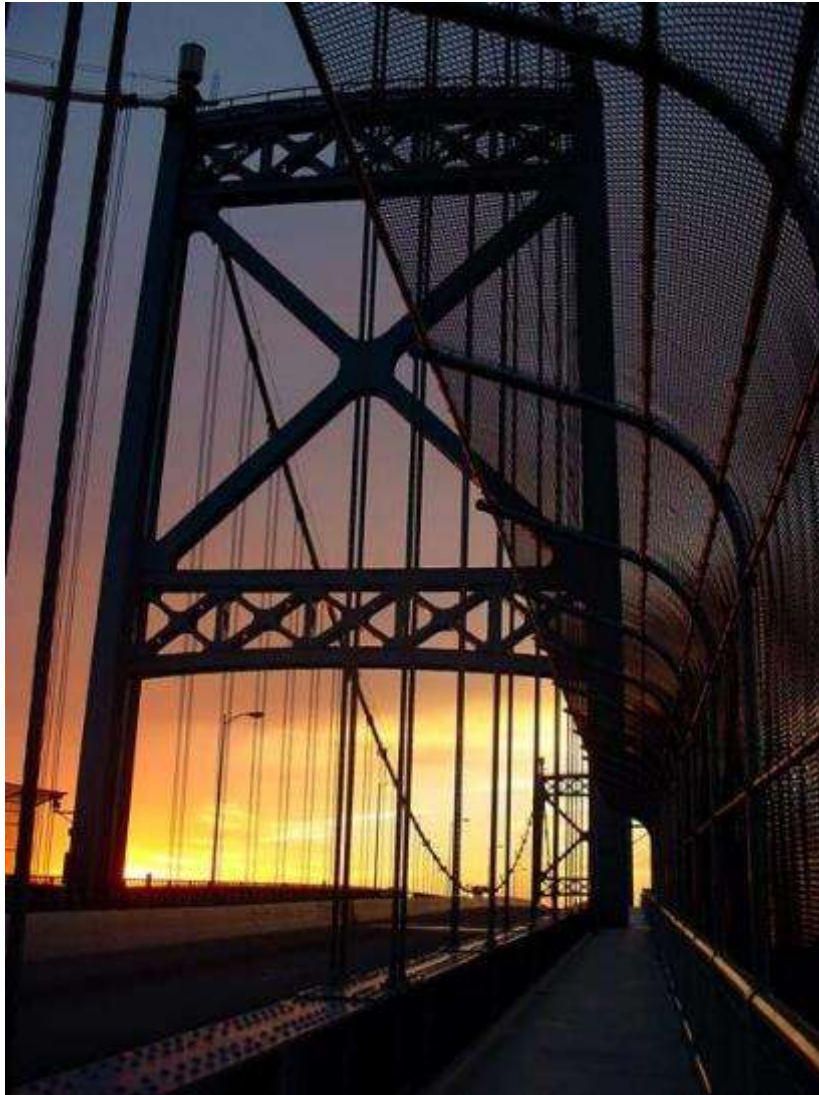
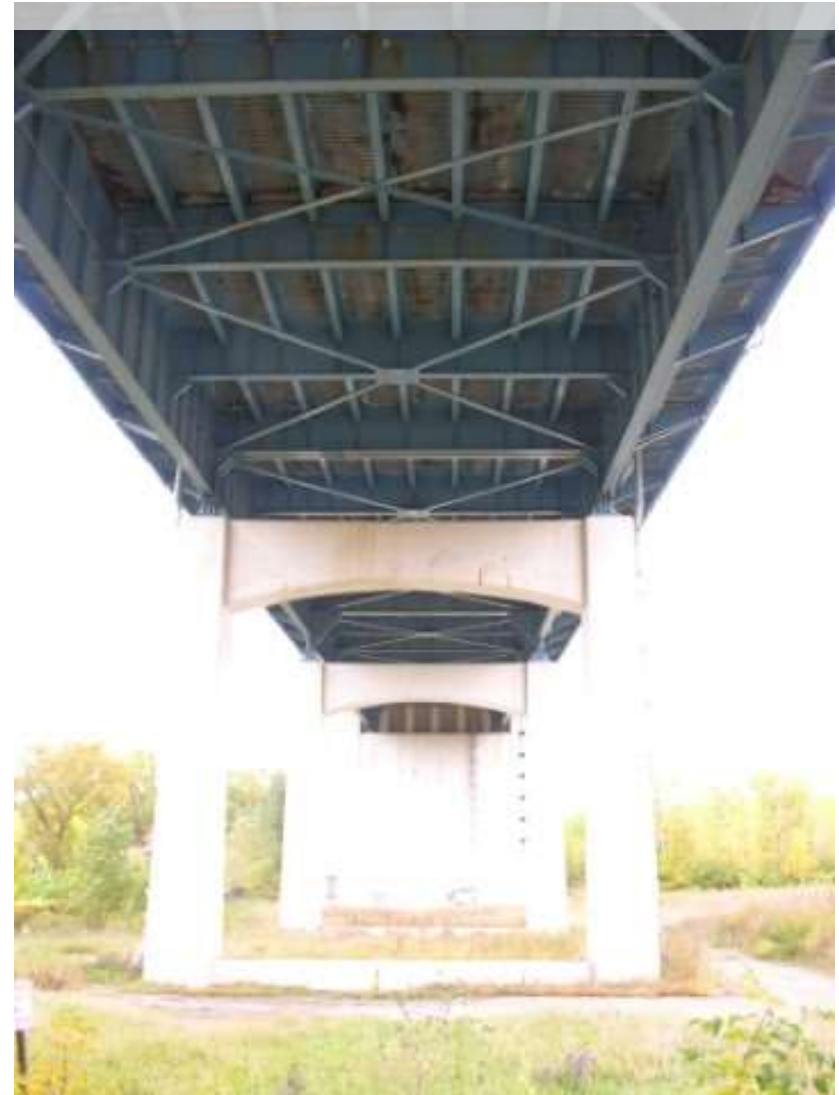
Tower Repairs

- Struts and X-bracing
- Lacing and Lattice work
- Concrete base patching

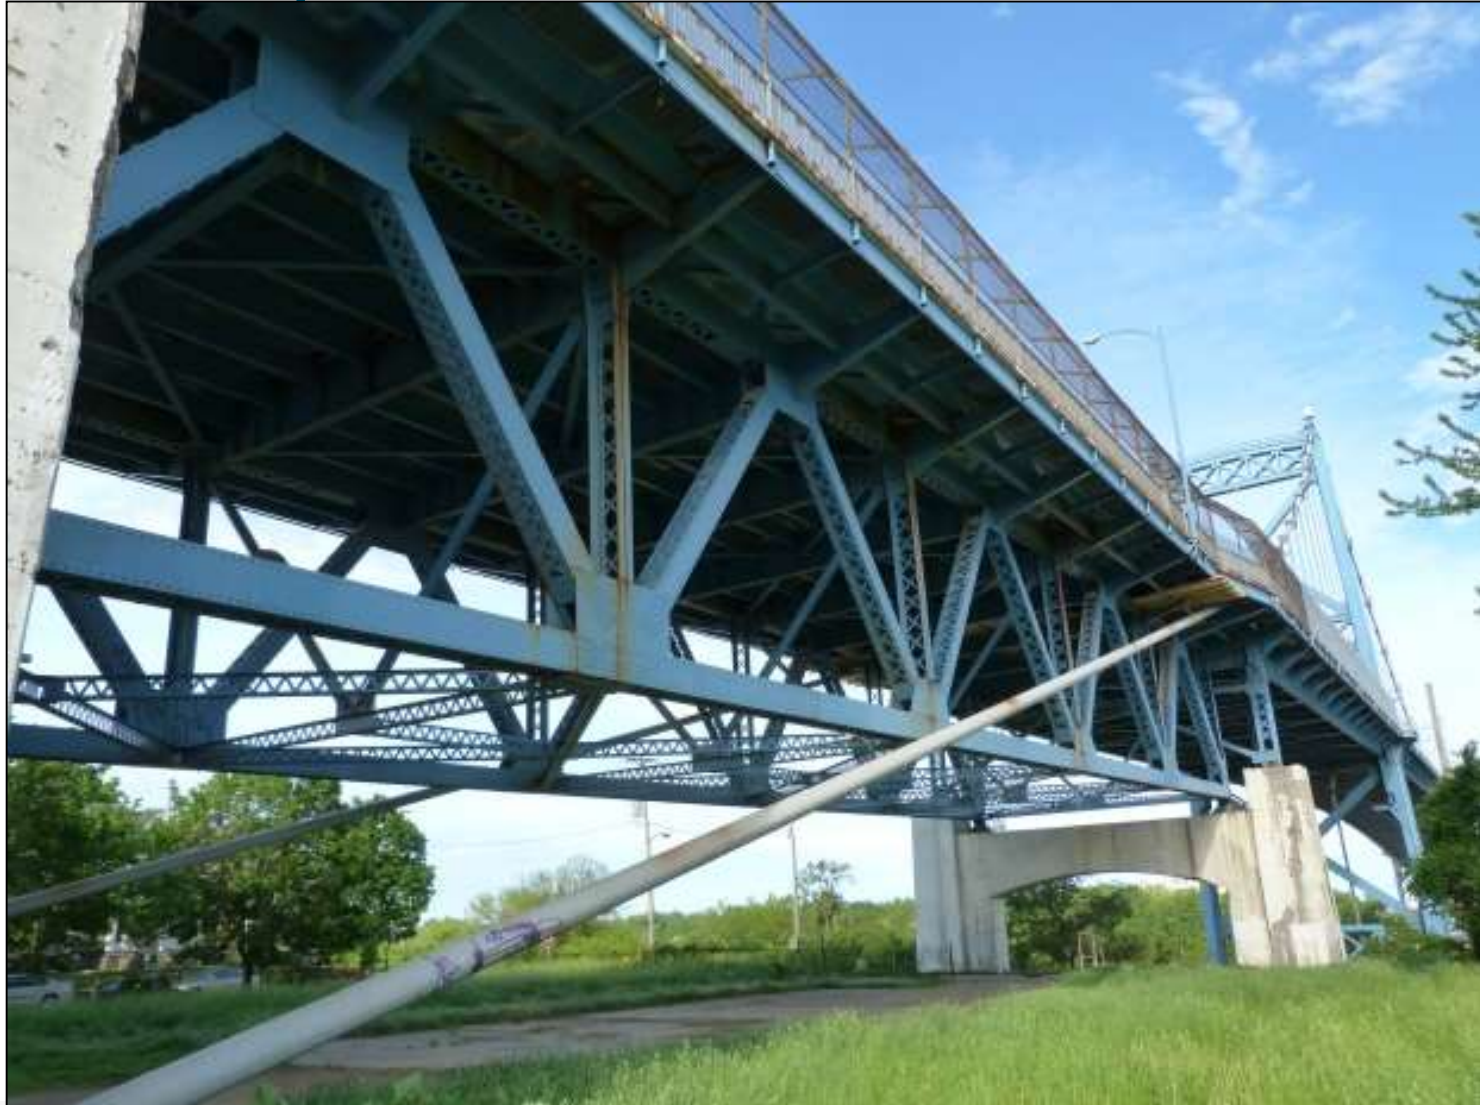
Truss Replacement Evaluation

Two Steel Deck Trusses

Rehabilitation vs. Replacement
Analysis

Replaced with a Two Span Steel
Multi-girder Bridge Structure

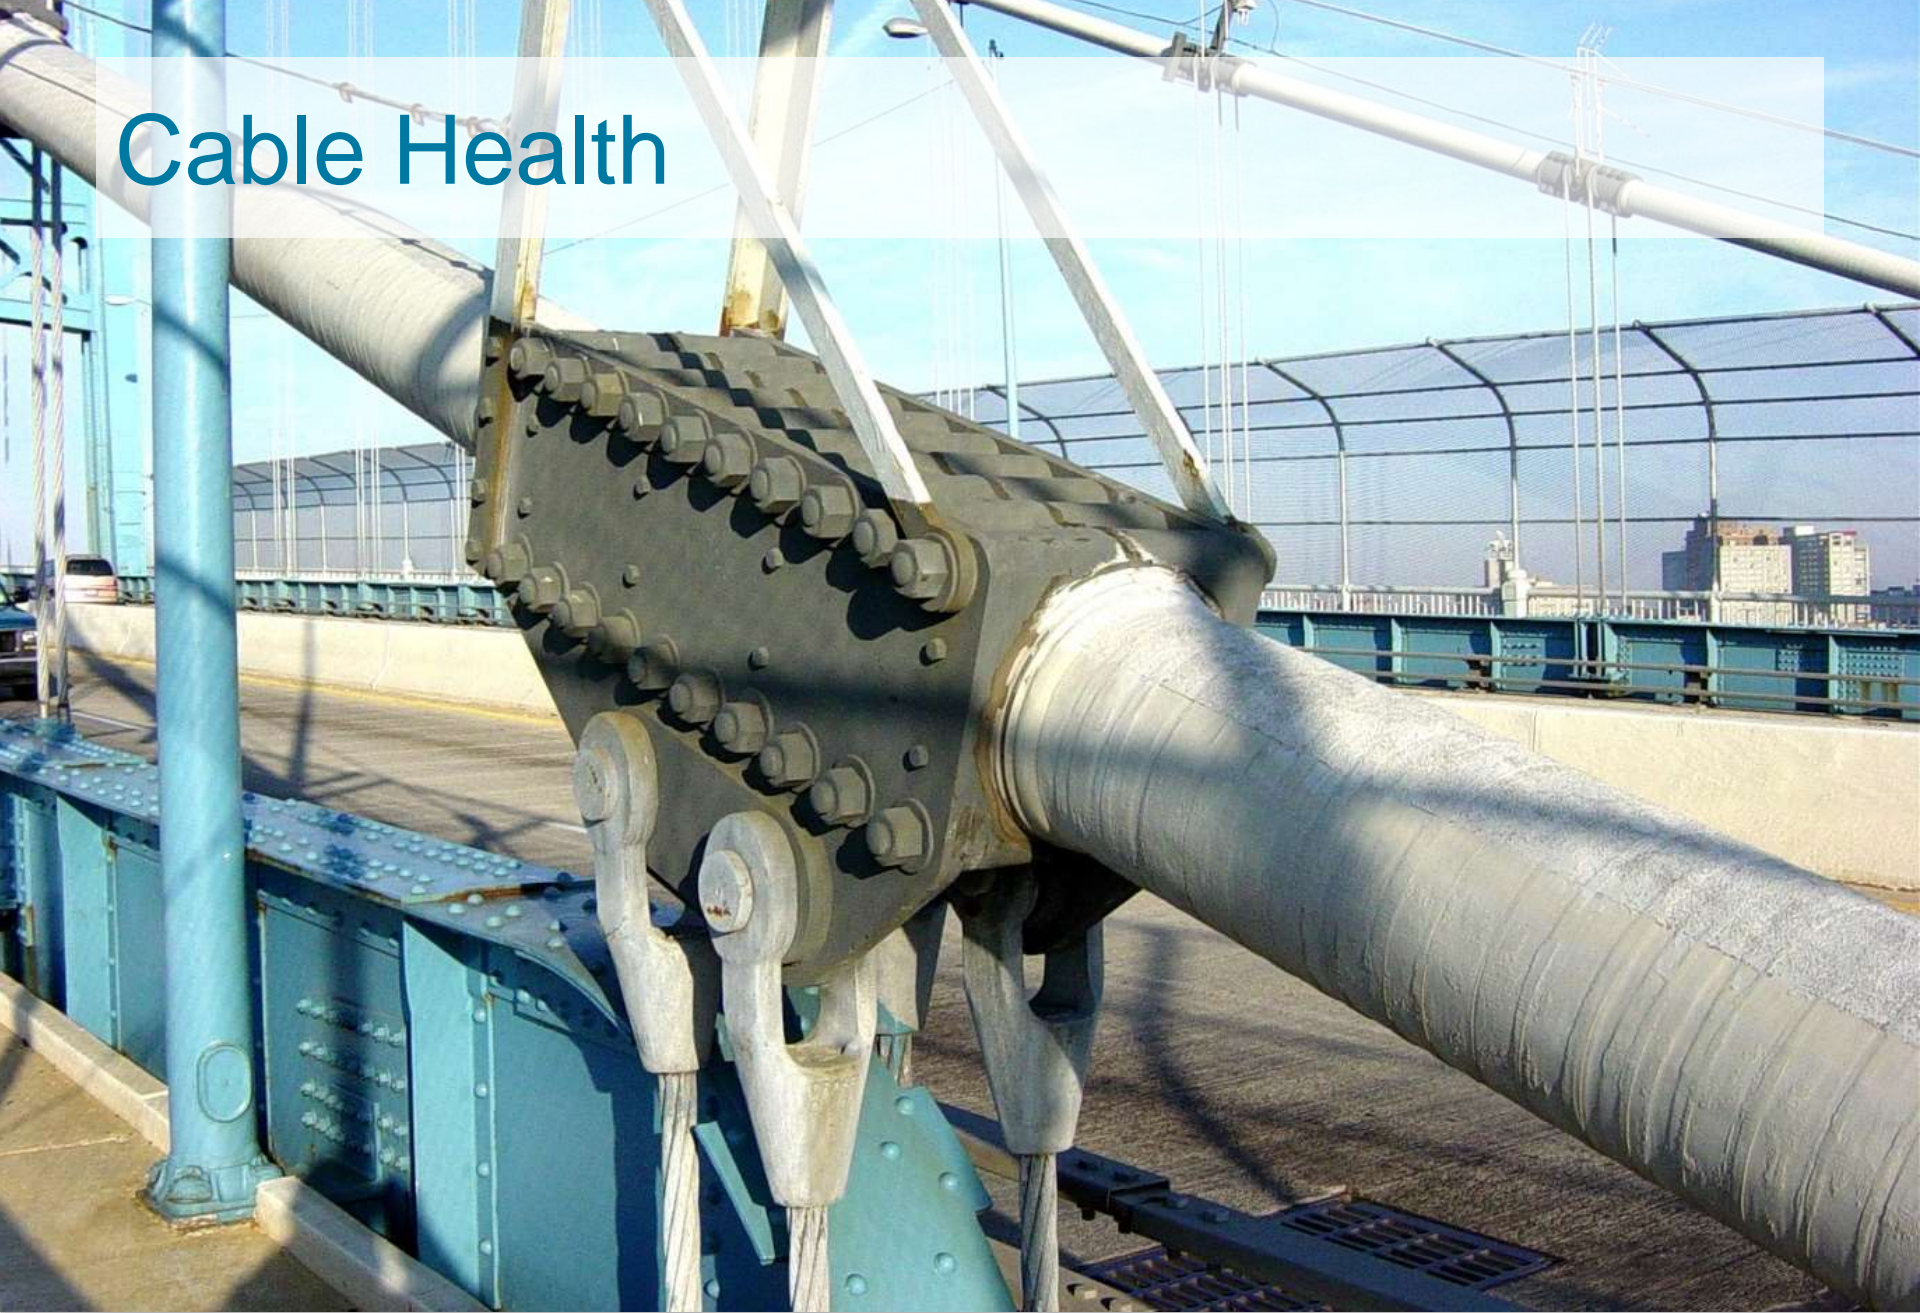
Original Cable Cross Section

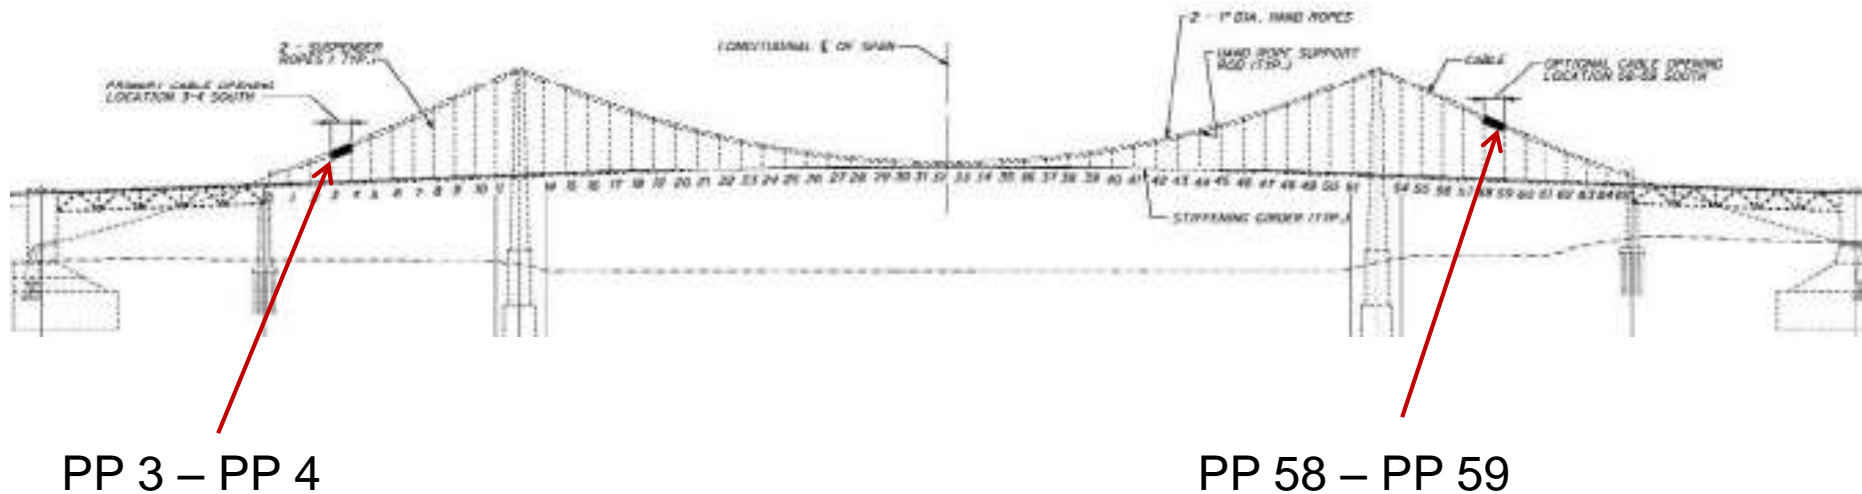
Cable Opening

- How many locations and where?
 - South Cable

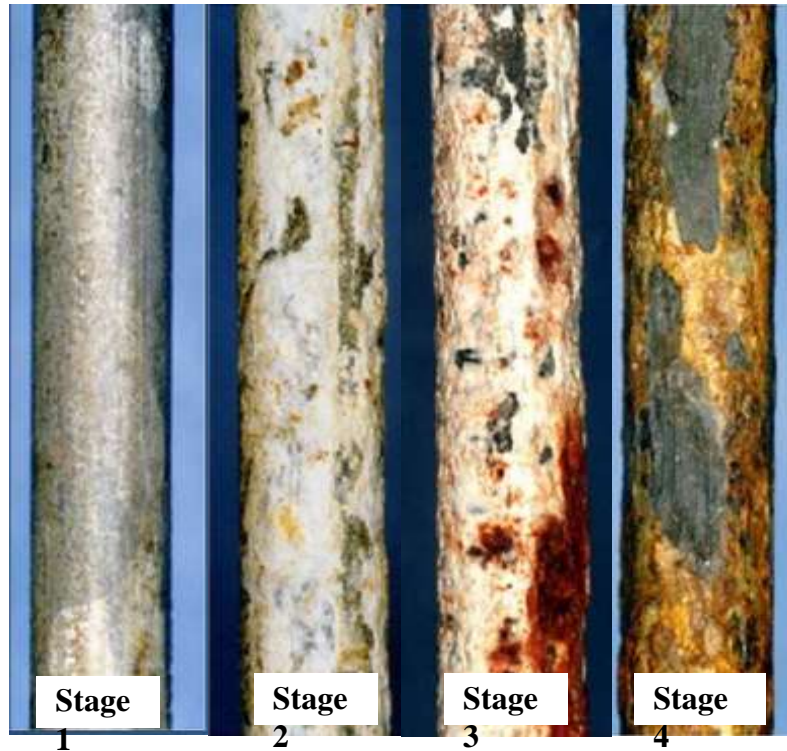
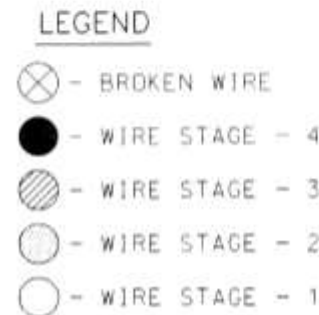
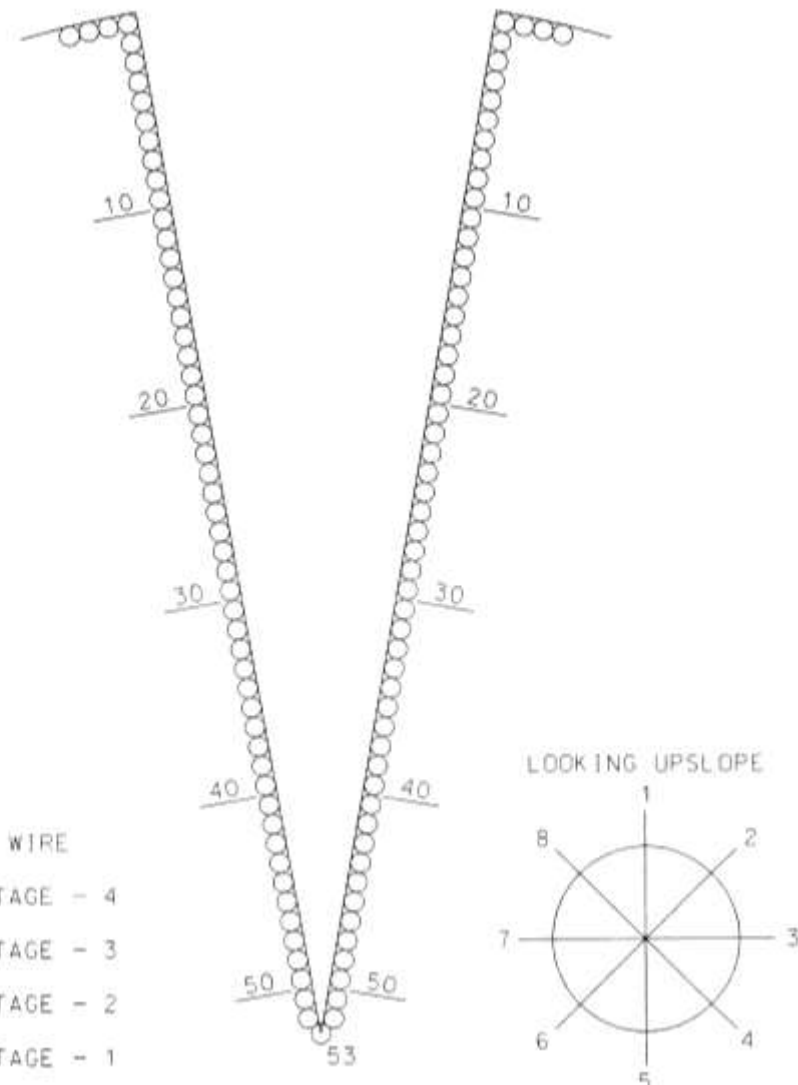
Wire Inspection

- Corrosion Stages of Cable Wires
(Figure 1.4.2.2-1 of NCHRP Report 534)

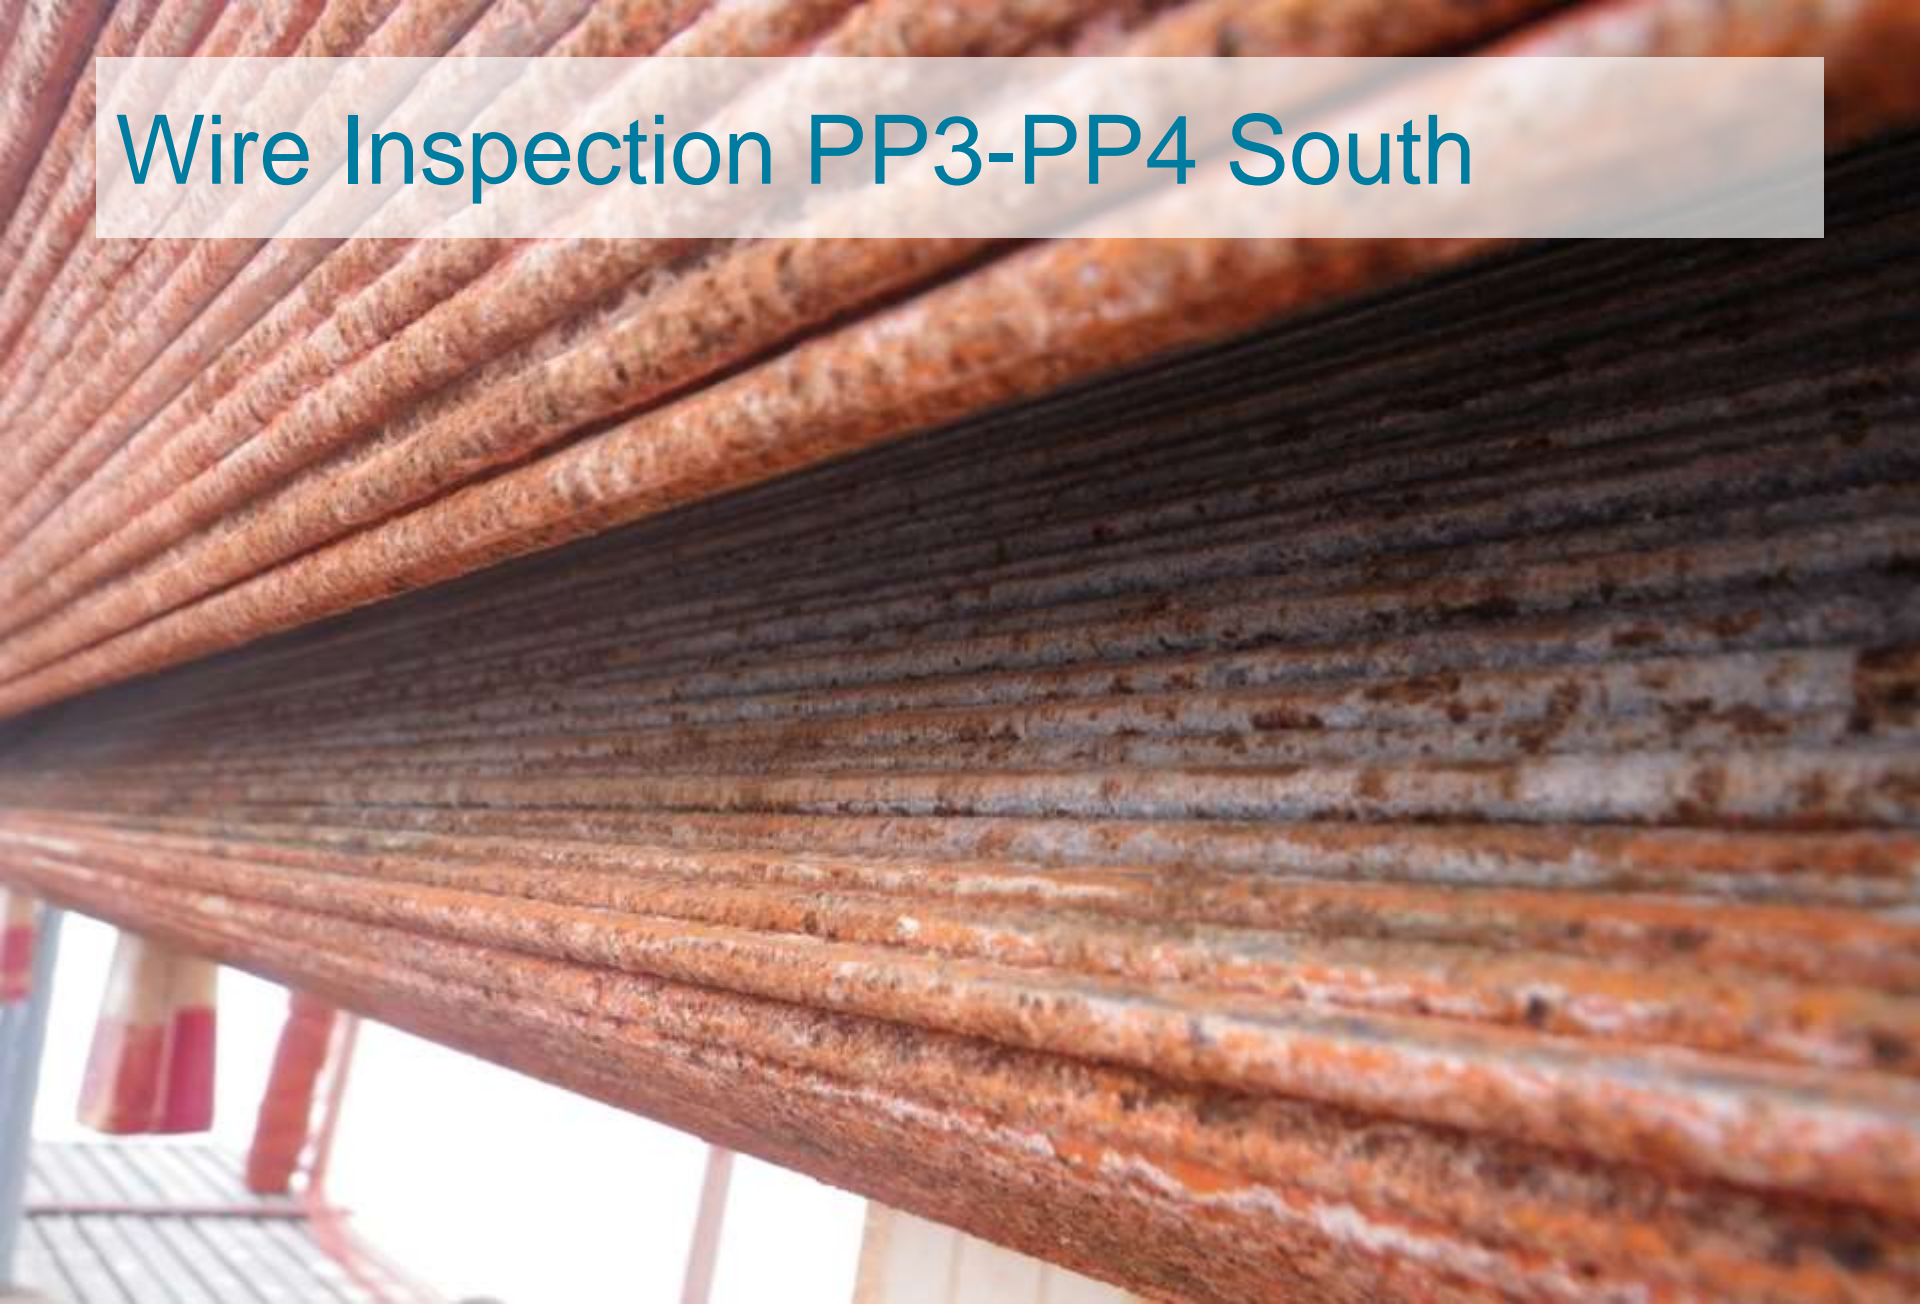
Wire Inspection PP3-PP4 South

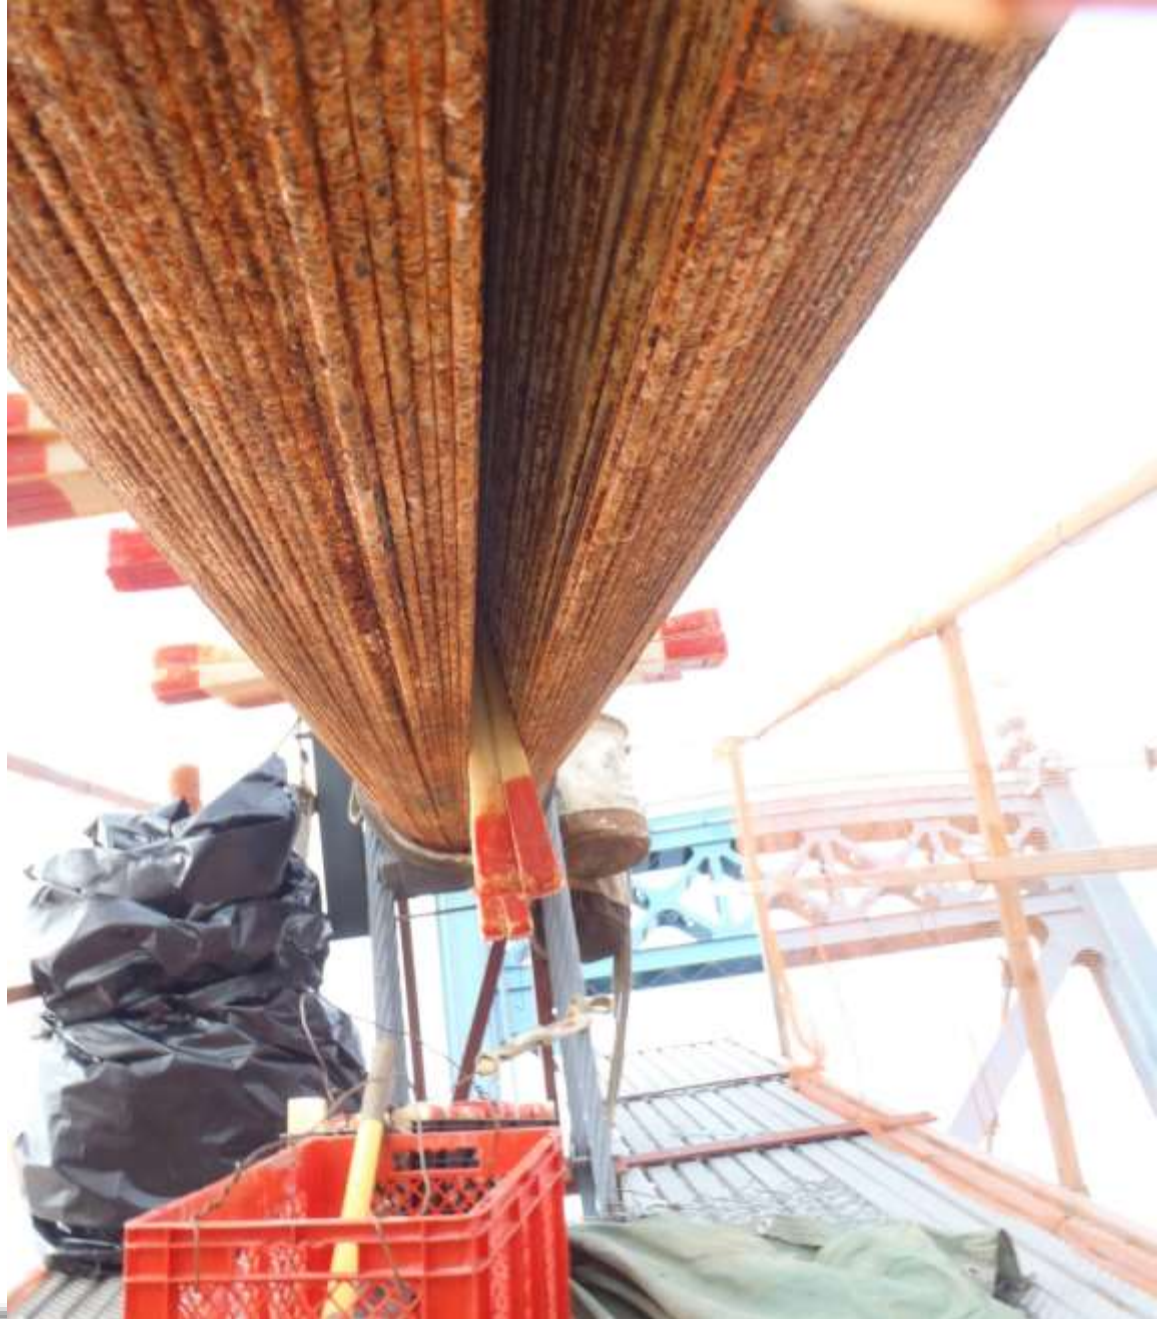
Wire Inspection PP58-PP59 South

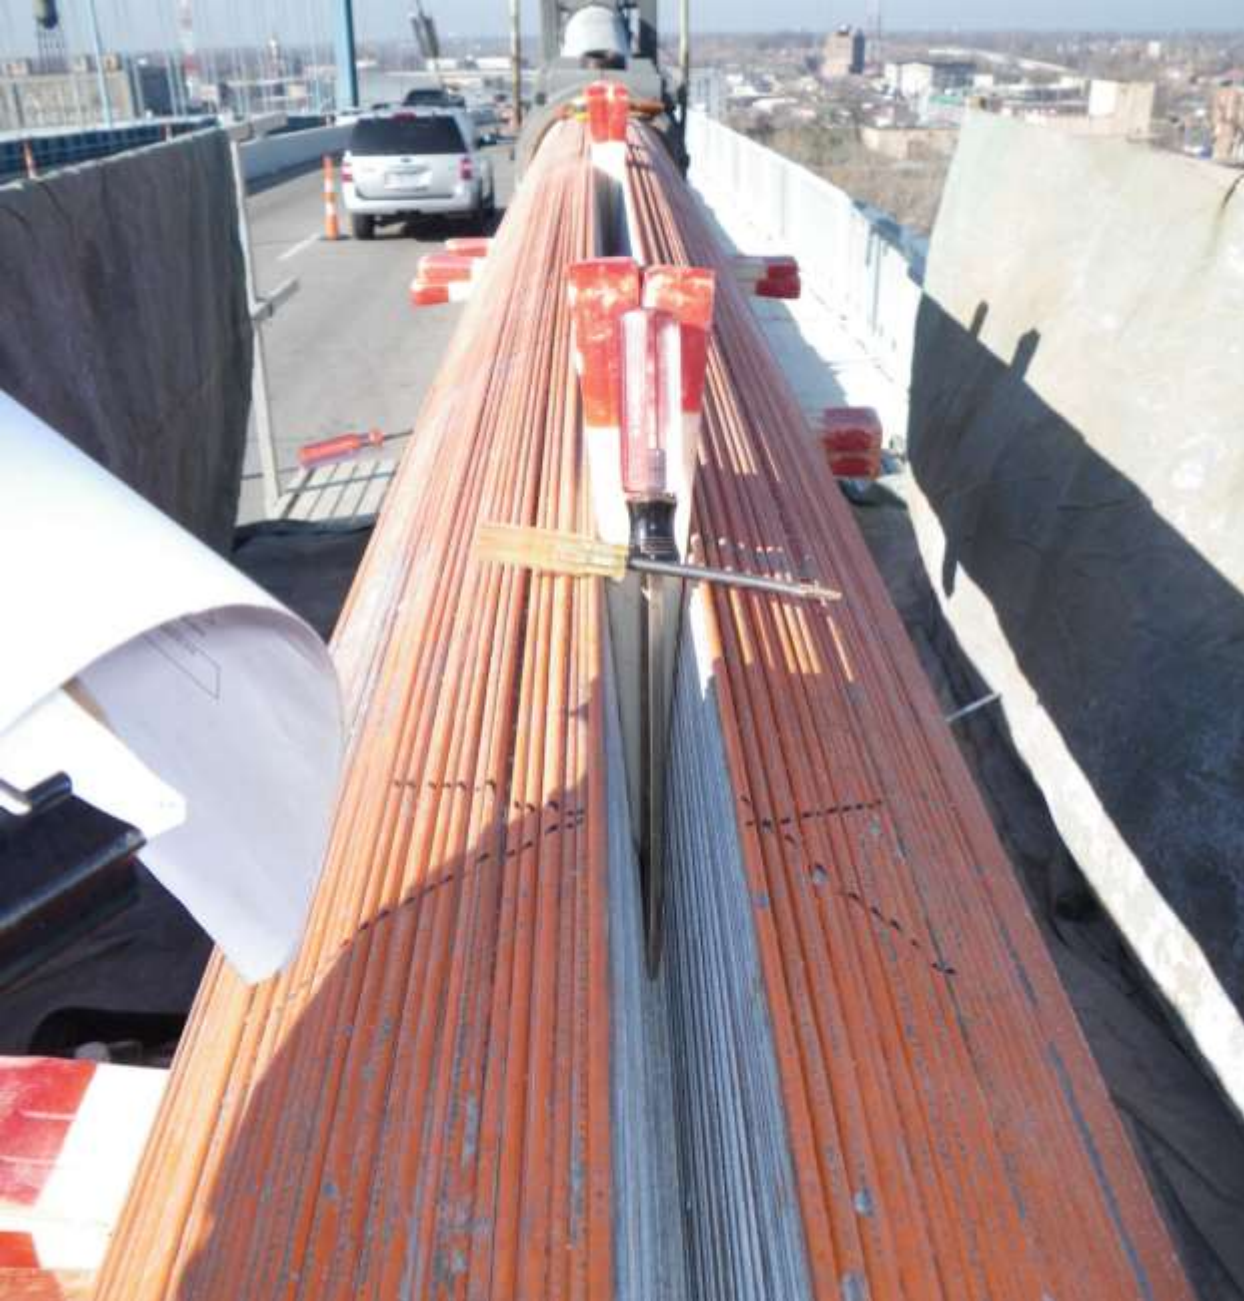
Wire Inspection PP31- PP32 North

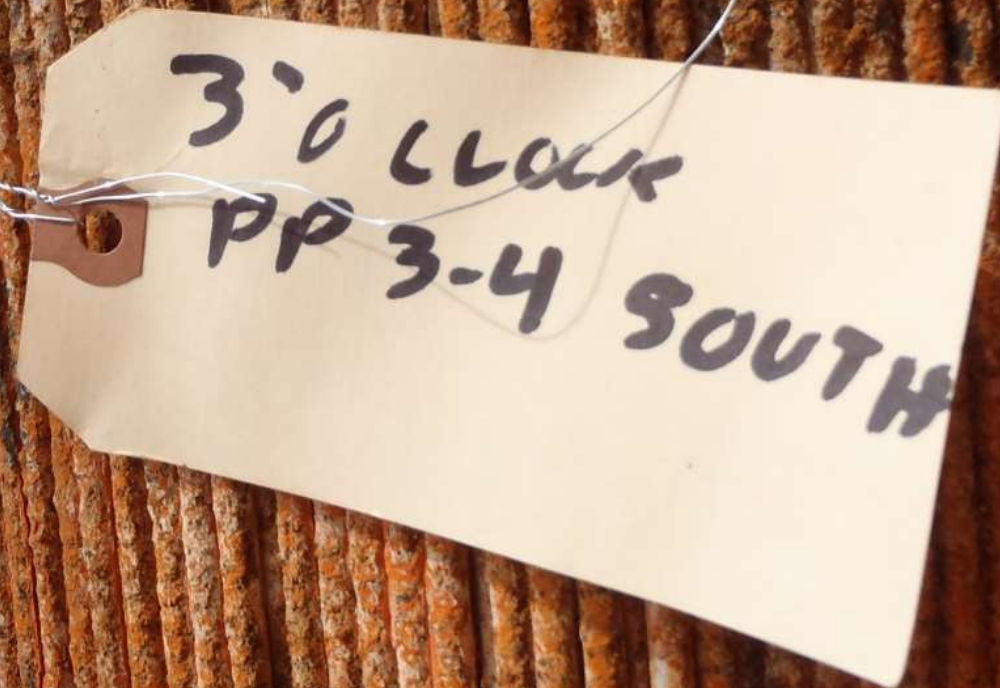
Wire Sample PP3- PP4 South

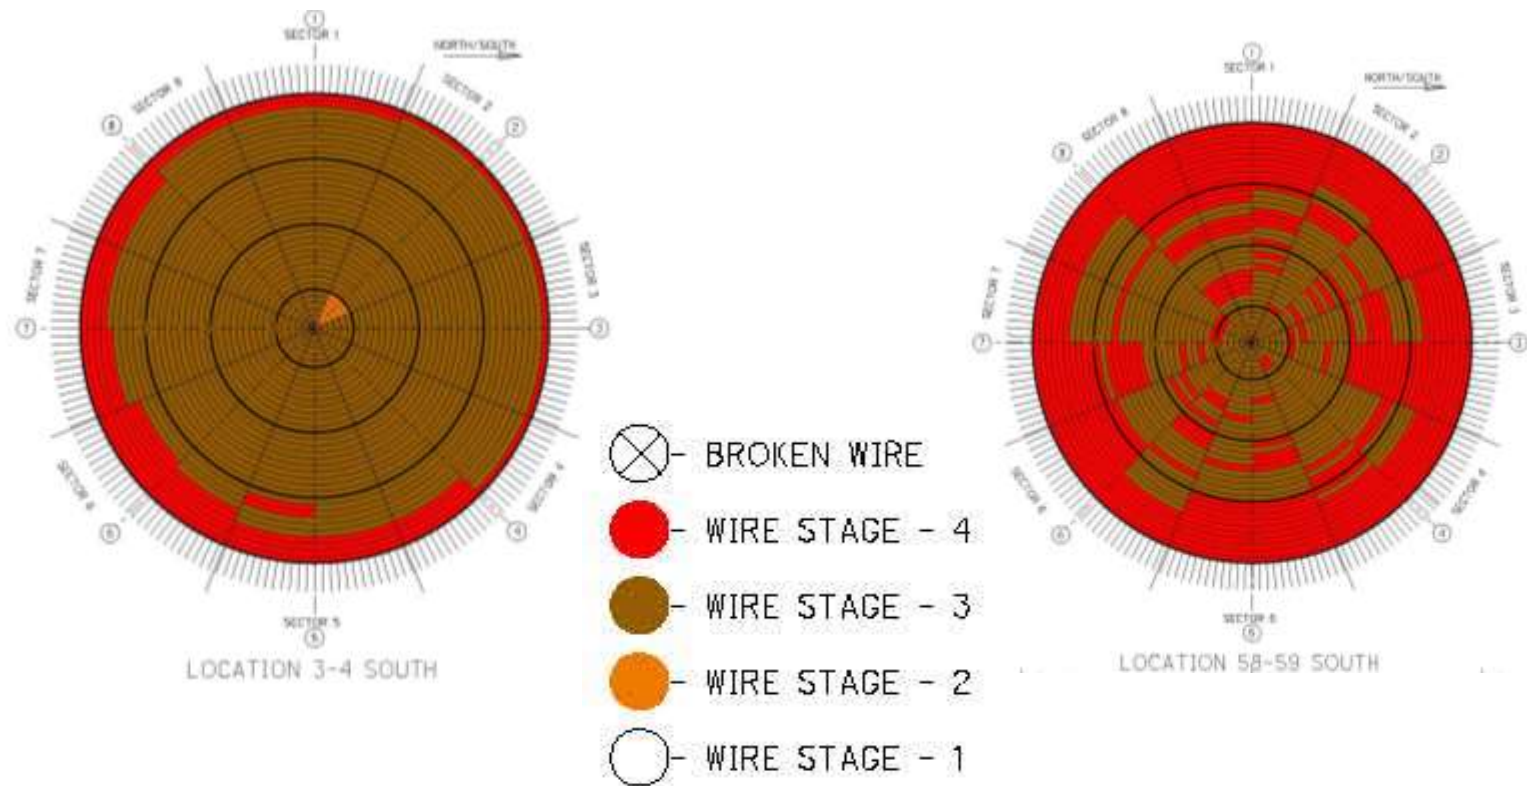
Cable Strength Calculation

- Estimate # of wires at each stage of corrosion

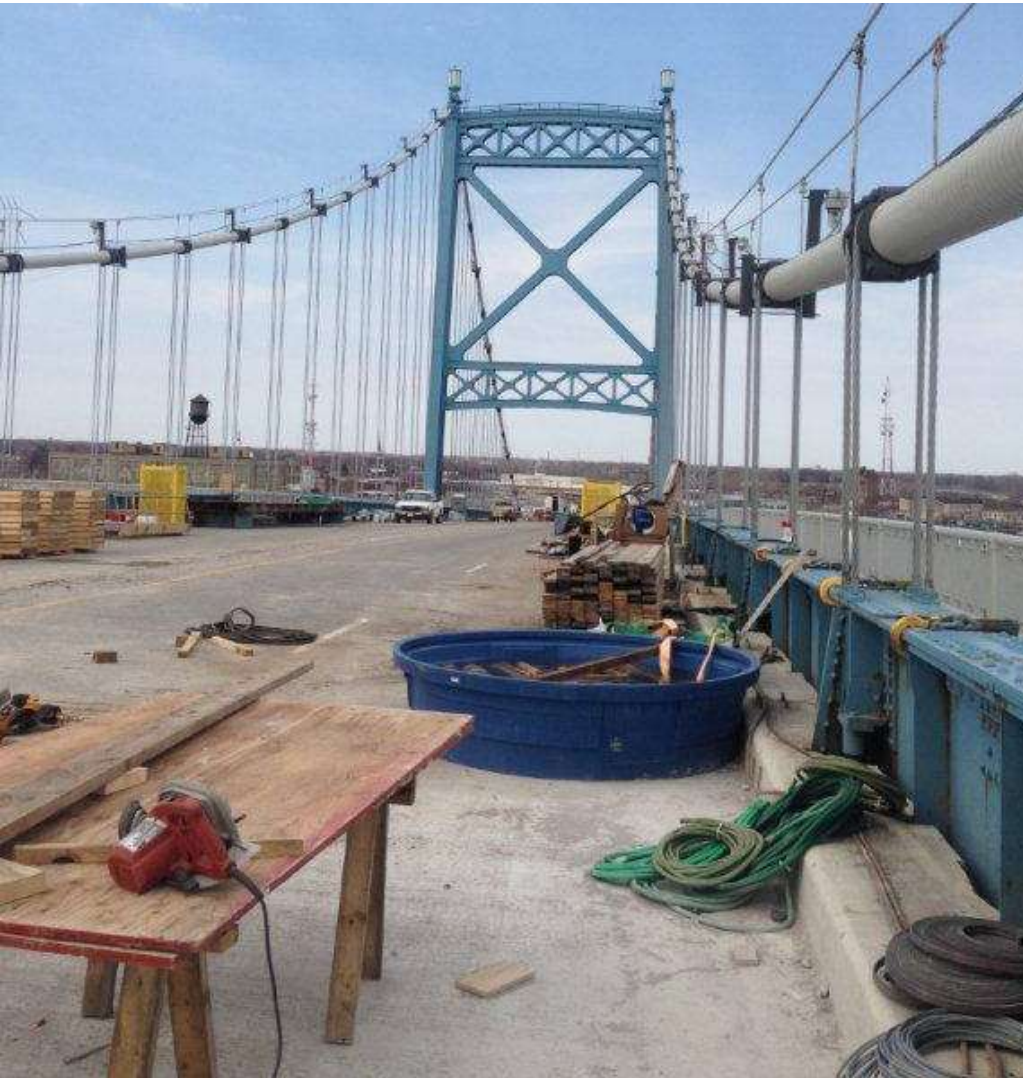
Construction: Bridge Closure

- Consideration given to phase construction
- Deemed not feasible due to unbalanced loading of the suspension cables.
- Existing deck comprised of standard weight concrete
- Proposed lightweight Concrete deck

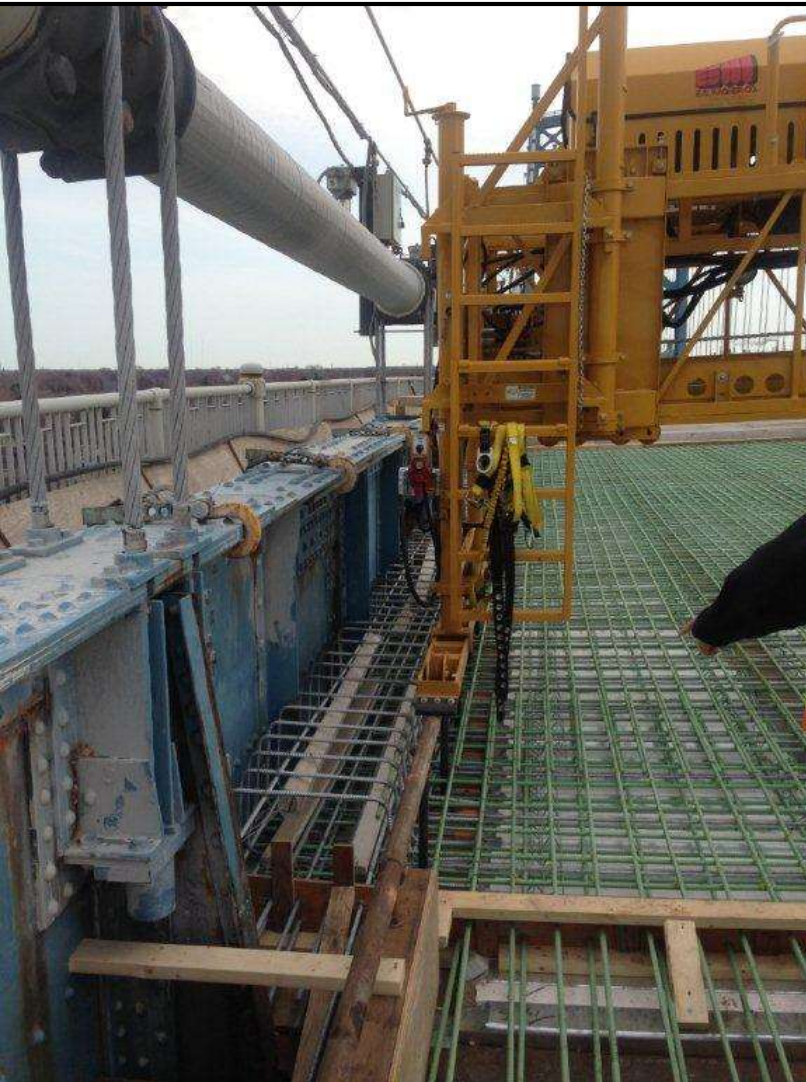
Construction: Deck Edge

- Cathodic Protection incorporated into deck edge design.
- Concerns about interface of Suspension Girder and reinforced concrete deck.
- Heavy concentration of saltwater in bridge deck gutter line.

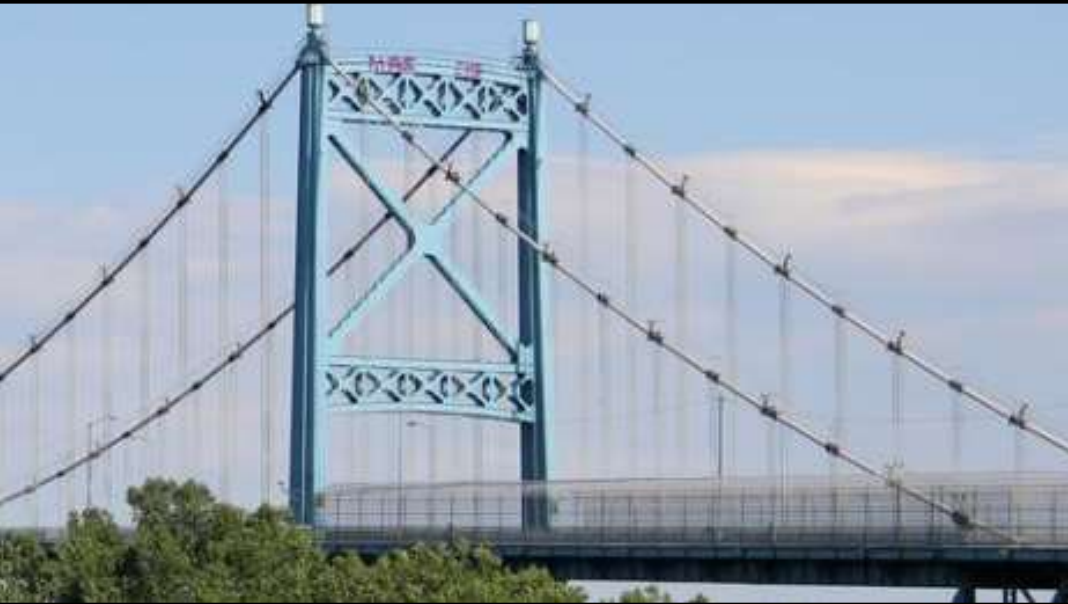
Construction: Steel Repairs

Suspension Girders

Floorbeam moment plates and connections

Challenge: Bolt spacing of large moment plates are variable
