# ORIL update on Box Beam Bridges

# Effectiveness of Adjacent Precast Concrete Box-Beam Connections

OTEC 2015

Mohamed Habouh and Ali Almonbhi - Graduate Students  
Anil Patnaik - Professor  
Department of Civil Engineering

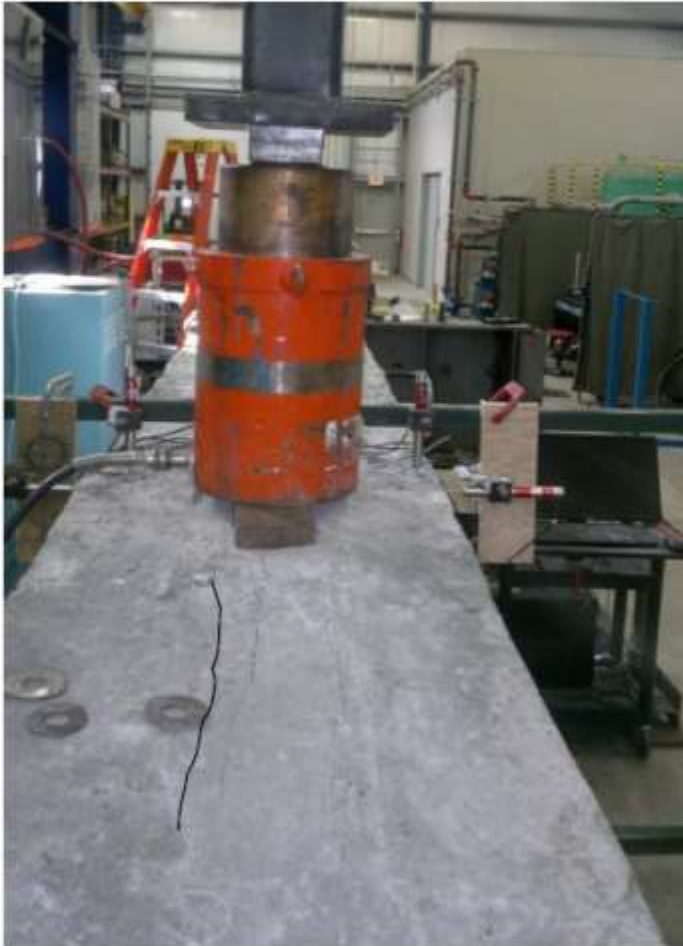
## Failure Mode of Beam Set # 7 - Sandblasted Surface with High Strength Concrete

Flexure Failure in the Middle Concrete Unit

This Beam Assembly was  
Tested 5 Times

- 1<sup>st</sup> test – Loaded up to 100 kips
- 2<sup>nd</sup> test – Loaded up to 100 kips
- 3<sup>rd</sup> test – Loaded up to 200 kips

Tie rods were removed from both  
ends

- 4<sup>th</sup> test – Loaded up to 200 kips
- 5<sup>th</sup> test – Loaded up to 275 kips

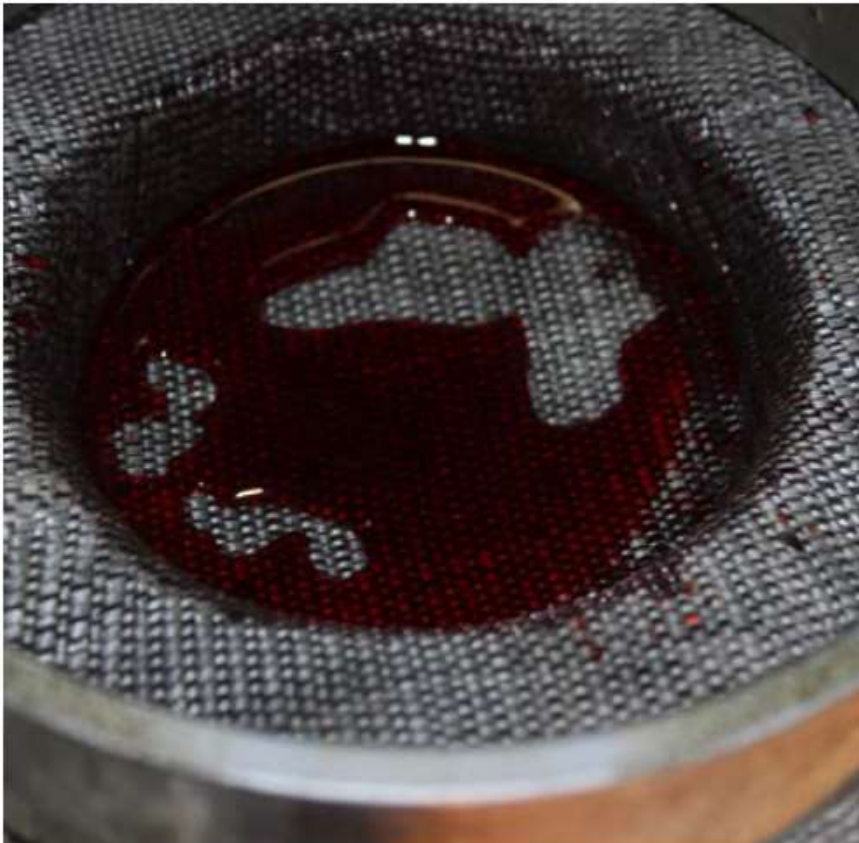
**Top view**

# Detection of Leakage Initiation Test

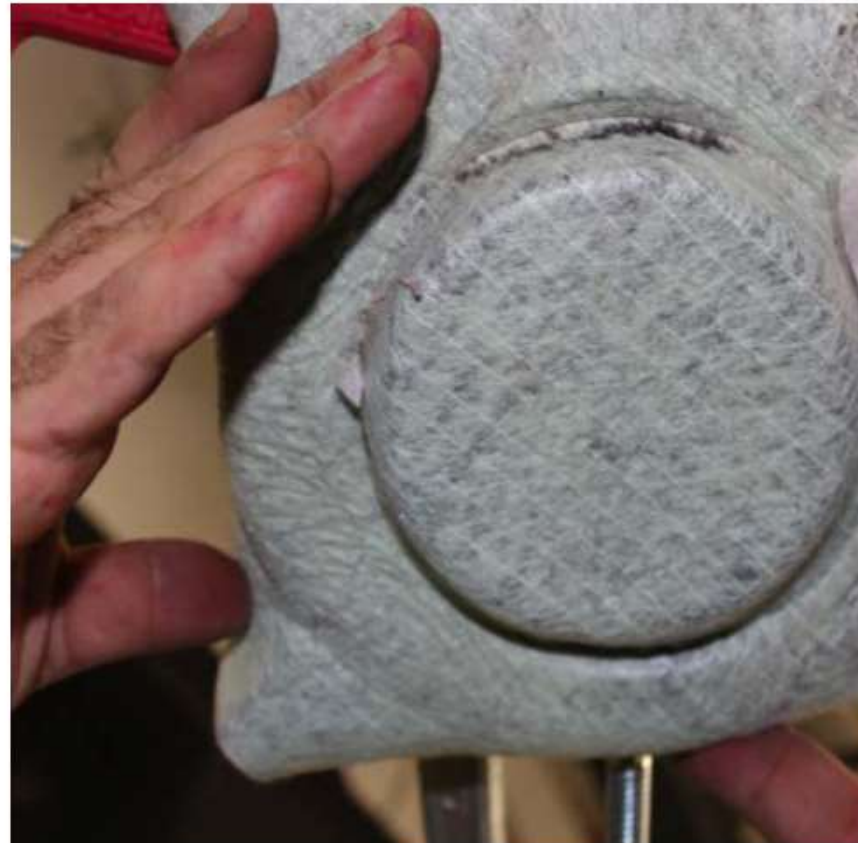
**Bottom view, some tears in the external fabric, but no leakage**
