Indian Mill Bridge Rehabilitation PID 92339

Wyandot County Engineer's Office

Indian Mill Bridge Rehabilitation

TRUSS REMOVAL AND REINSTALLATION WHILE
PRESERVING THE SCENIC SANDUSKY RIVER

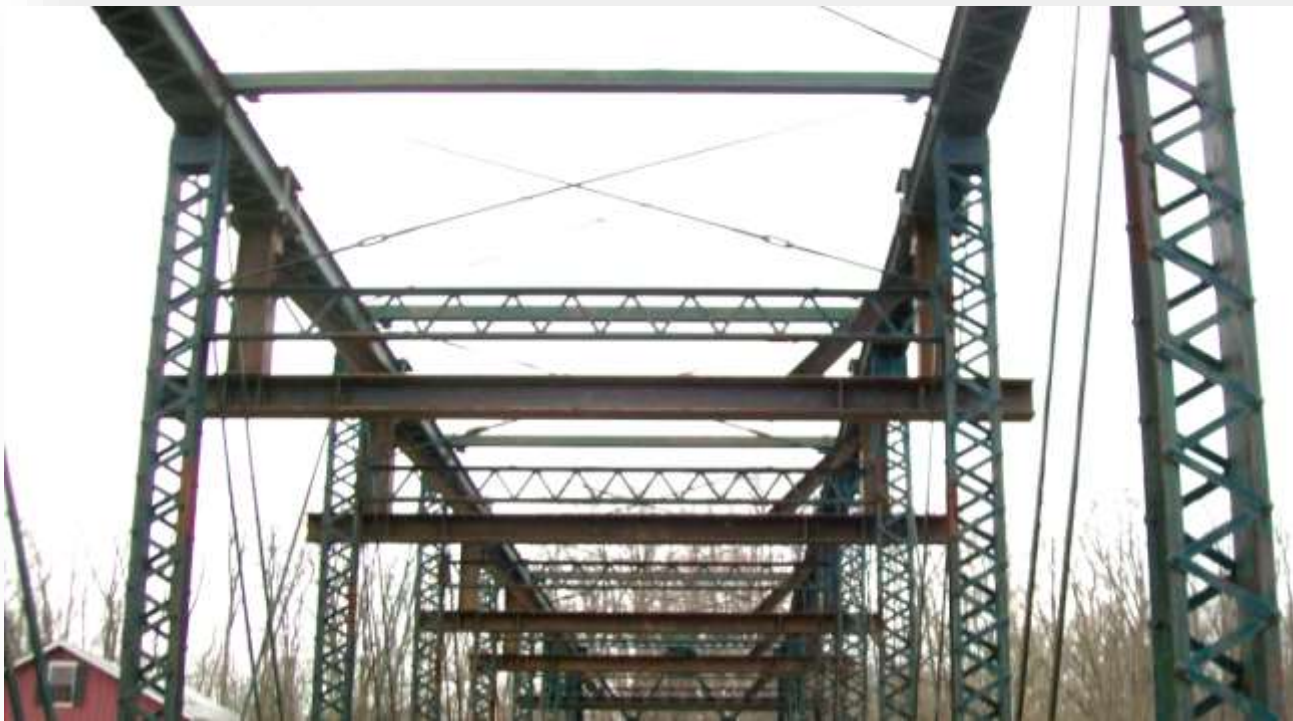
Frames were installed to transfer the existing dead load of the Indian Mill Bridge to the narrower Liberty Bridge.

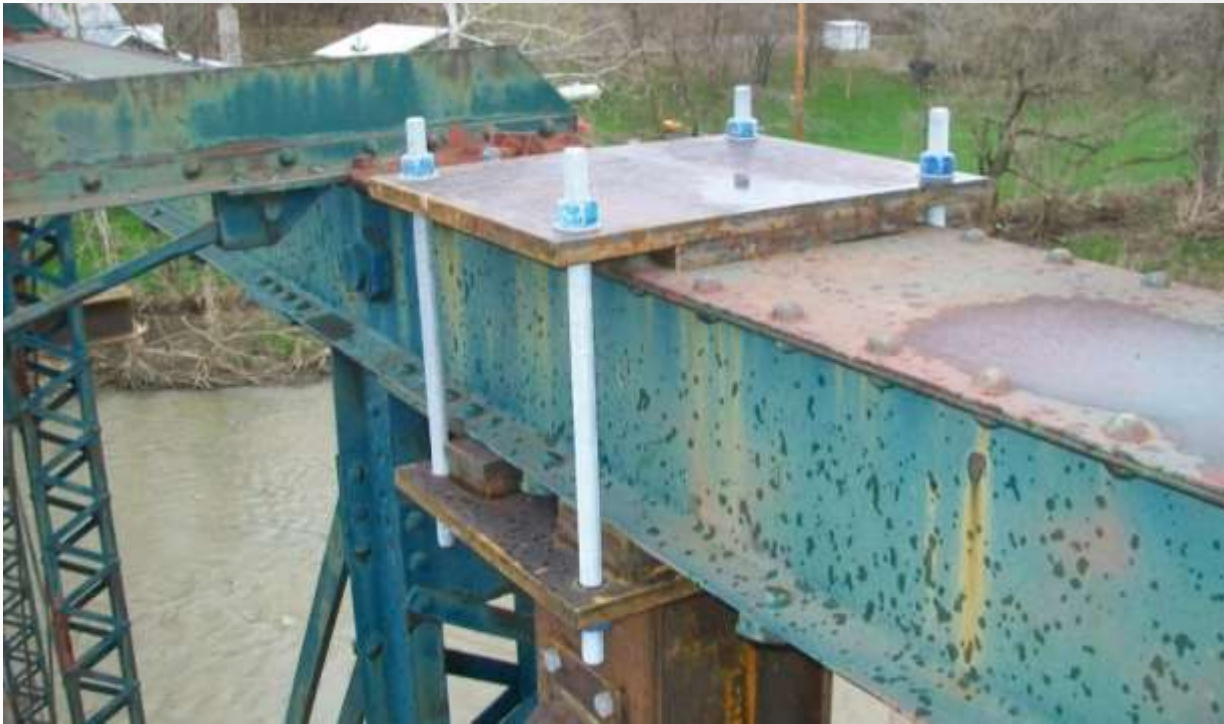
Frames were bolted to top chord so that lift points would release dead load stresses in the bottom chord and tension diagonals.

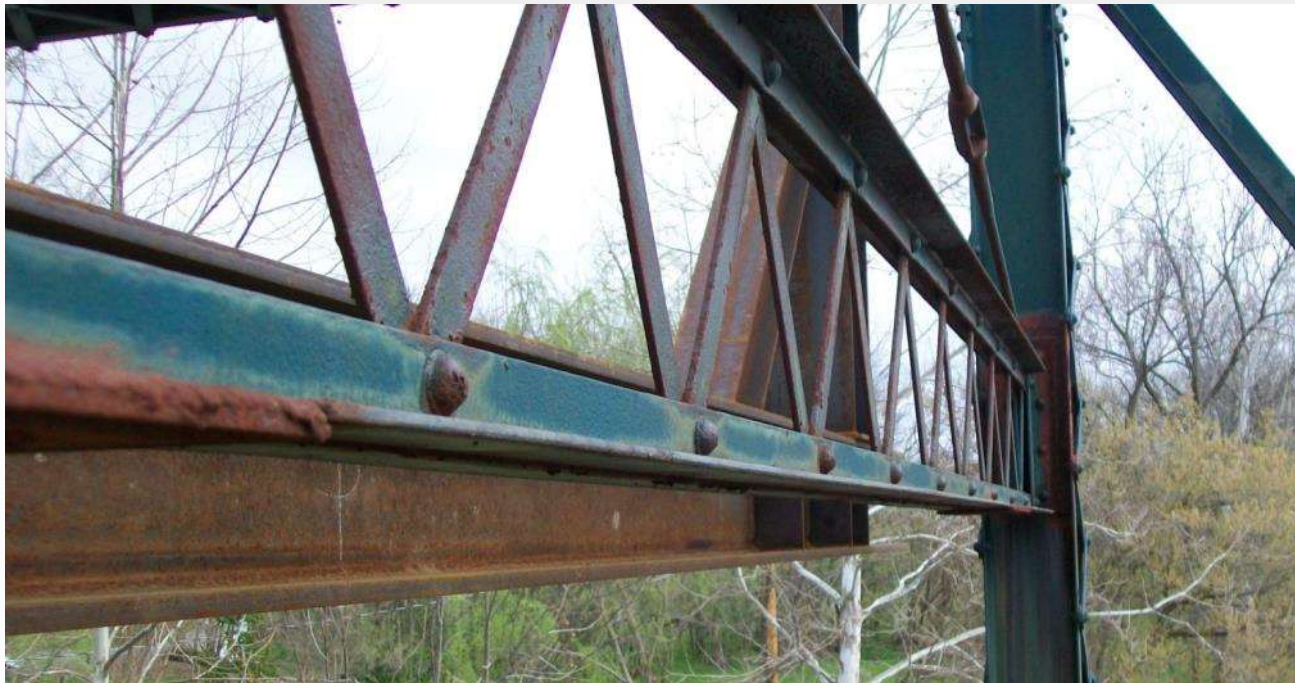
Framework was constructed to establish pick points below the existing Portal Bracing.

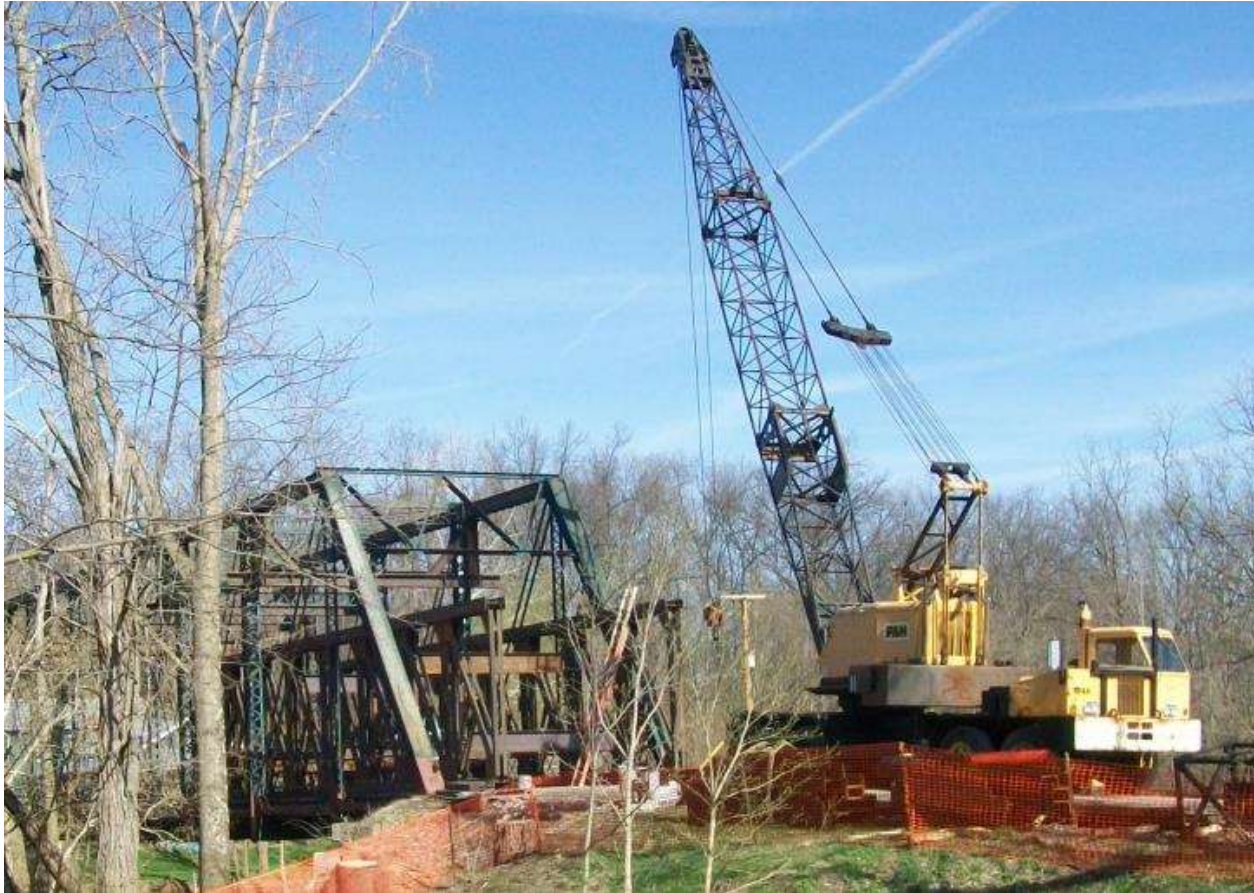
The Liberty was installed by a small work crane at the East Abutment

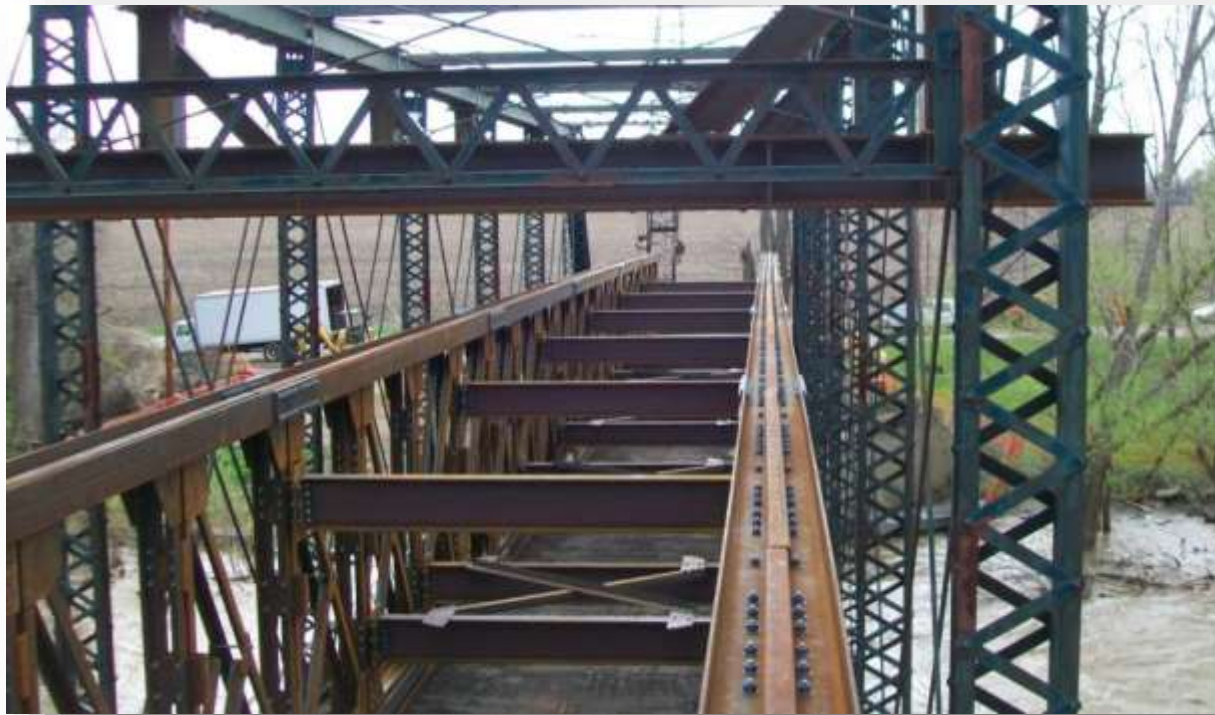
The Hillman rollers were placed under the Liberty bridge on a steel channel so it could be rolled across the existing deck.

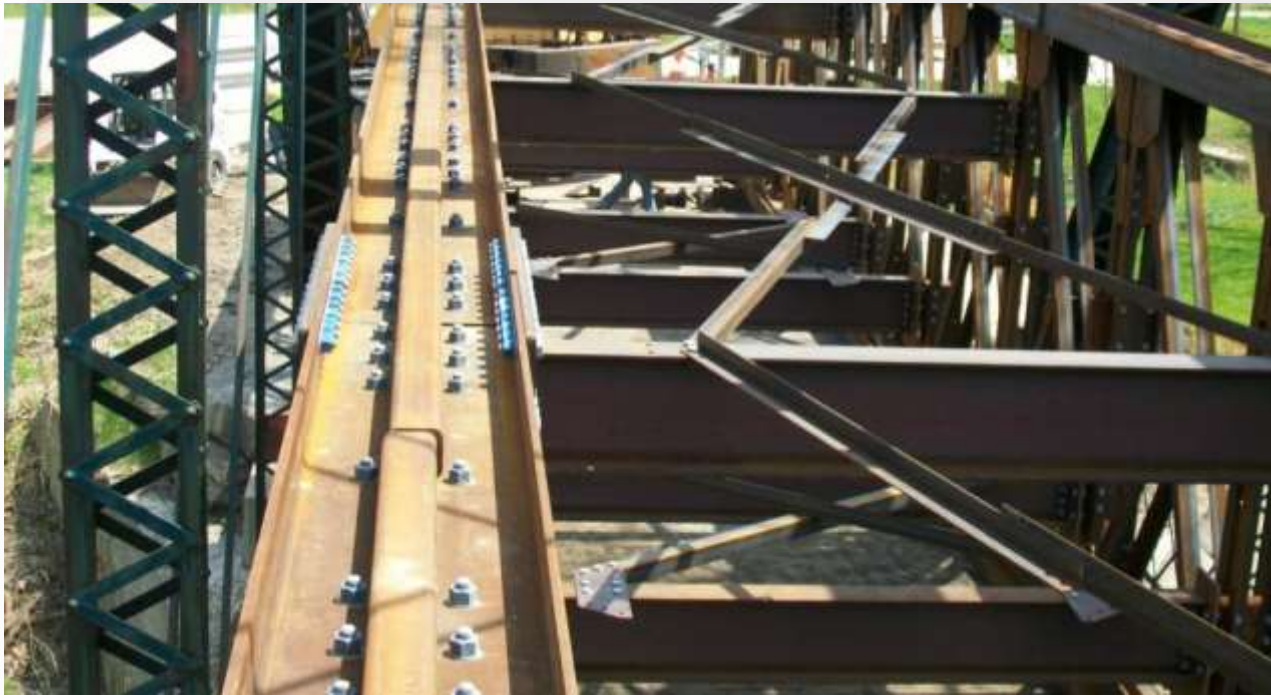
The Liberty floorbeams were staggered at top and bottom connection points to create additional top chord bracing.

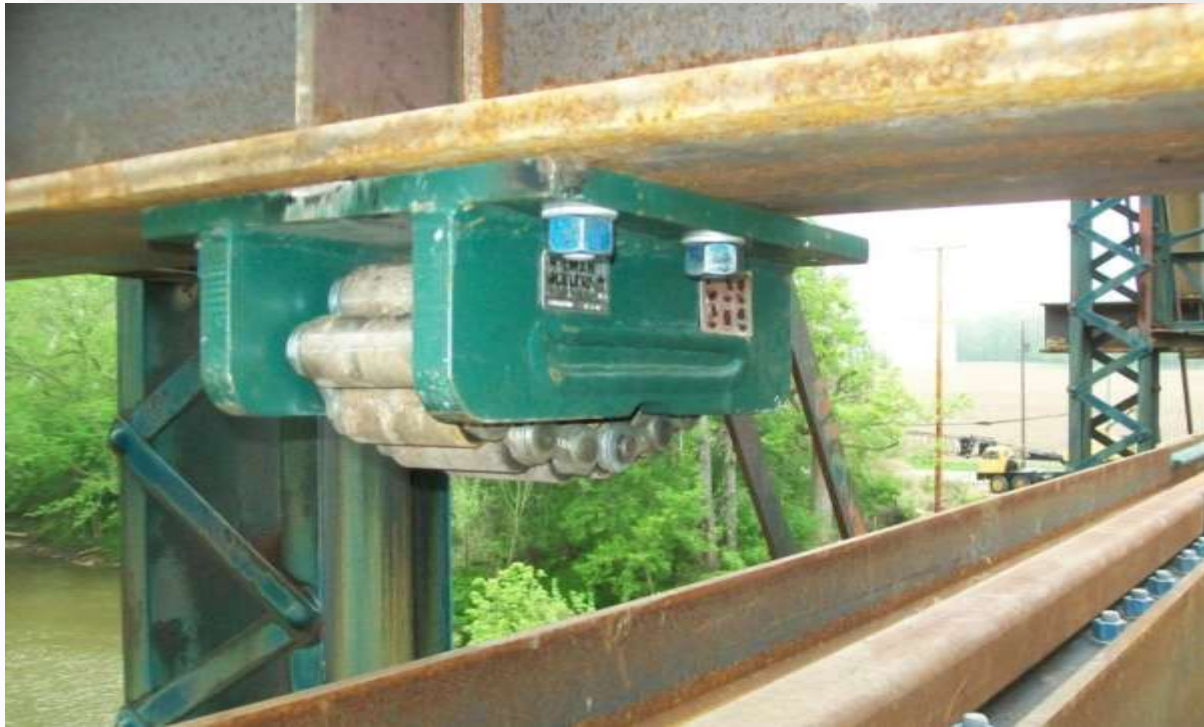
A tubular rail was used to space the rollers away from the bolted connections of the Liberty.

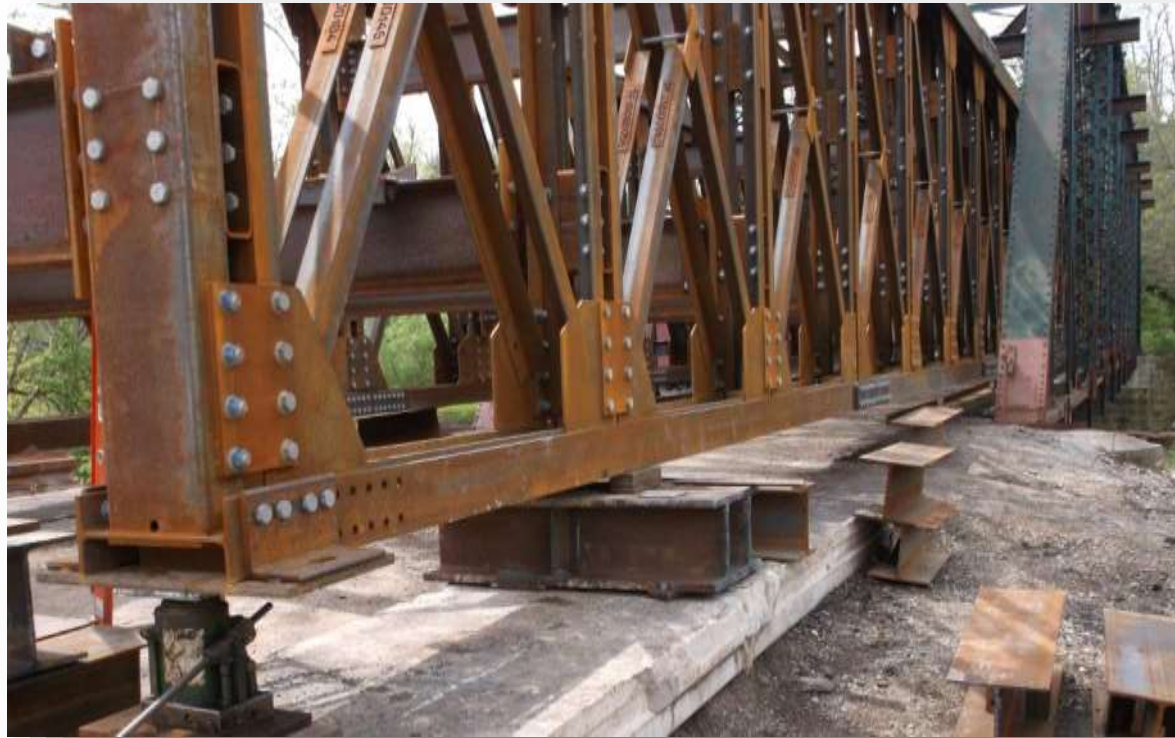
Jacks and cribbing were used to raise the Liberty.

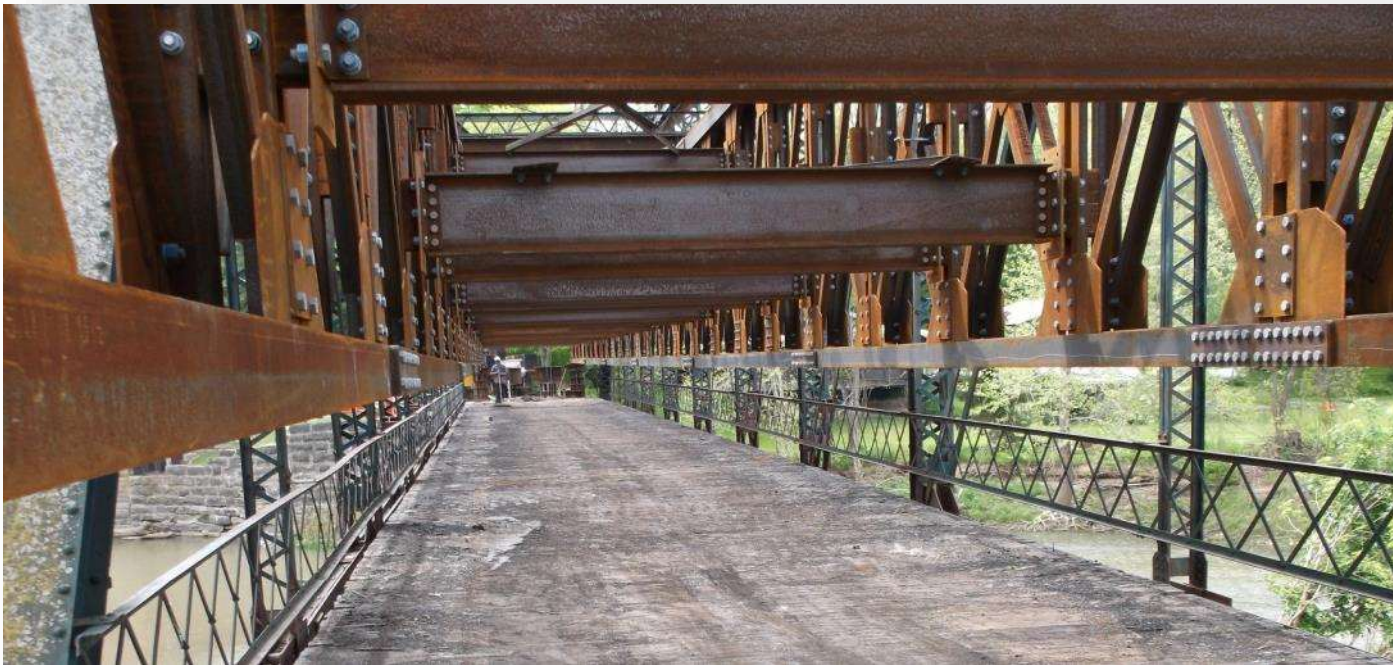
Once the Liberty was jacked tight against the upper framing there was ample room for removal of the existing deck and stringers.

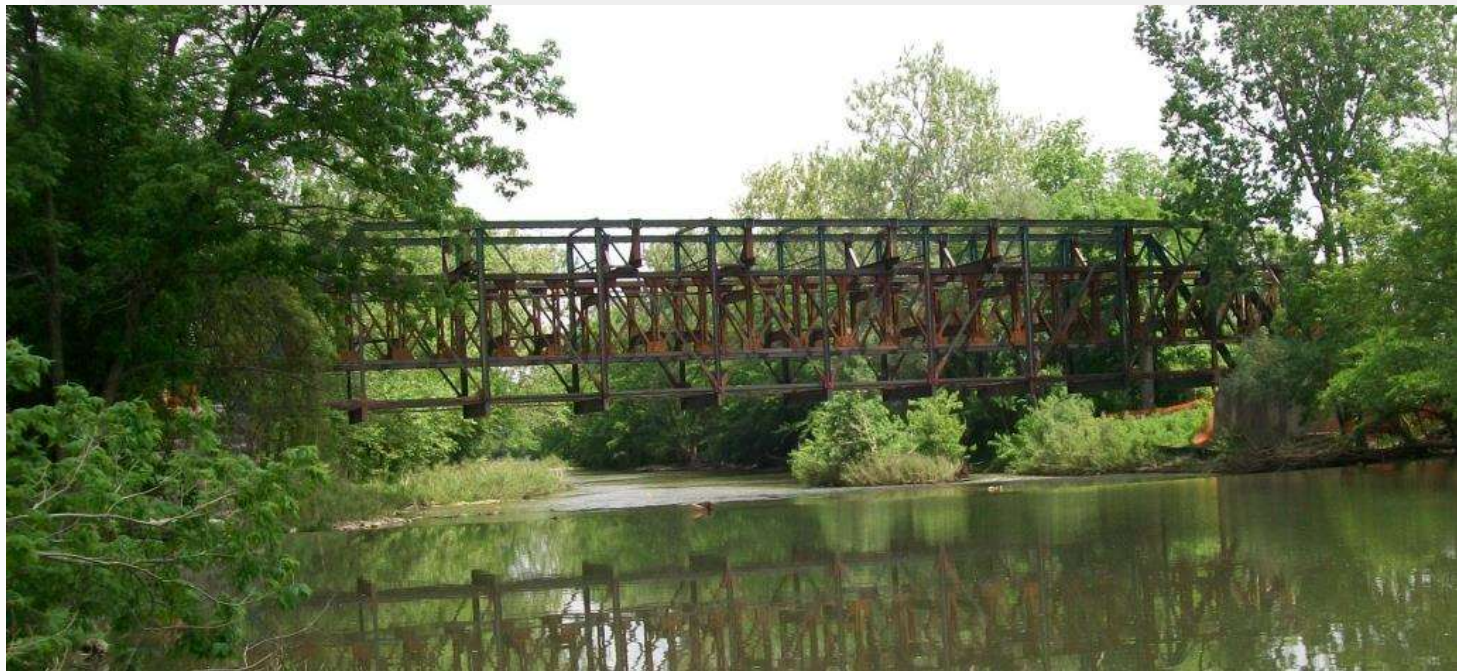
A side view of the bridge about to be lifted. The combined bridge lift was about 100 tons.

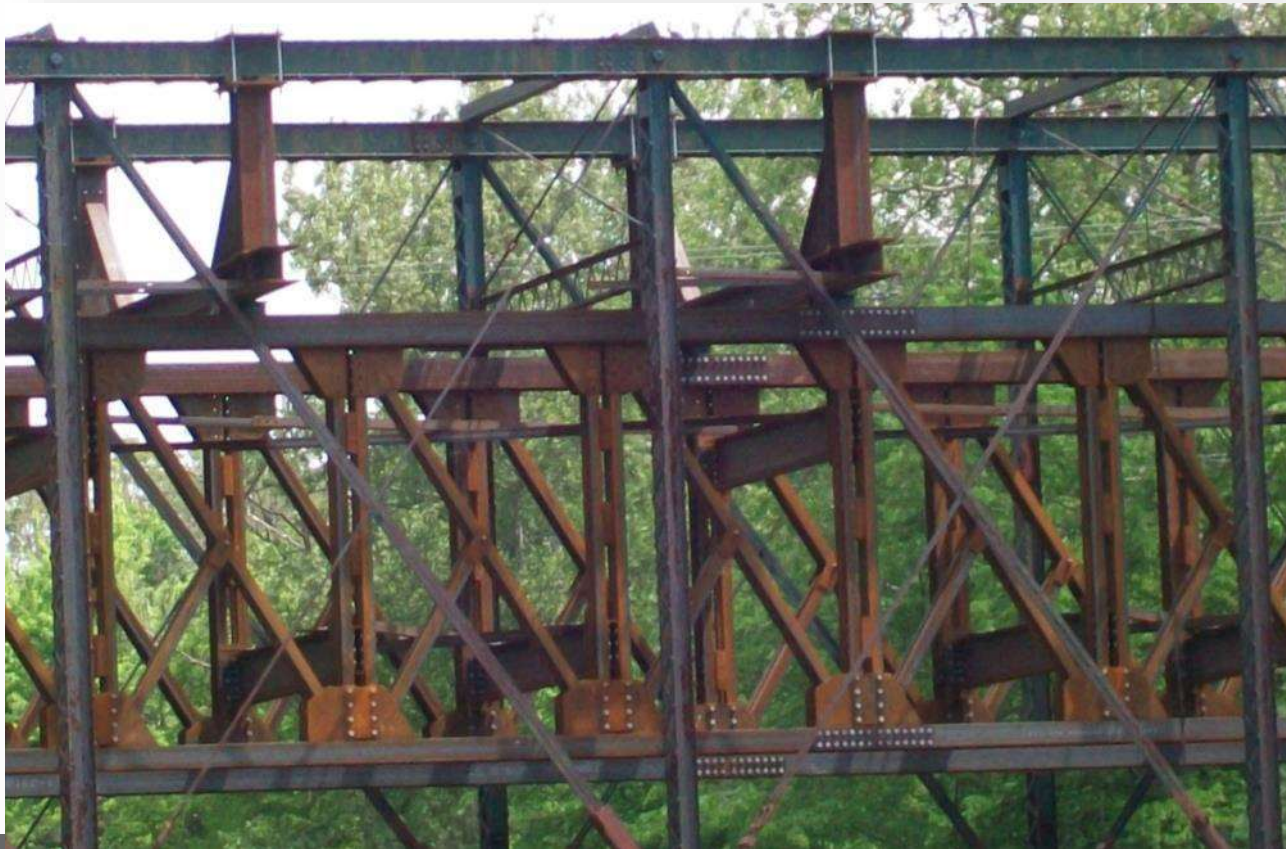
As the Liberty was raised the rollers were adjusted and additional bracing added to stabilize the transfer beams.

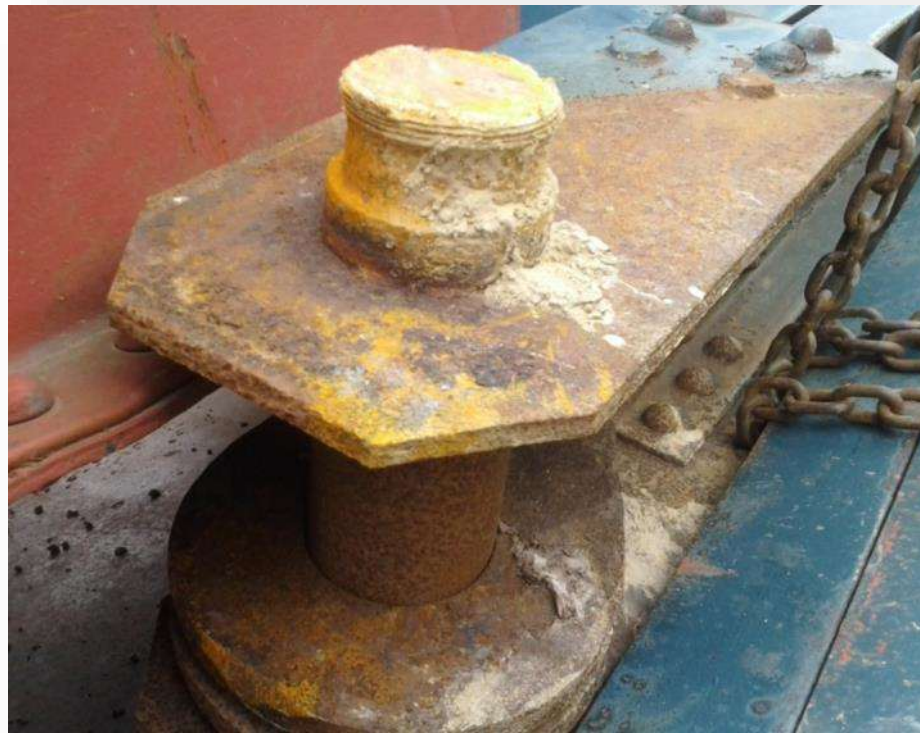
As the components were disassembled, previously unknown factors were discovered. Some pins showed heavy deterioration that was hidden from view.

The eyebars and bracing rods were replaced with new Grade 50 shapes with identical dimensions. The new pins were fabricated from stainless steel .

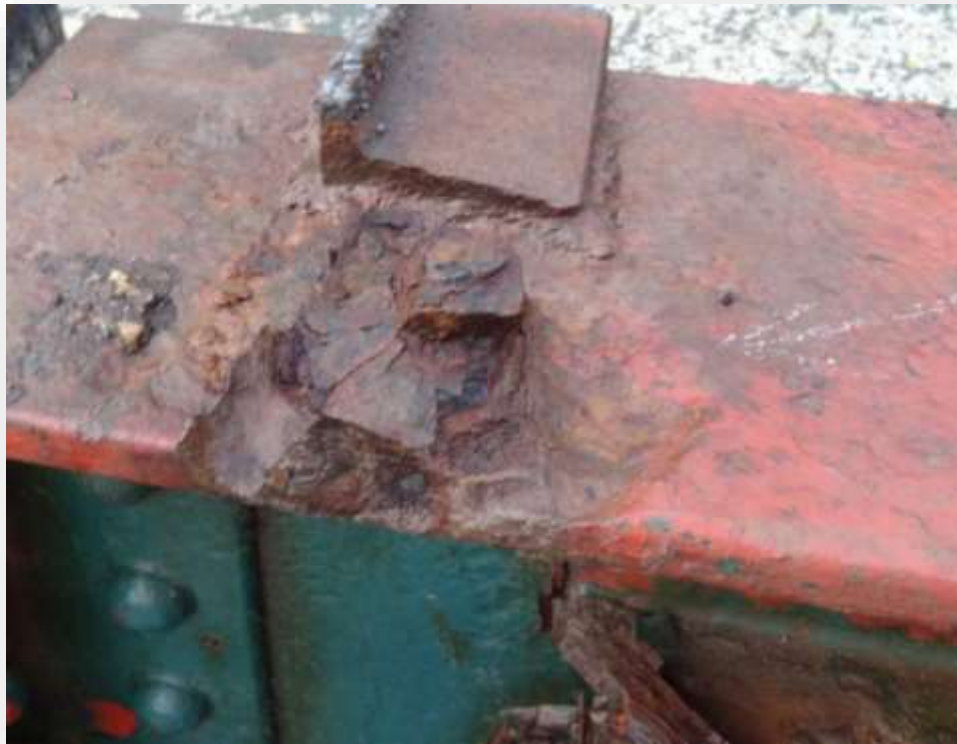
Floorbeam flanges were found to be worse than anticipated and the county decided the floorbeams should be replaced.

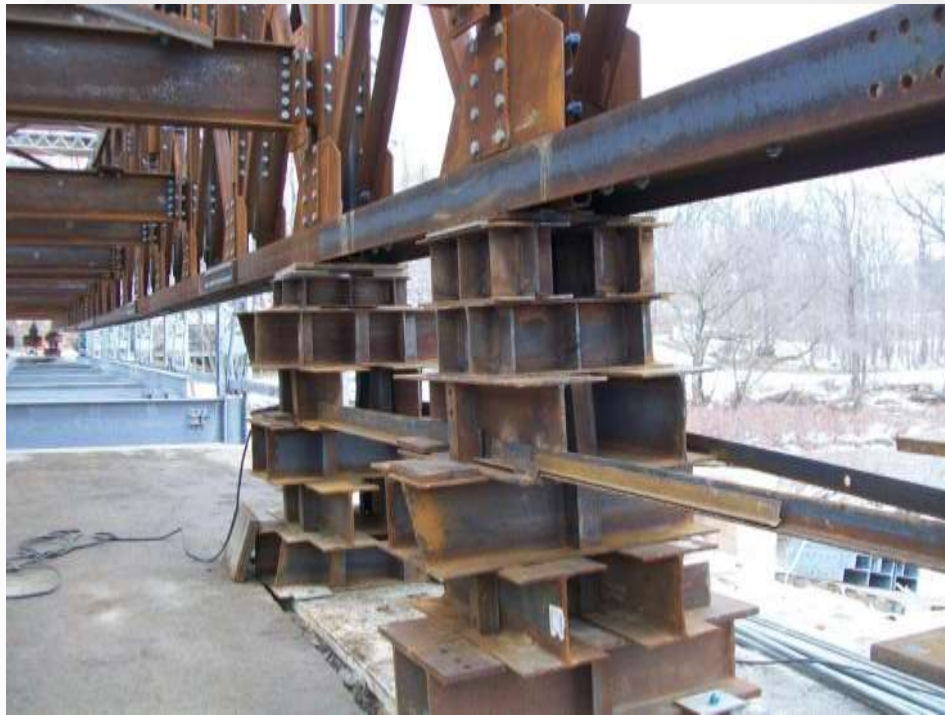
The Liberty was raised slightly to keep the new floor beams above the abutment seat and to correct settlement caused by freezing and thawing.

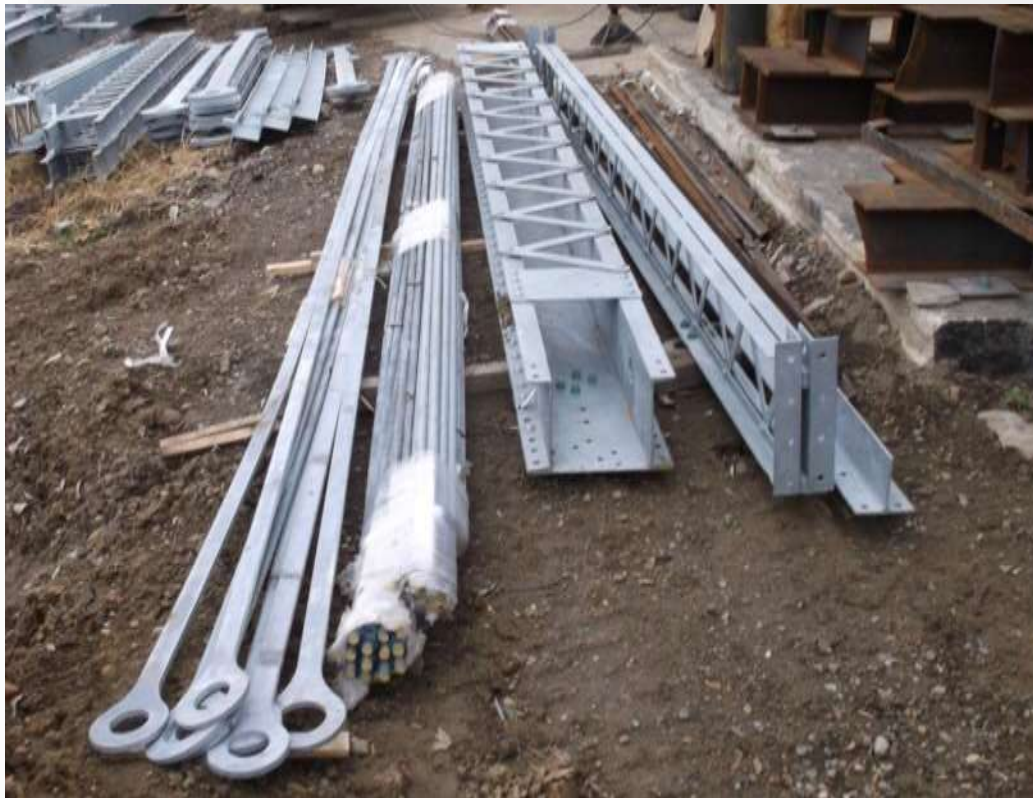
The rehabilitated and galvanized components were delivered to the East Abutment.

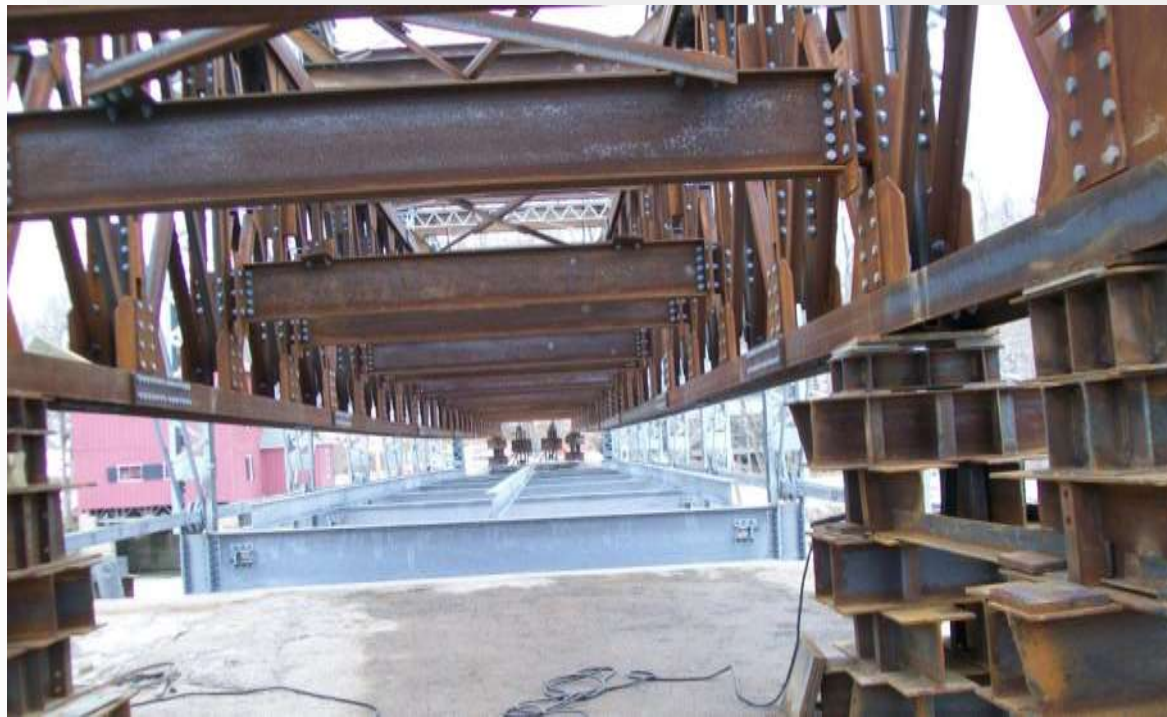
Unequal sag of the Liberty and uniform camber of the Indian Mill truss was accommodated with shims between the rollers and the support frames

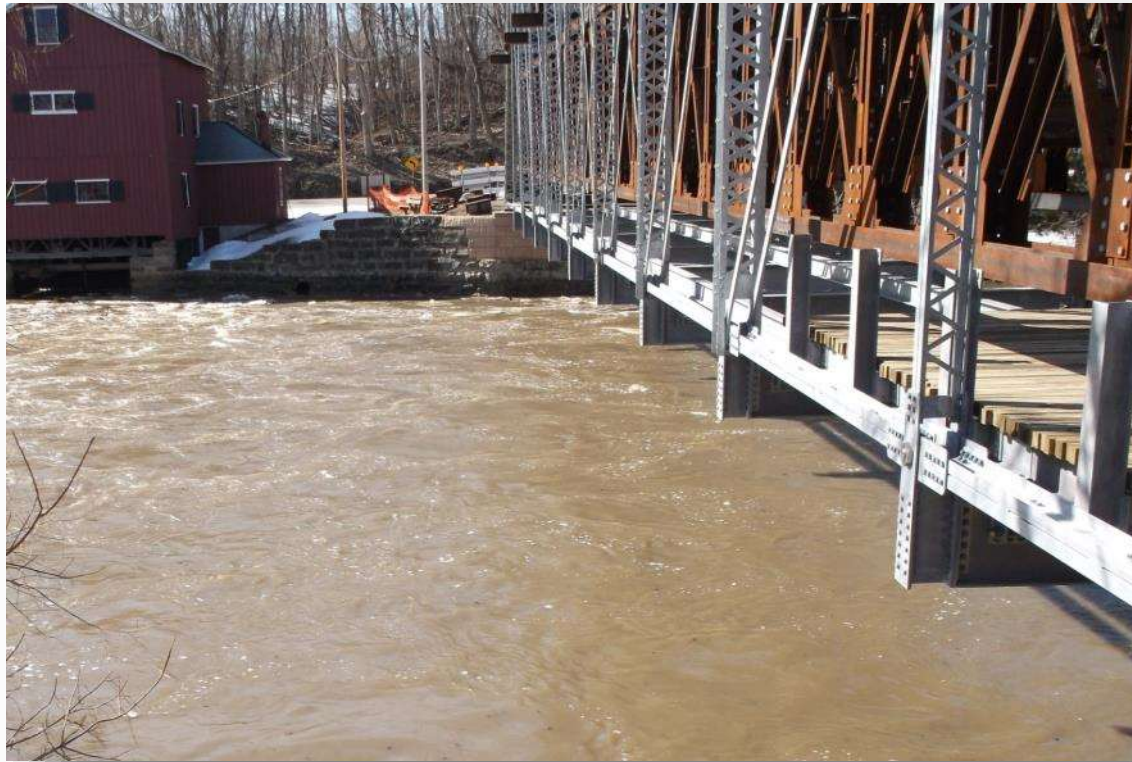
Another flood caused zero interruption. The new stringers and wood floor was installed with the Liberty still in place.

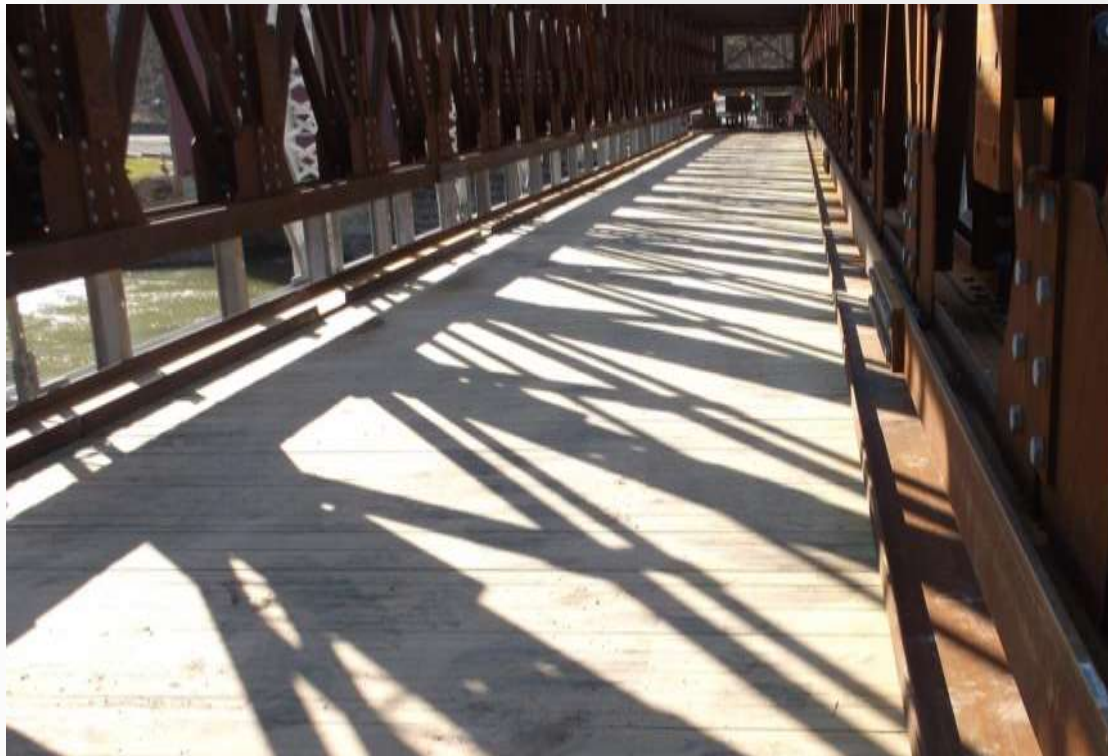
Steel channels were placed on the new floor to protect it from the steel rollers during removal.

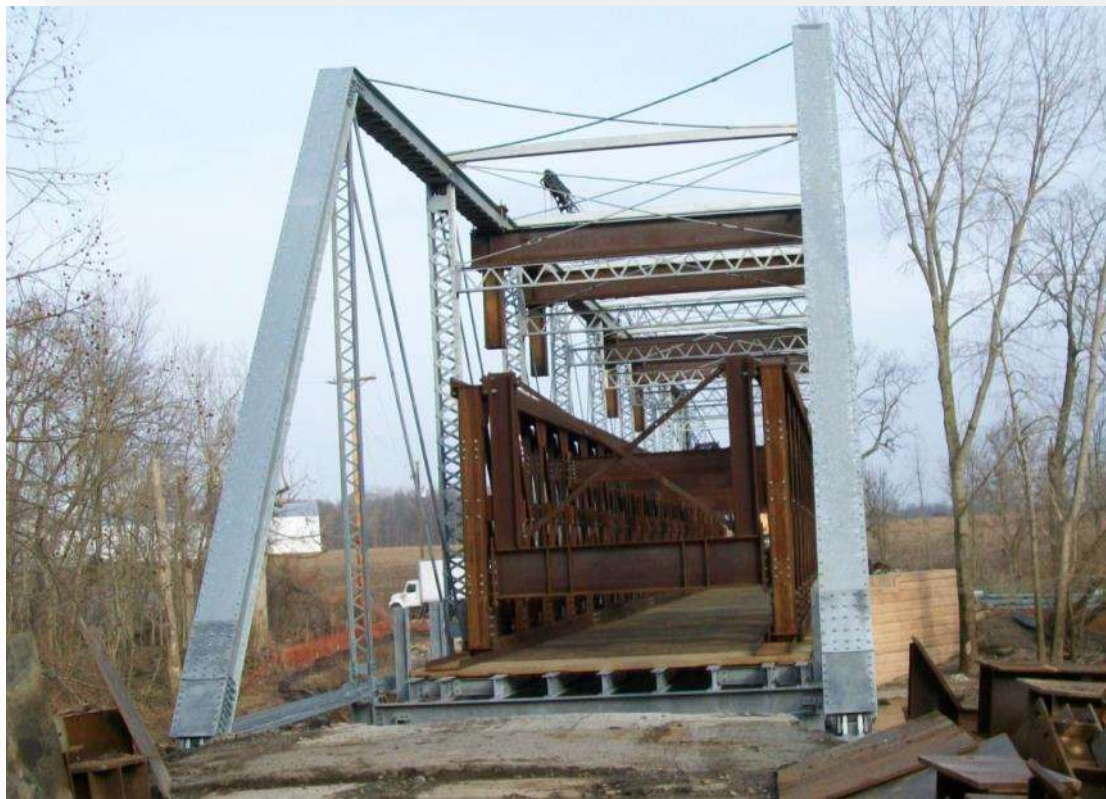
The Liberty was lowered onto the deck and rolled toward the East abutment.

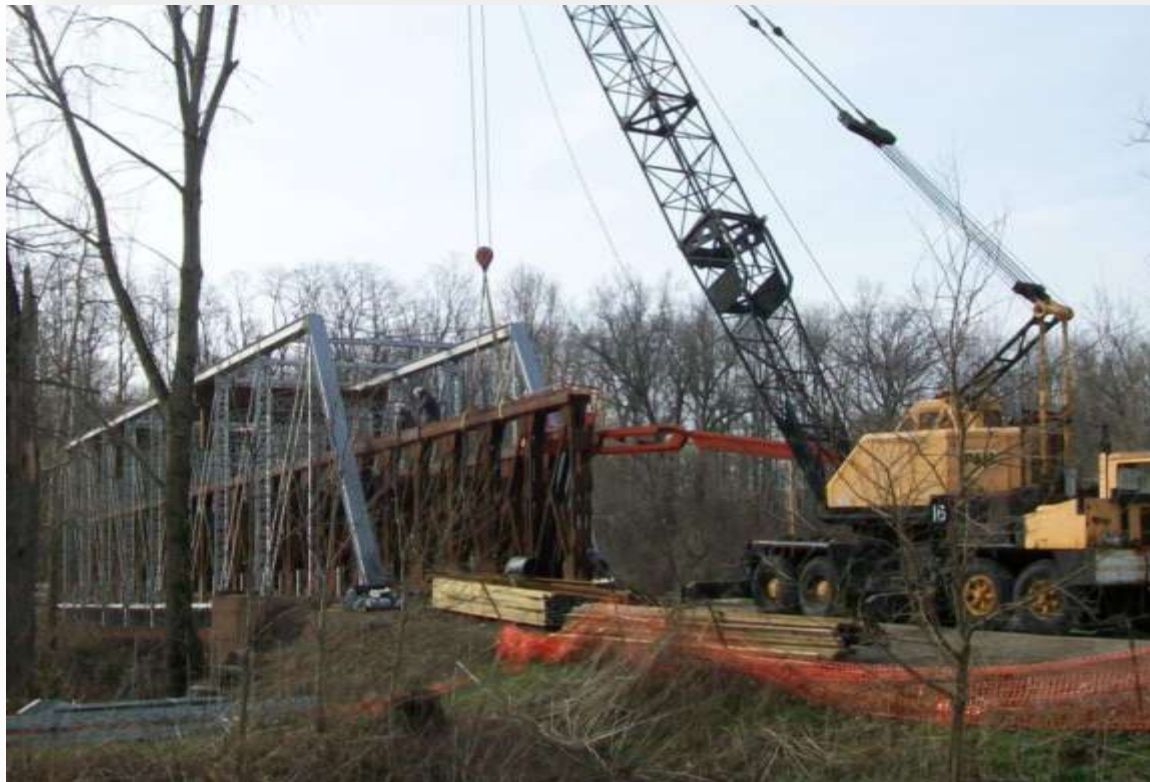
The Liberty sections were removed in truckable sections and returned to Cambridge.

The support frames were removed and remaining bridge components were installed from the deck. Paving and guardrail installation followed.
