# Bridge Preservation

Corrosion Mitigation of Existing Concrete Structures

Vector Corrosion Technologies

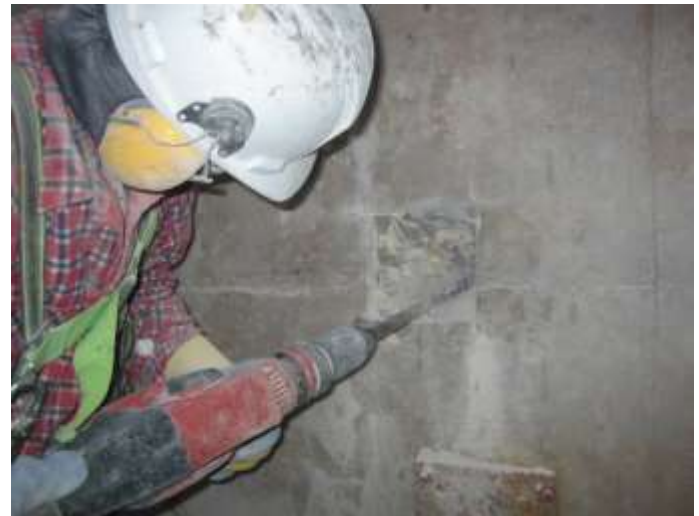
# ICRI No. 310.1R–2008 Guideline for Surface Preparation for Repair of Concrete Deterioration Resulting from Reinforcing Steel Corrosion

## Key Issues Re Corrosion

- Remove concrete from full circumference of all reinforcing steel.
- Remove corrosion by-products from steel
- Expand area of patch outside area of active corrosion (clean steel).

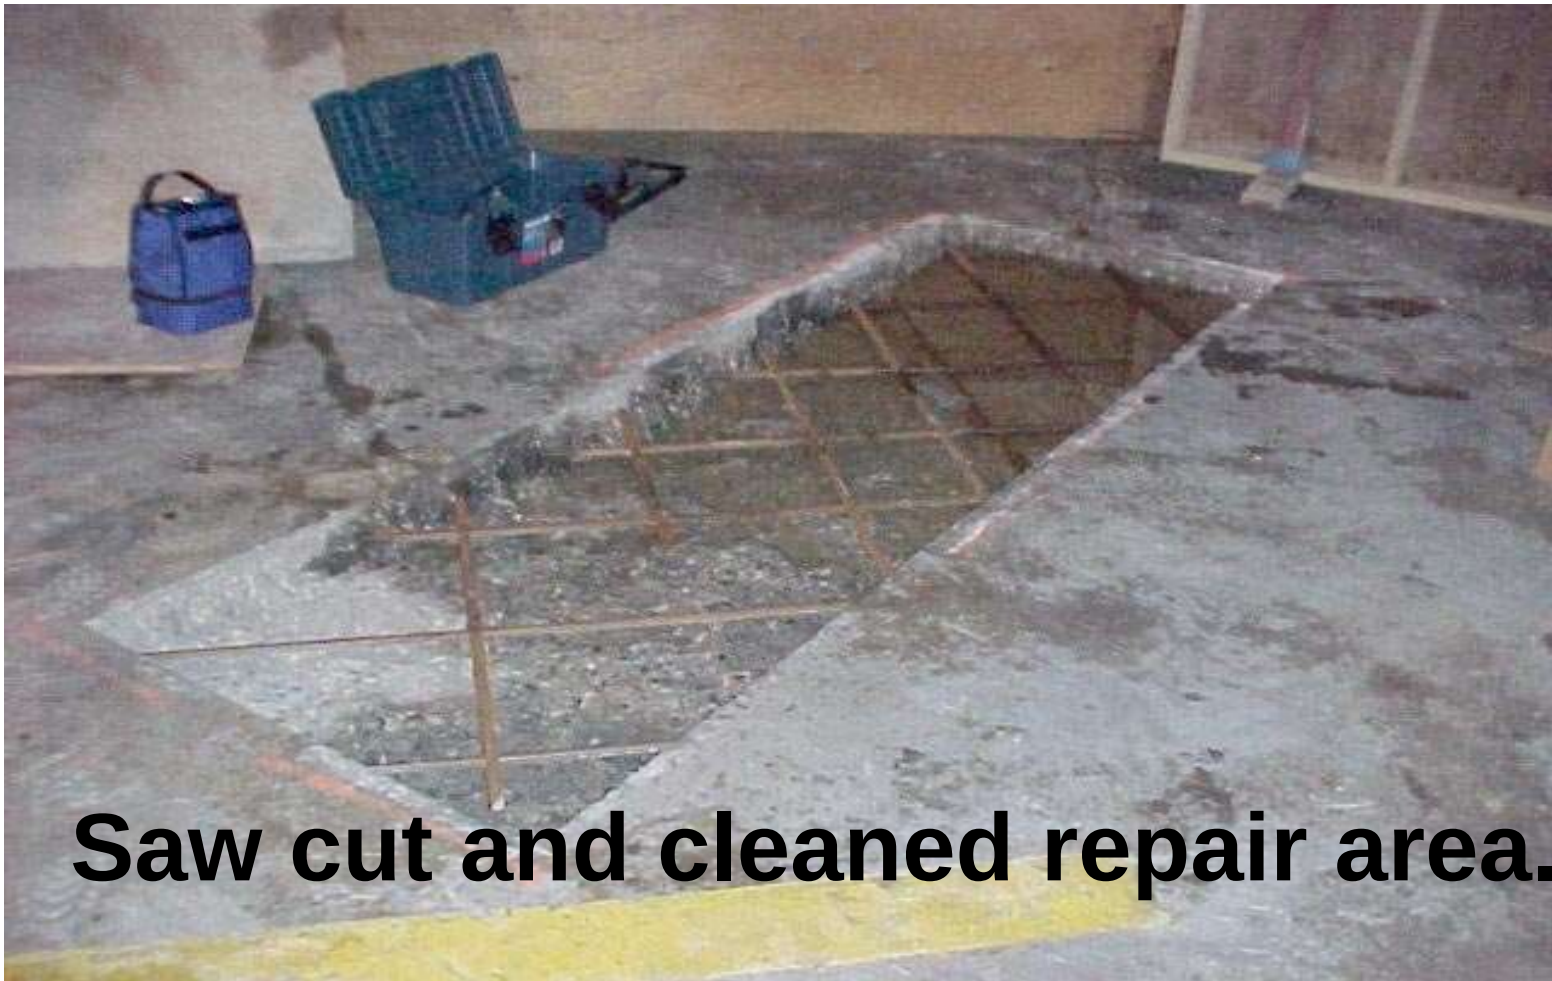
**Saw cut and cleaned repair area.**

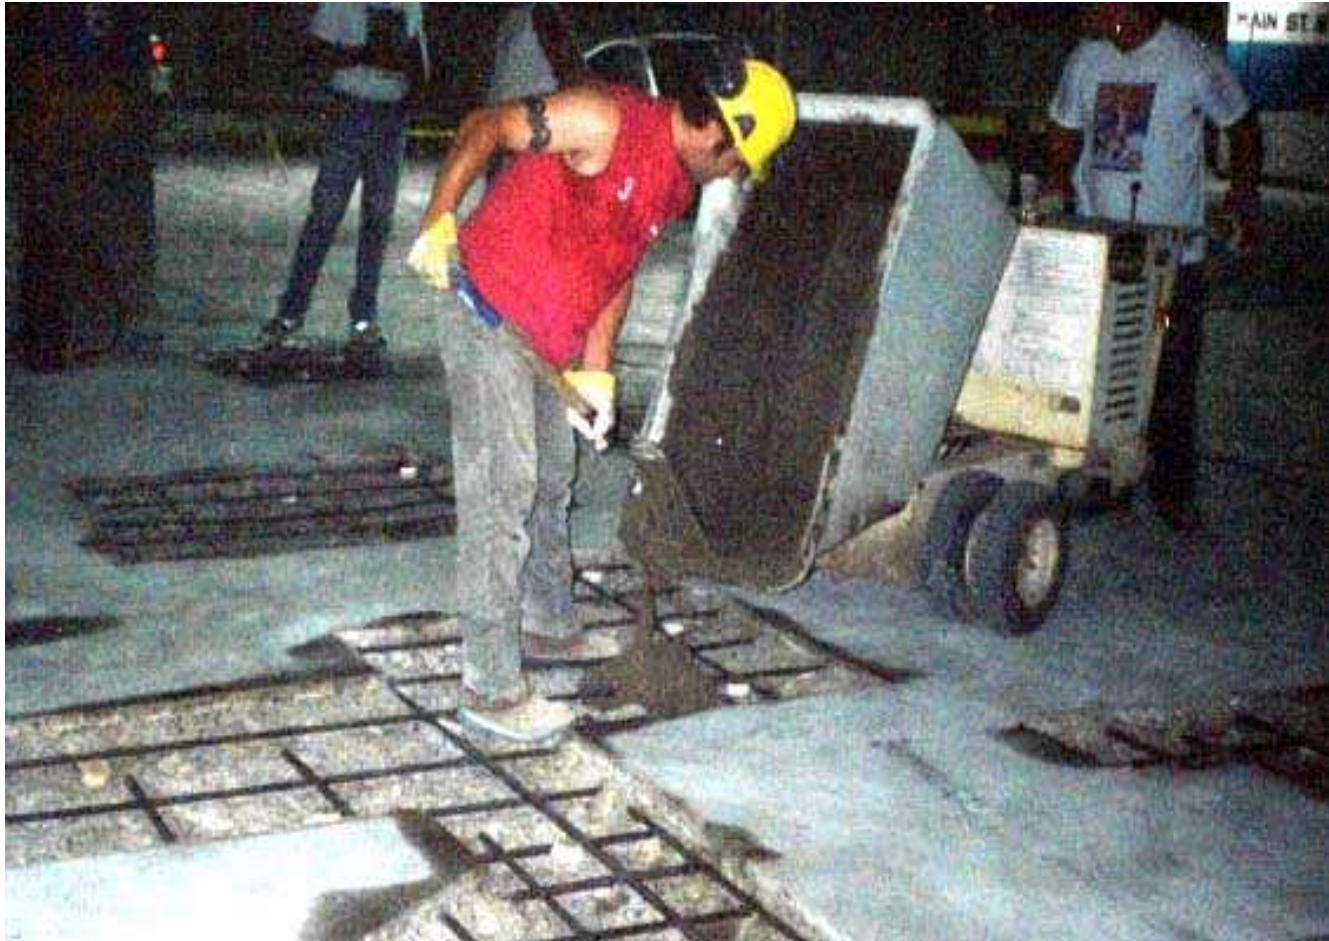
**Embedding anodes with repair material.**

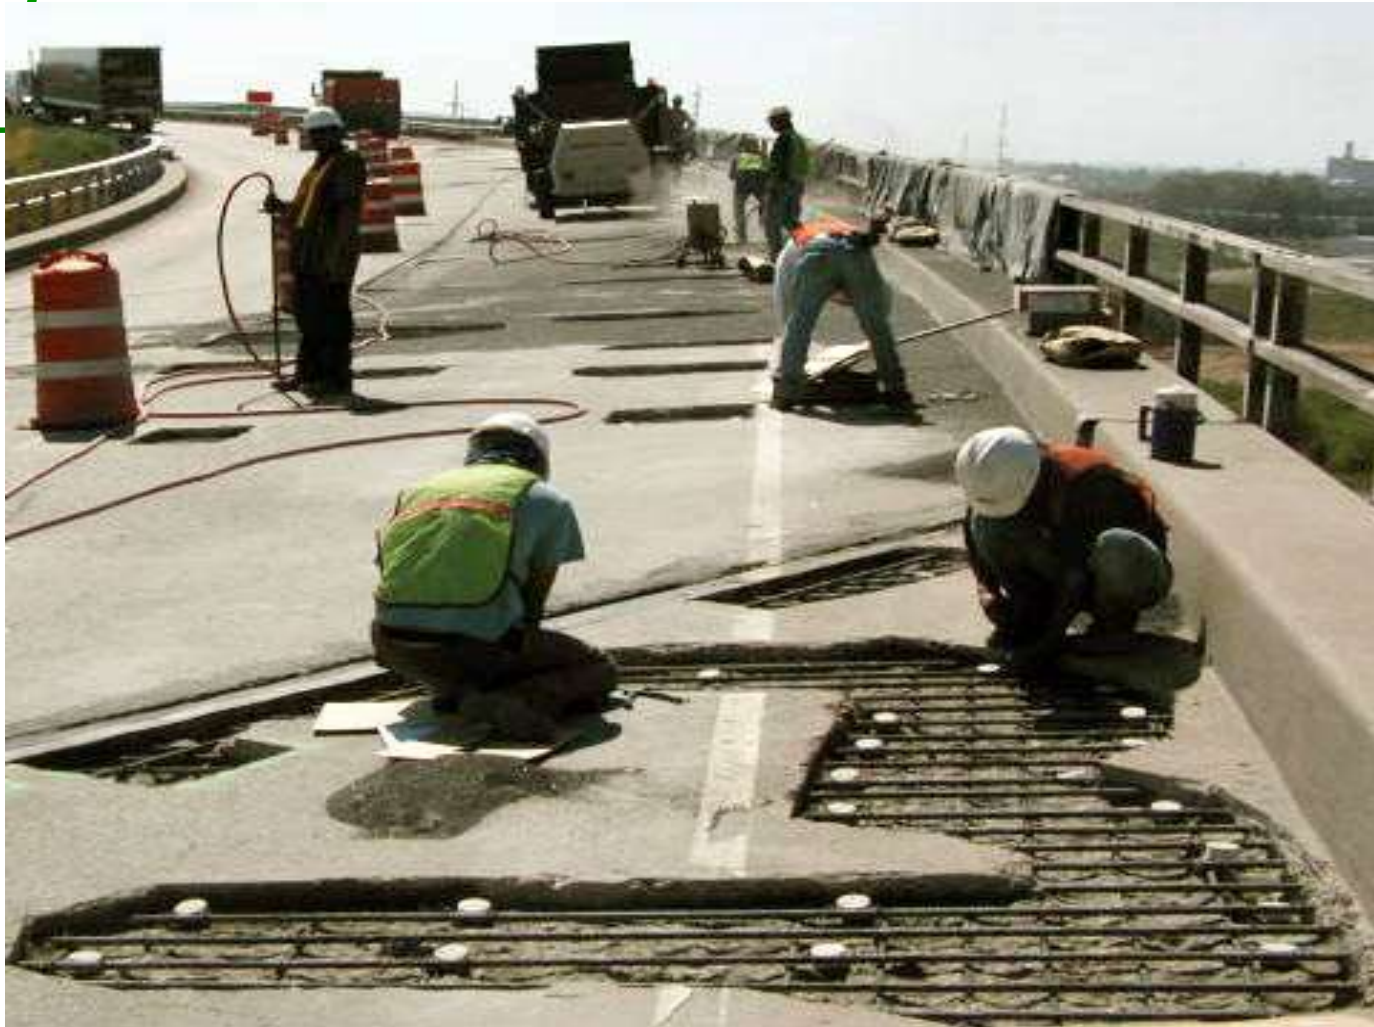
**Bridge Deck - Chip and Patch Repairs.  
Colorado DOT – Greeley, CO**

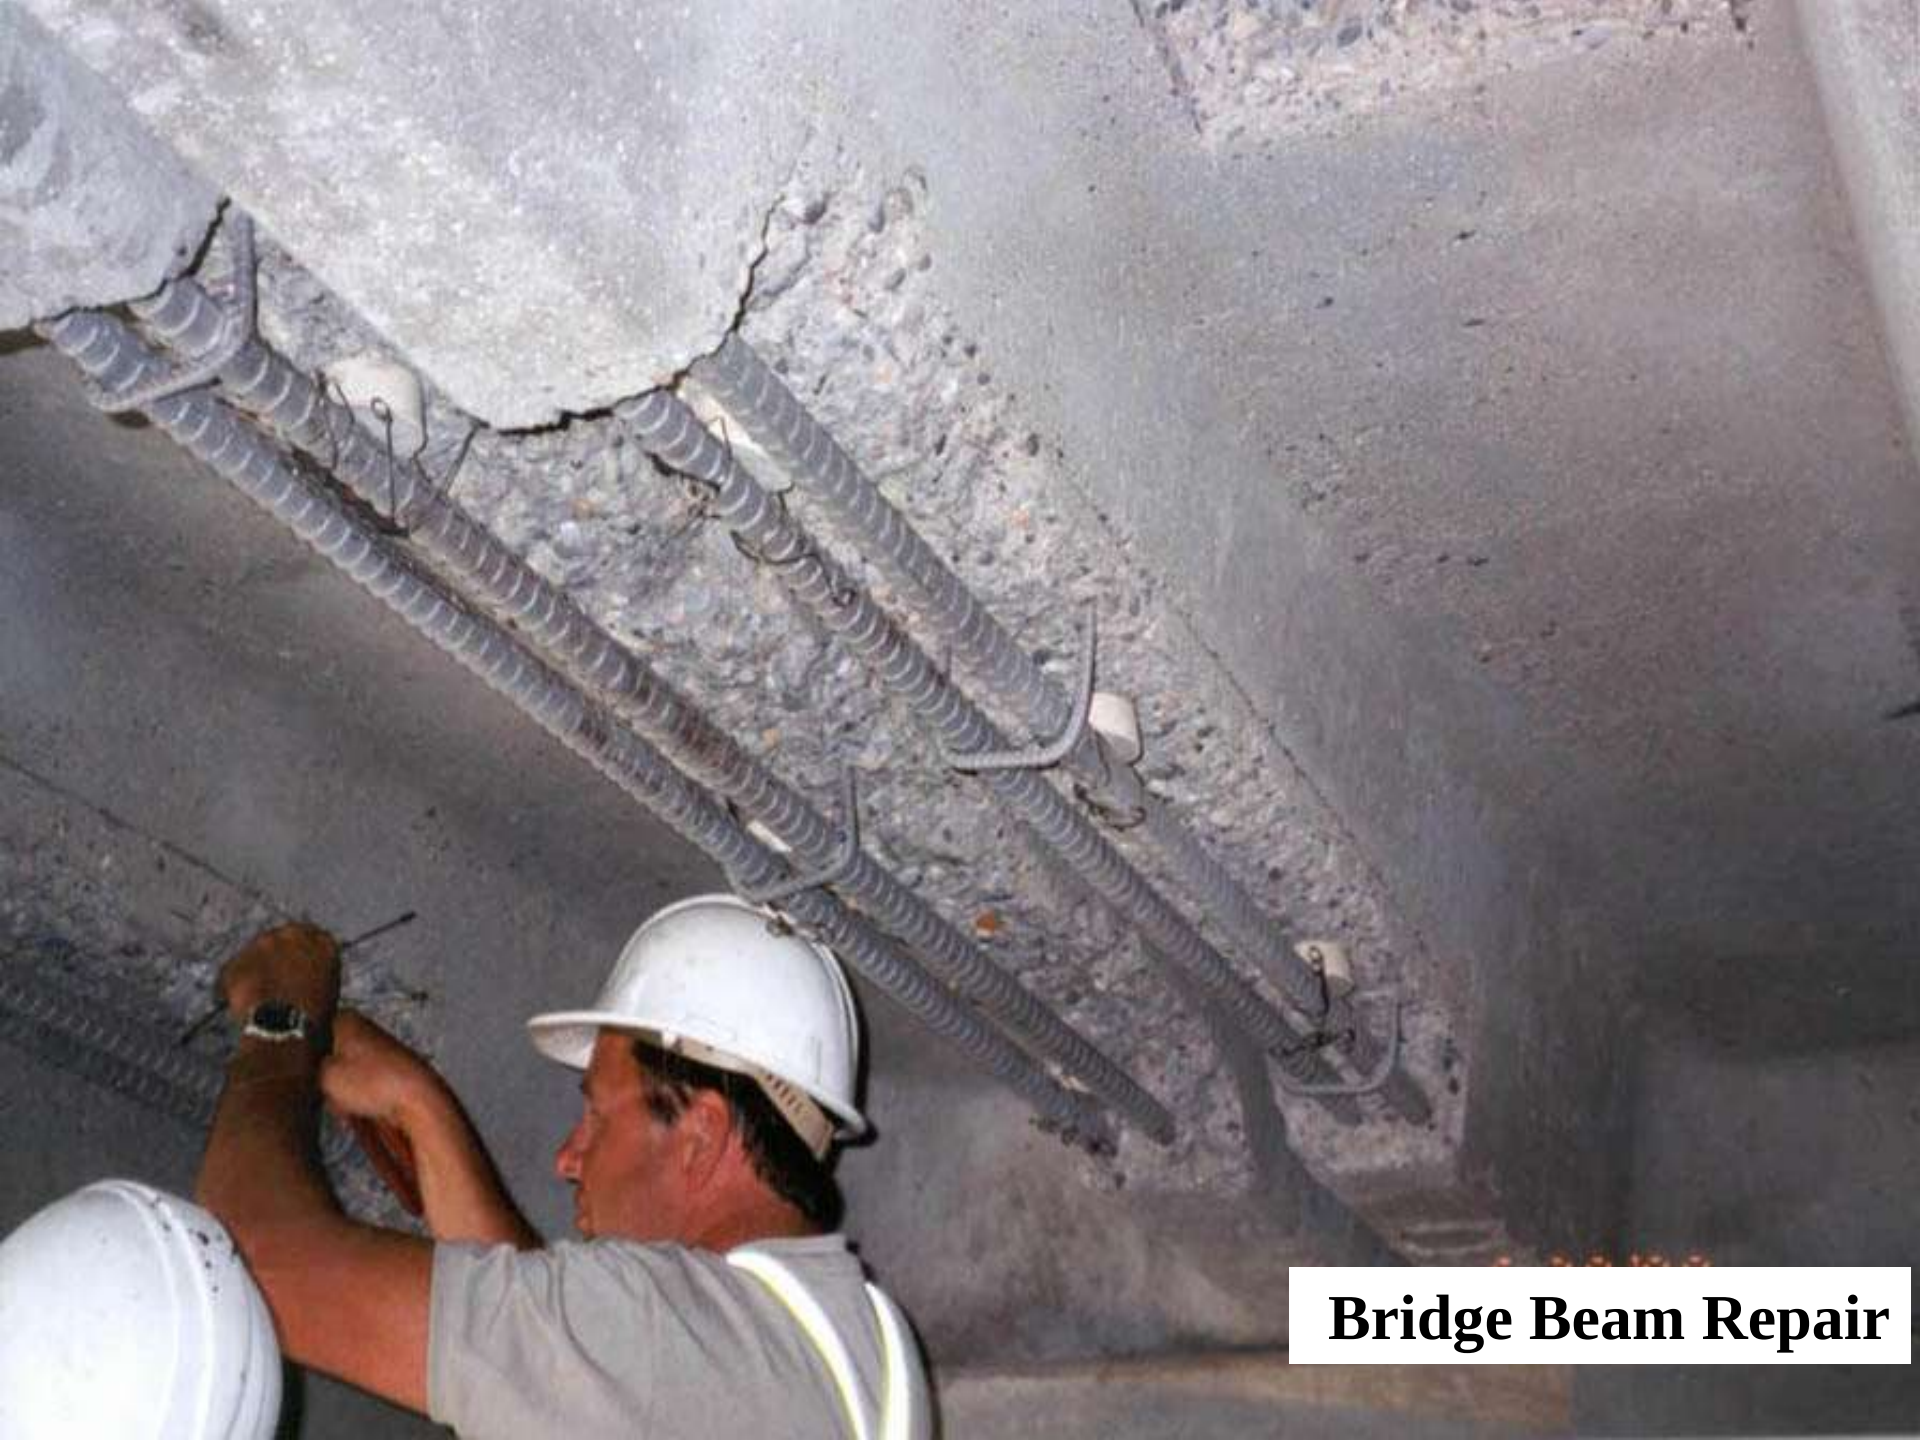
**Bridge Beam Repair**

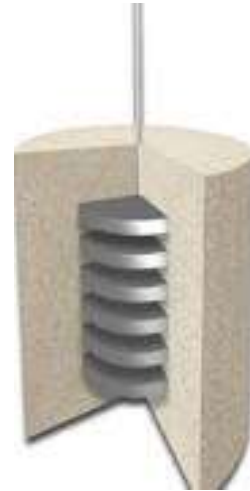
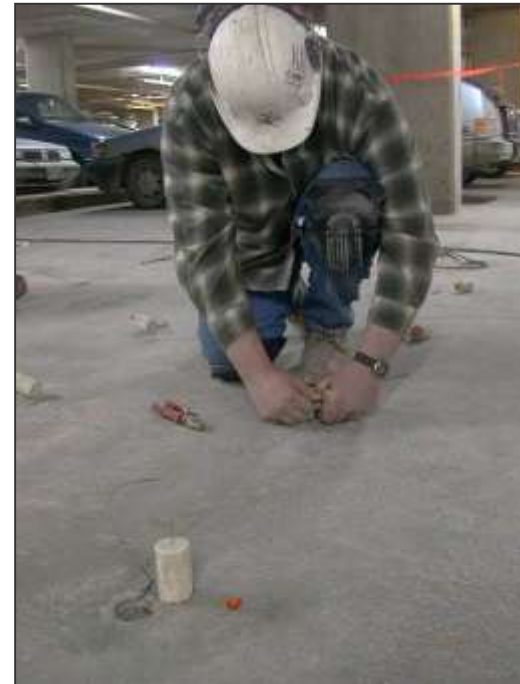
# Embedded Galvanic Anodes

- Embedded anode for corrosion control
- Installed into drilled holes
- Protect sound but contaminated areas
- Corrosion “hot spots”

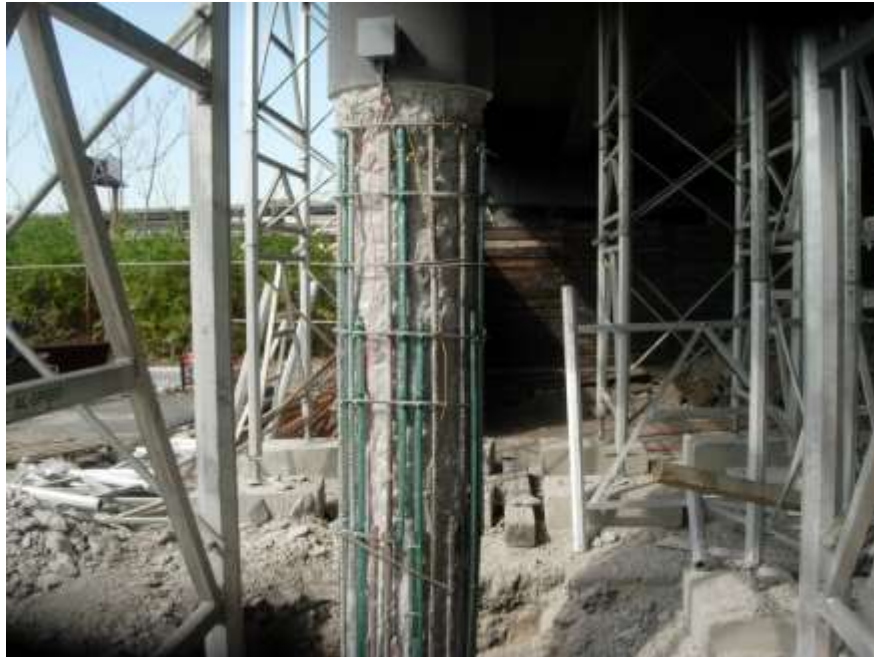
**Bridge Column Repair**

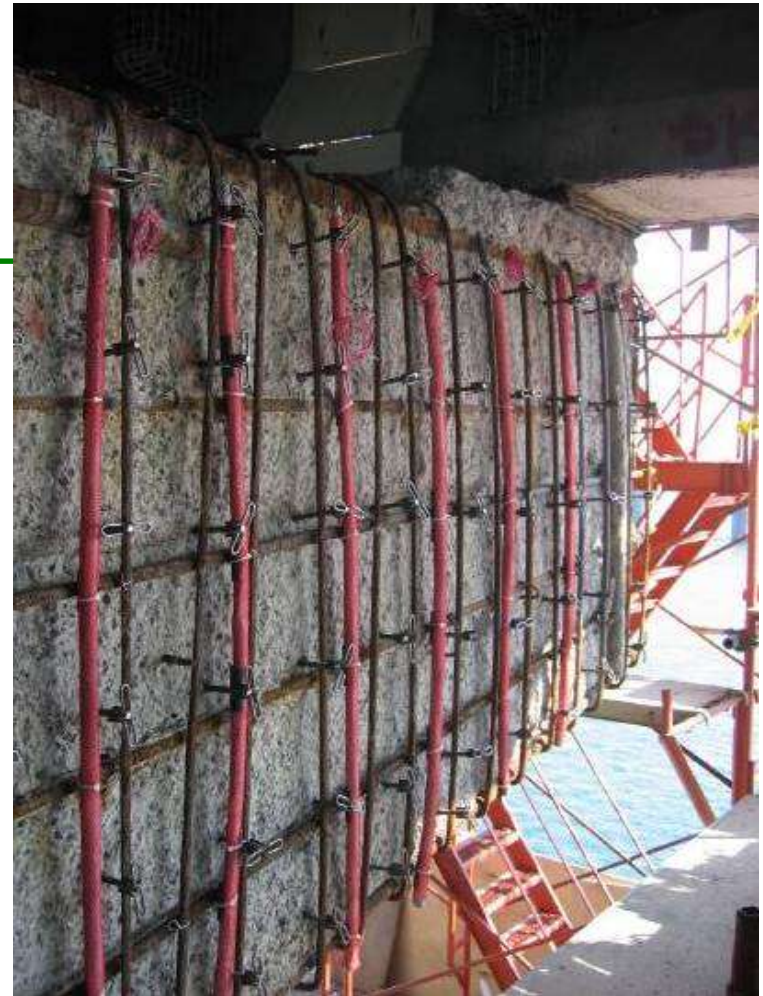
**Bridge Pier Cap Repair**
