ORIL Bridge Updates

Professor Eric Steinberg, Ph.D., P.E. Warren Schlatter, P.E., P.S. ORIL Board

CEAO Bridge Conference August 18, 2016

Ohio's Research Initiative for Locals (ORIL)

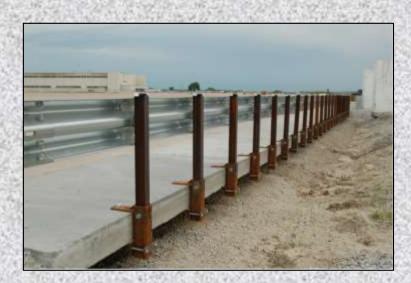
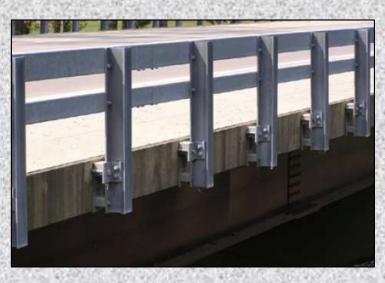
MGS (MASH TL3)

Illinois Two-Tube (R350 TL4)

- PROS
 - MASH TL3
 - Simple w-beam and weak post design
 - Lower loads on mount
 - Low cost
 - FEA is an option for evaluation
 - No transition system required when attaching to the MGS guardrail
- CONS
 - Post spacing (3'-1.5") will require a lot of mount connections
 - Large deflections during impacts
 - Easily damaged nuisance hits, snow plowing, etc.
 - Containment of heavier trucks at low impact conditions???
 - Vertical load capacity?

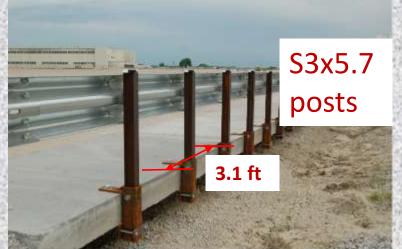
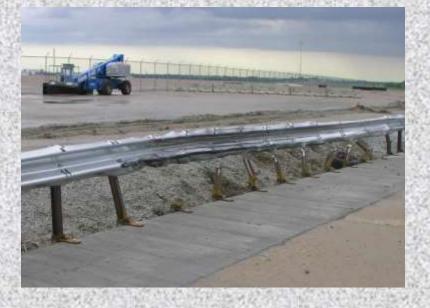
Illinois Two-Tube

- Report 350 TL4
- Simple two-tube and post design
- Post spacing (6'-3") (PRO??)
- FEA is an option for evaluation
- CONS
 - Will require very stiff mount to achieve same stiffness as original system (i.e., for acceptance under original letter)
 - These loads have to be carried by the bridge fascia beam.

TS 8x4x5/16 TS 6x4x1/4

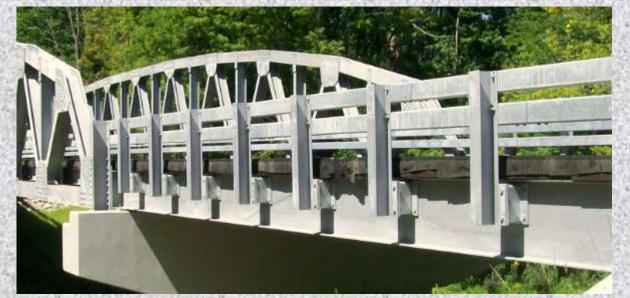
Guardrail System Mounted to Steel Fascia Beams Illinois Two-Tube

Similar Design with Mounting to Fascia Beam (from US Bridge)

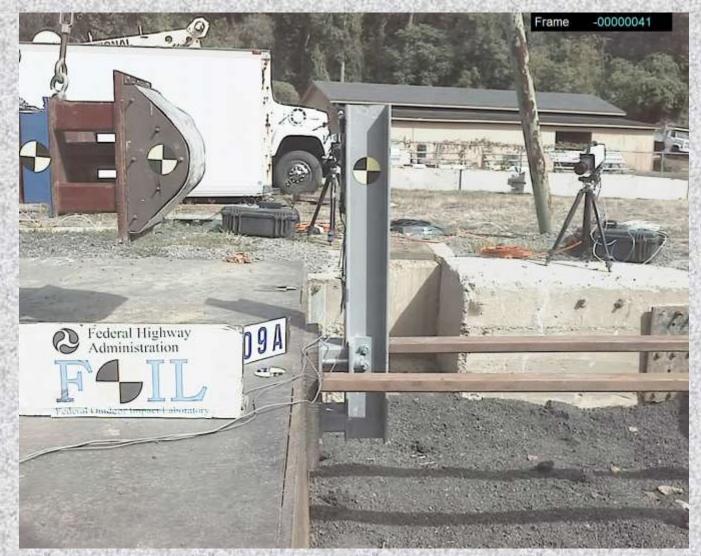
Guardrail System Mounted to Steel Fascia Beams Pendulum Testing for Model Verification

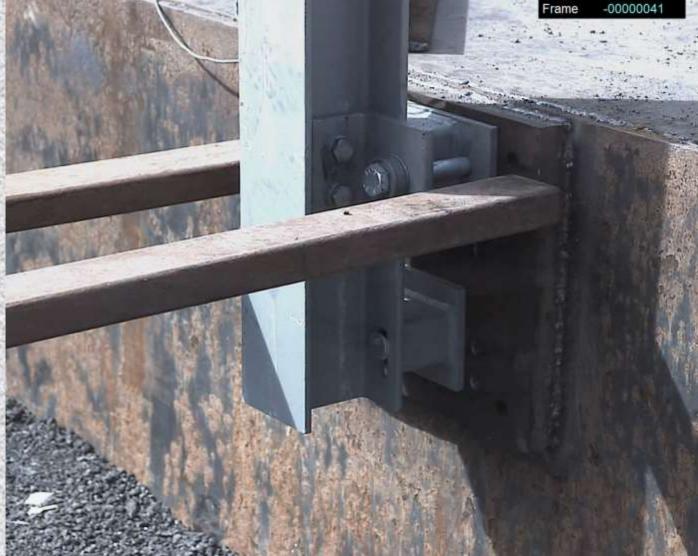
Guardrail System Mounted to Steel Fascia Beams Pendulum Testing for Model Verification

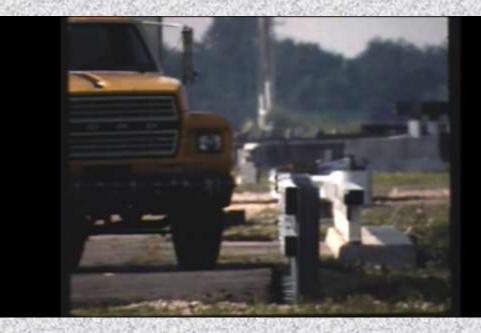
Railing:

- Illinois Two-Tube
- Length = 84 ft
- Vehicle
 - 18-kip SUT
 - Impact speed = 51.4 mph
 - Impact angle = 14.7 deg.
- Impact Point

- Max permanent deflection = 2.5 inches
- Max dynamic deflection was not reported

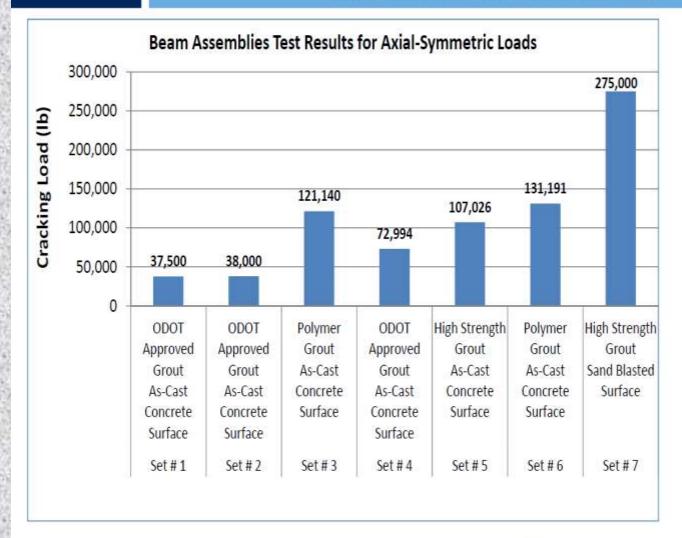
Failure Load (lb)	Set #	Surface Roughness	# of Specimes	Grout Materail	Key Way Depth
800	1	Sandblasted Surface	2	ODOT-Approved List	Partial depth
300	1	As-Cast	2	ODOT-Approved List	Full depth
Failure in Concrete Uni	1	Sandblasted Surface	2	ODOT-Approved List	Full depth
20,000	2	Sandblasted Surface	2	ODOT-Approved List	Full depth
Failure in Concrete Uni	1	As-Cast	2	HSC-Grout	Full depth
Failure in Concrete Uni	1	Sandblasted Surface	2	HSC-Grout	Full depth
32,000	2	Sandblasted Surface	2	HSC-Grout	Full depth
Failure in Concrete Uni	1	Sandblasted Surface	2	UHPG	Full depth
8,500	2	Sandblasted Surface	2	UHPG	Full depth
Failure in Concrete Uni	1	Sandblasted Surface	2	Polymer Grout	Full depth
13,000	2	Sandblasted Surface	2	Polymer Grout	Full depth

- 1. The waterproofing membranes themselves seem to have the strength and watertightness needed.
- 2. Construction practices during grouting, waterproofing and paving are likely to blame for many of todays problems
- Deeper and wider keyways, together with better grout, could provide an appropriate factor of safety to resist the eccentric loading experienced
