Protecting Your Infrastructure from Stream Erosion

Ohio Storm Water Management and
Drainage Conference

March 8, 2017

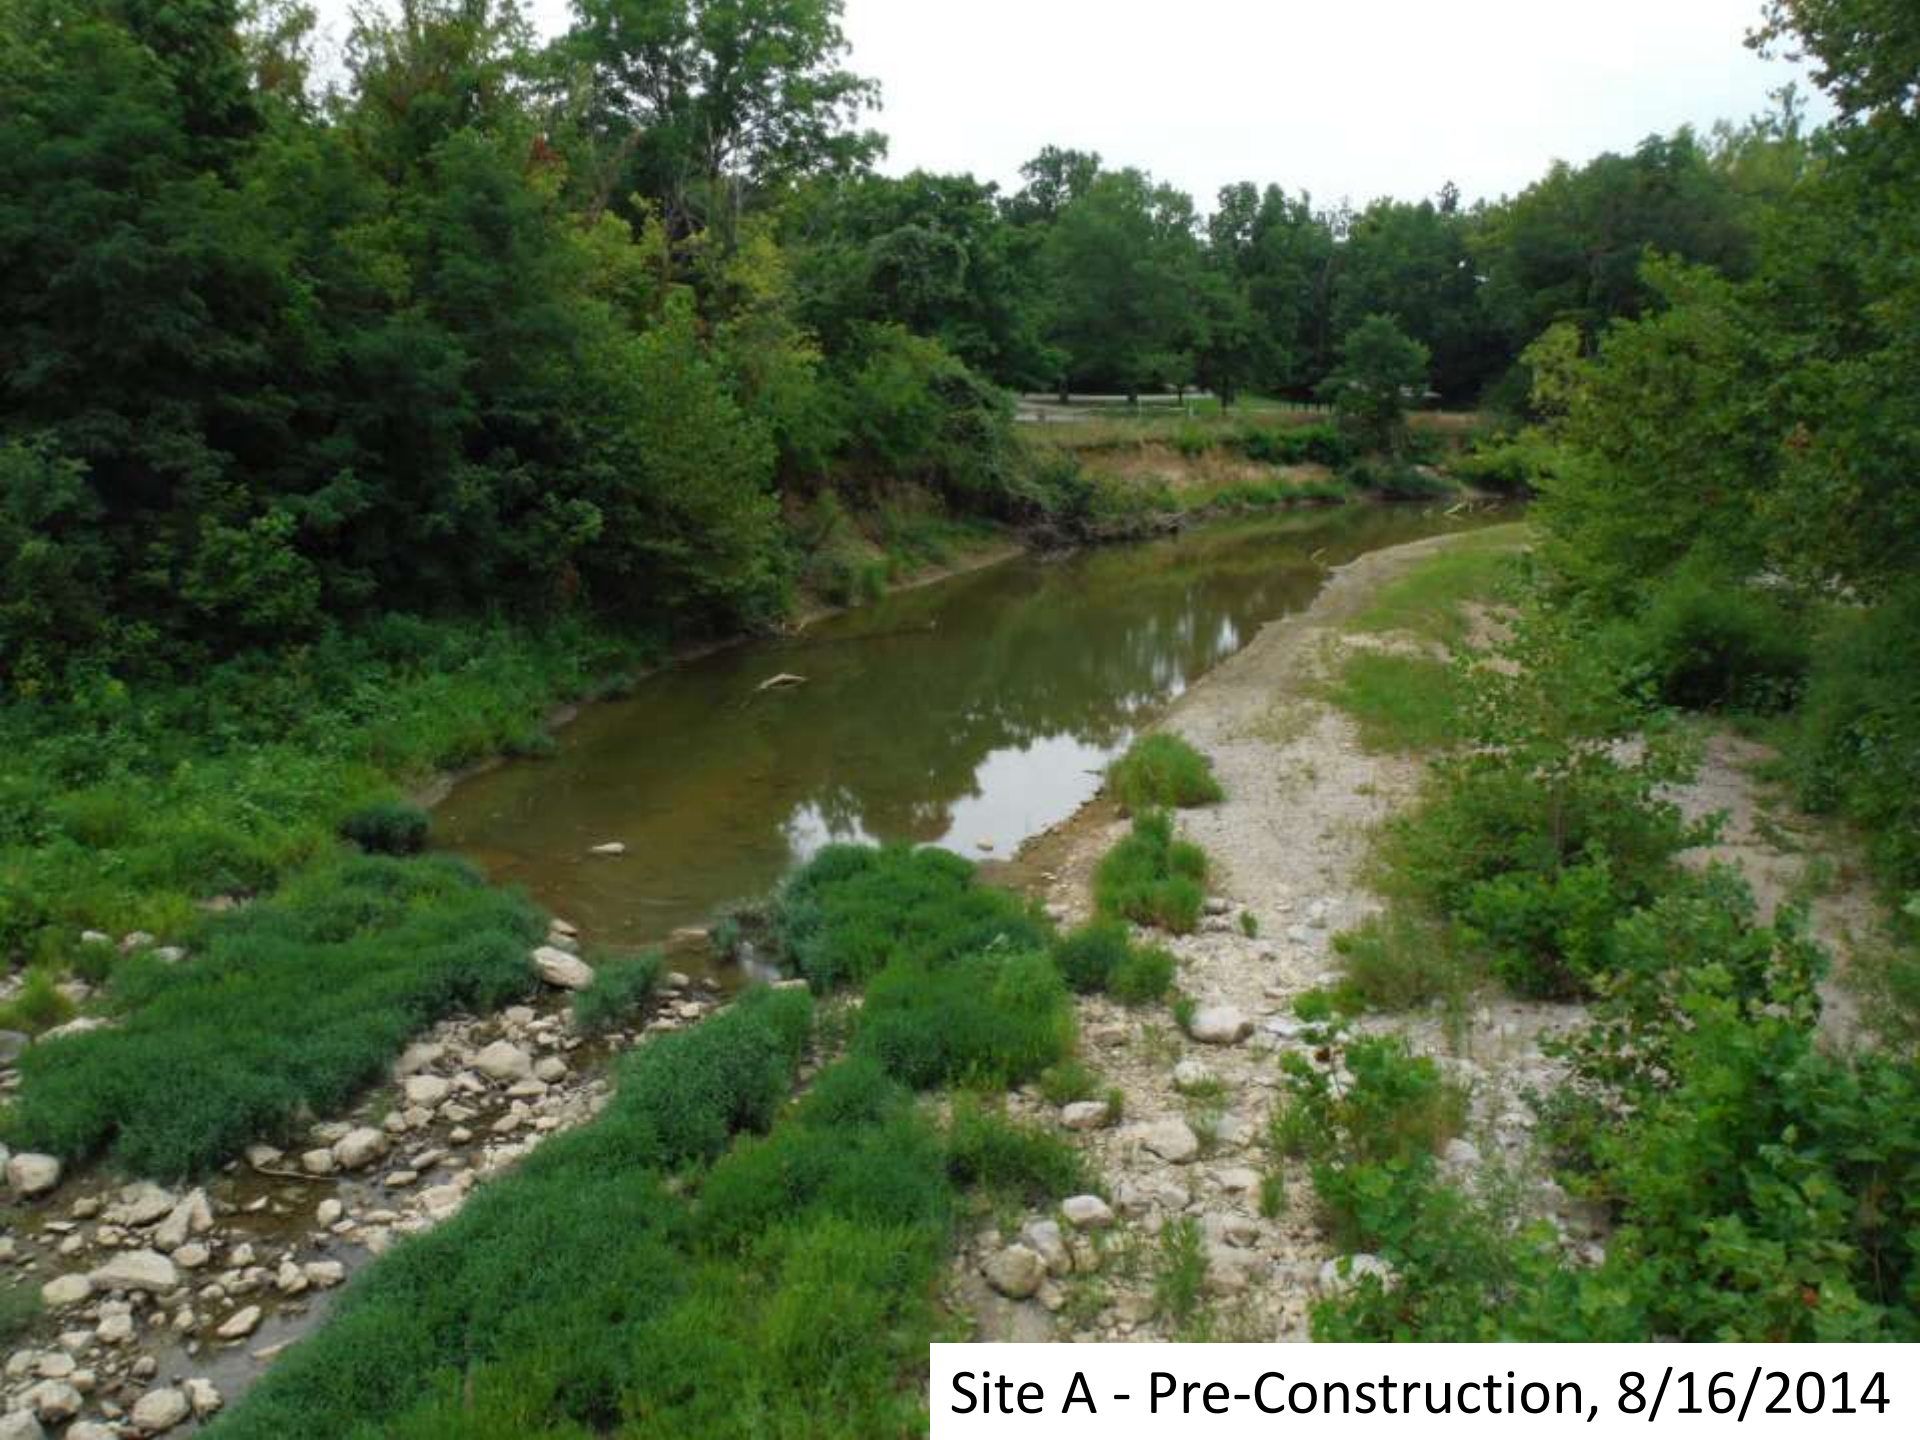
Site A - Pre-Construction, 8/16/2014

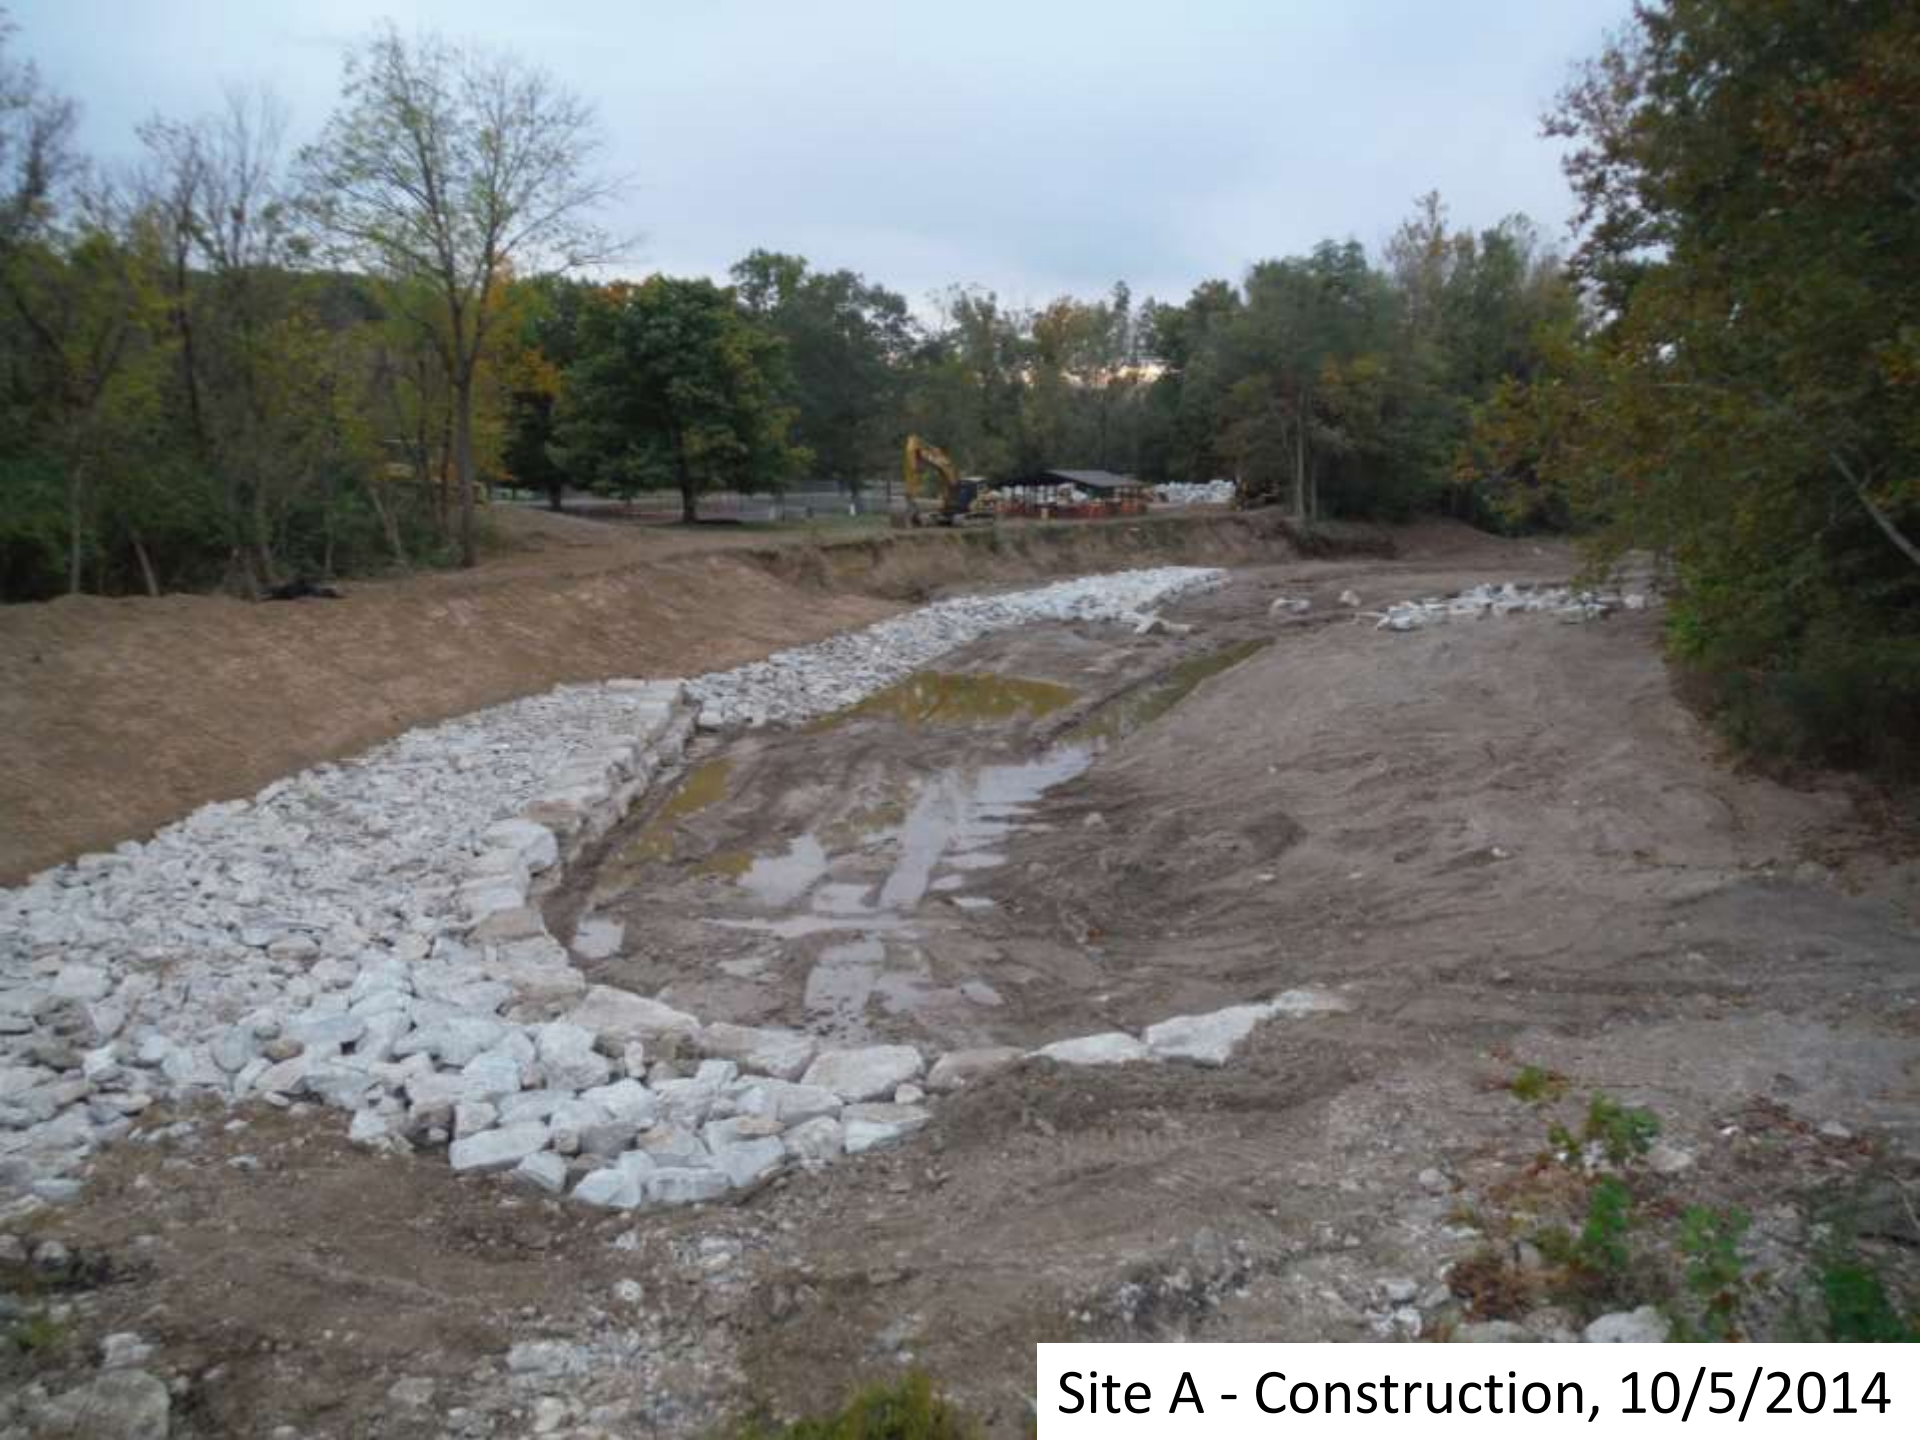
Site A - Construction, 10/5/2014

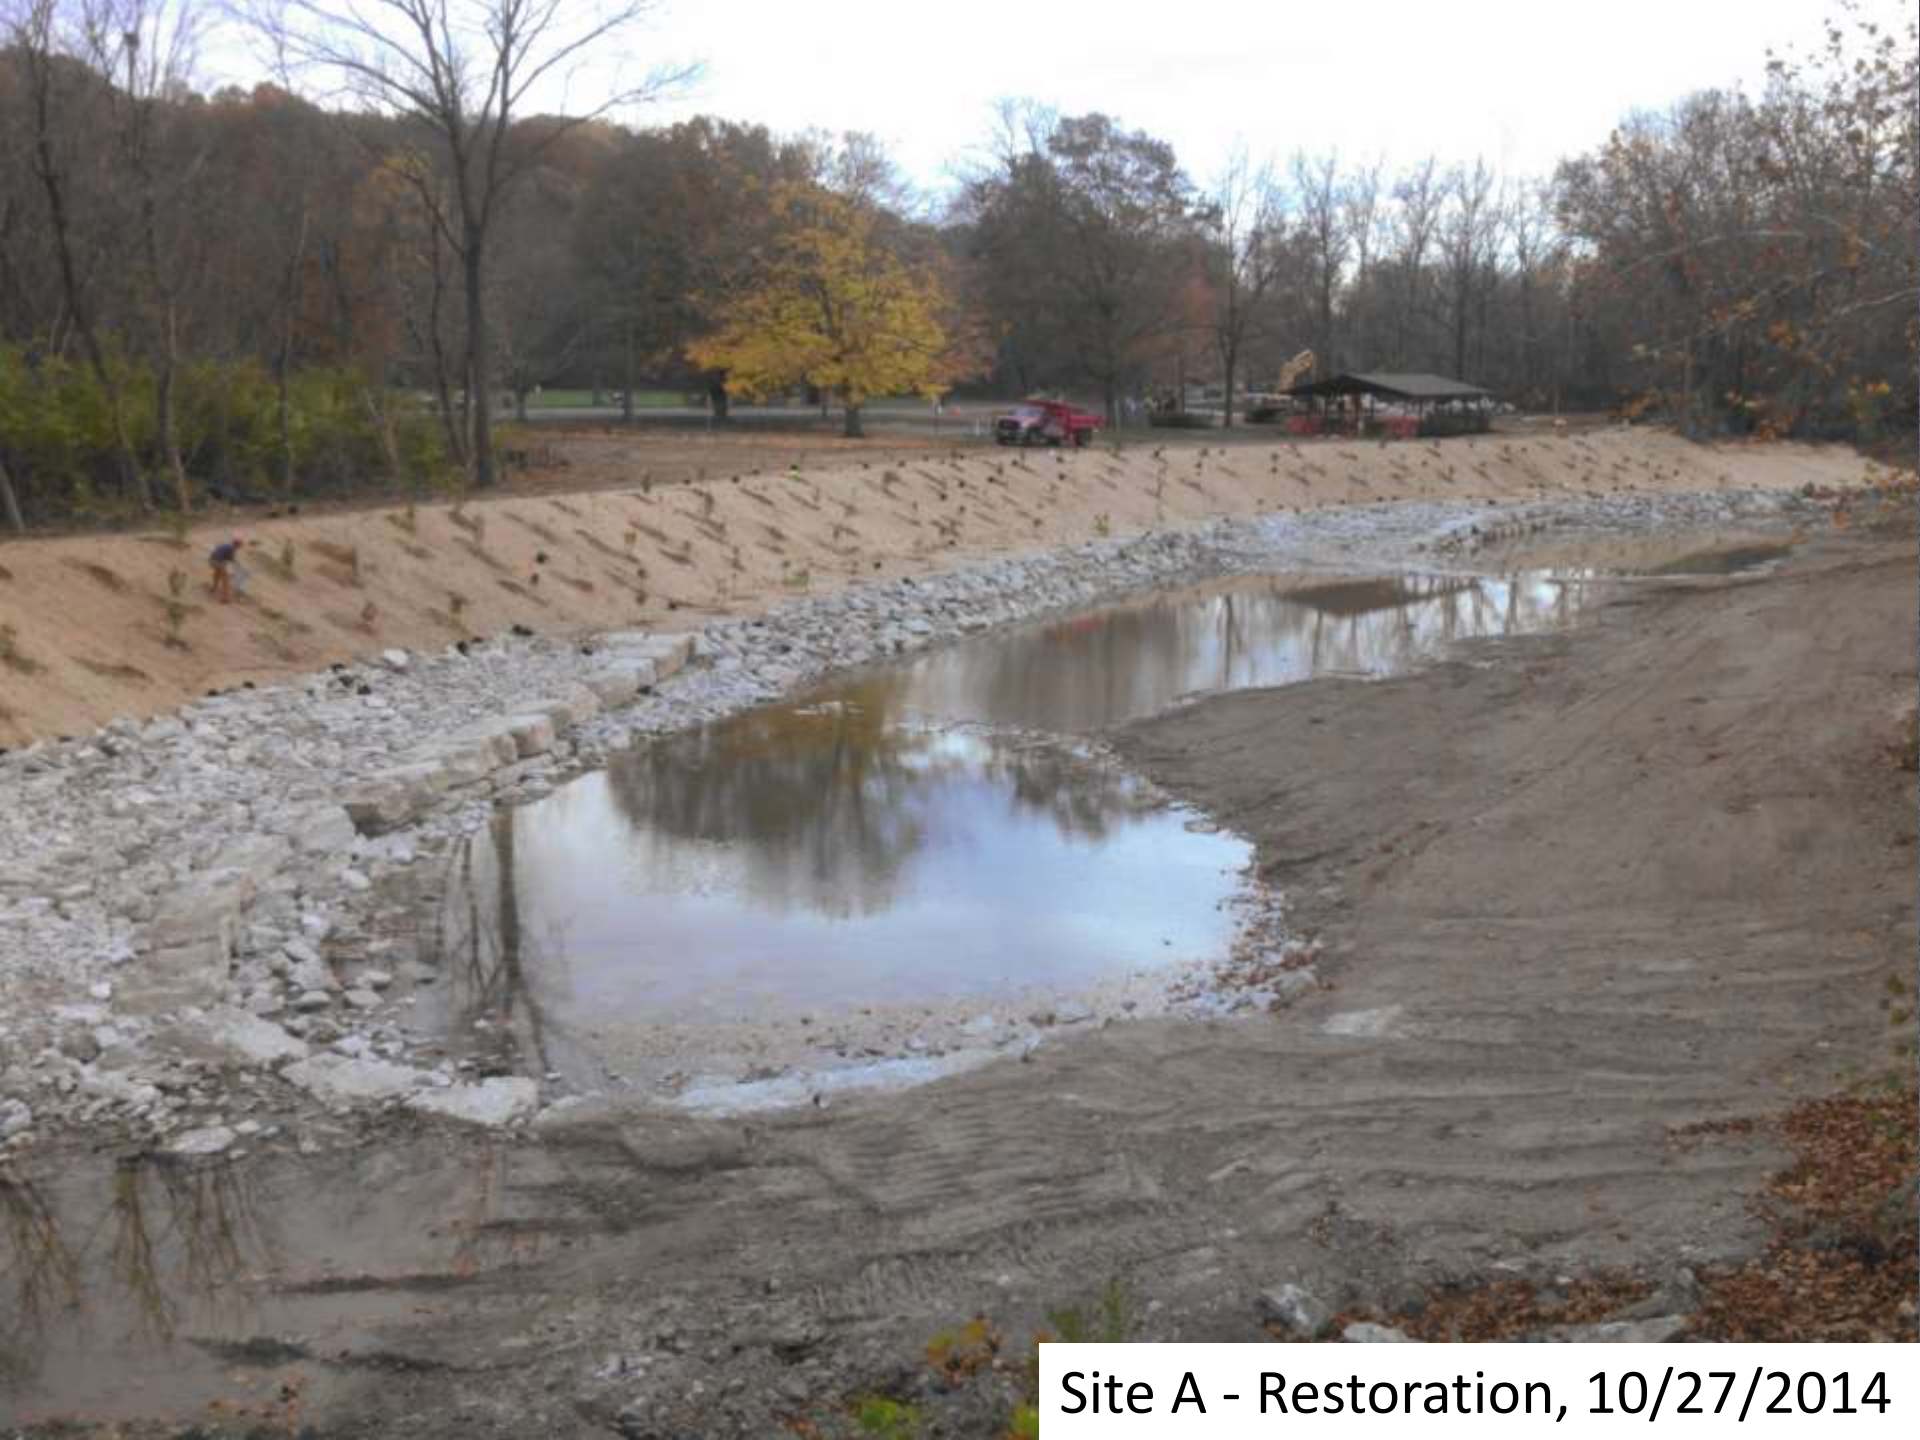
Site A - Restoration, 10/27/2014

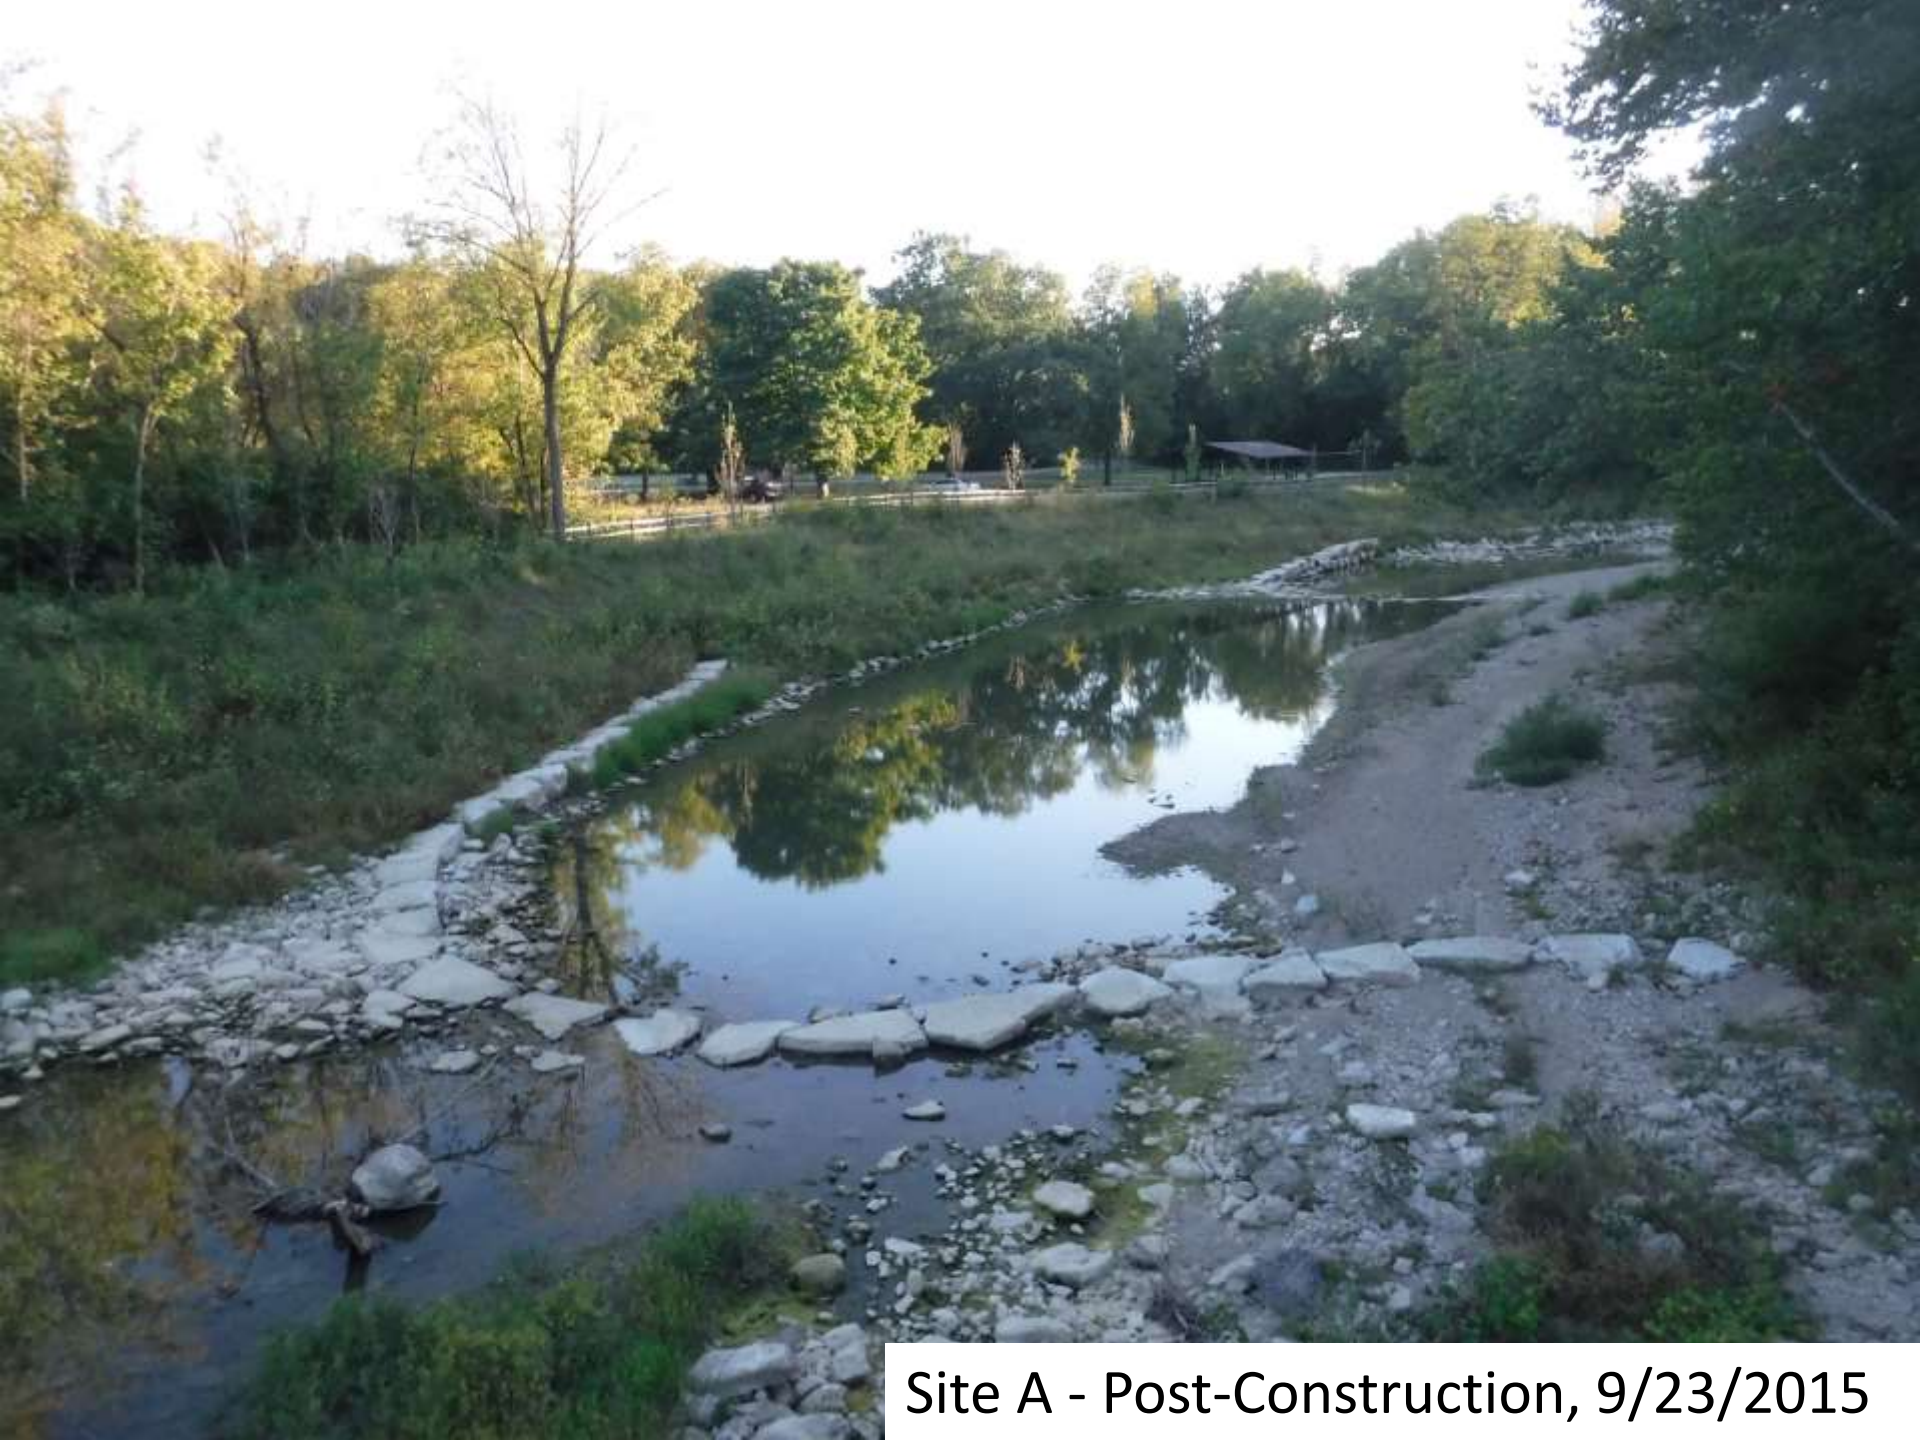
Site A - Post-Construction, 9/23/2015

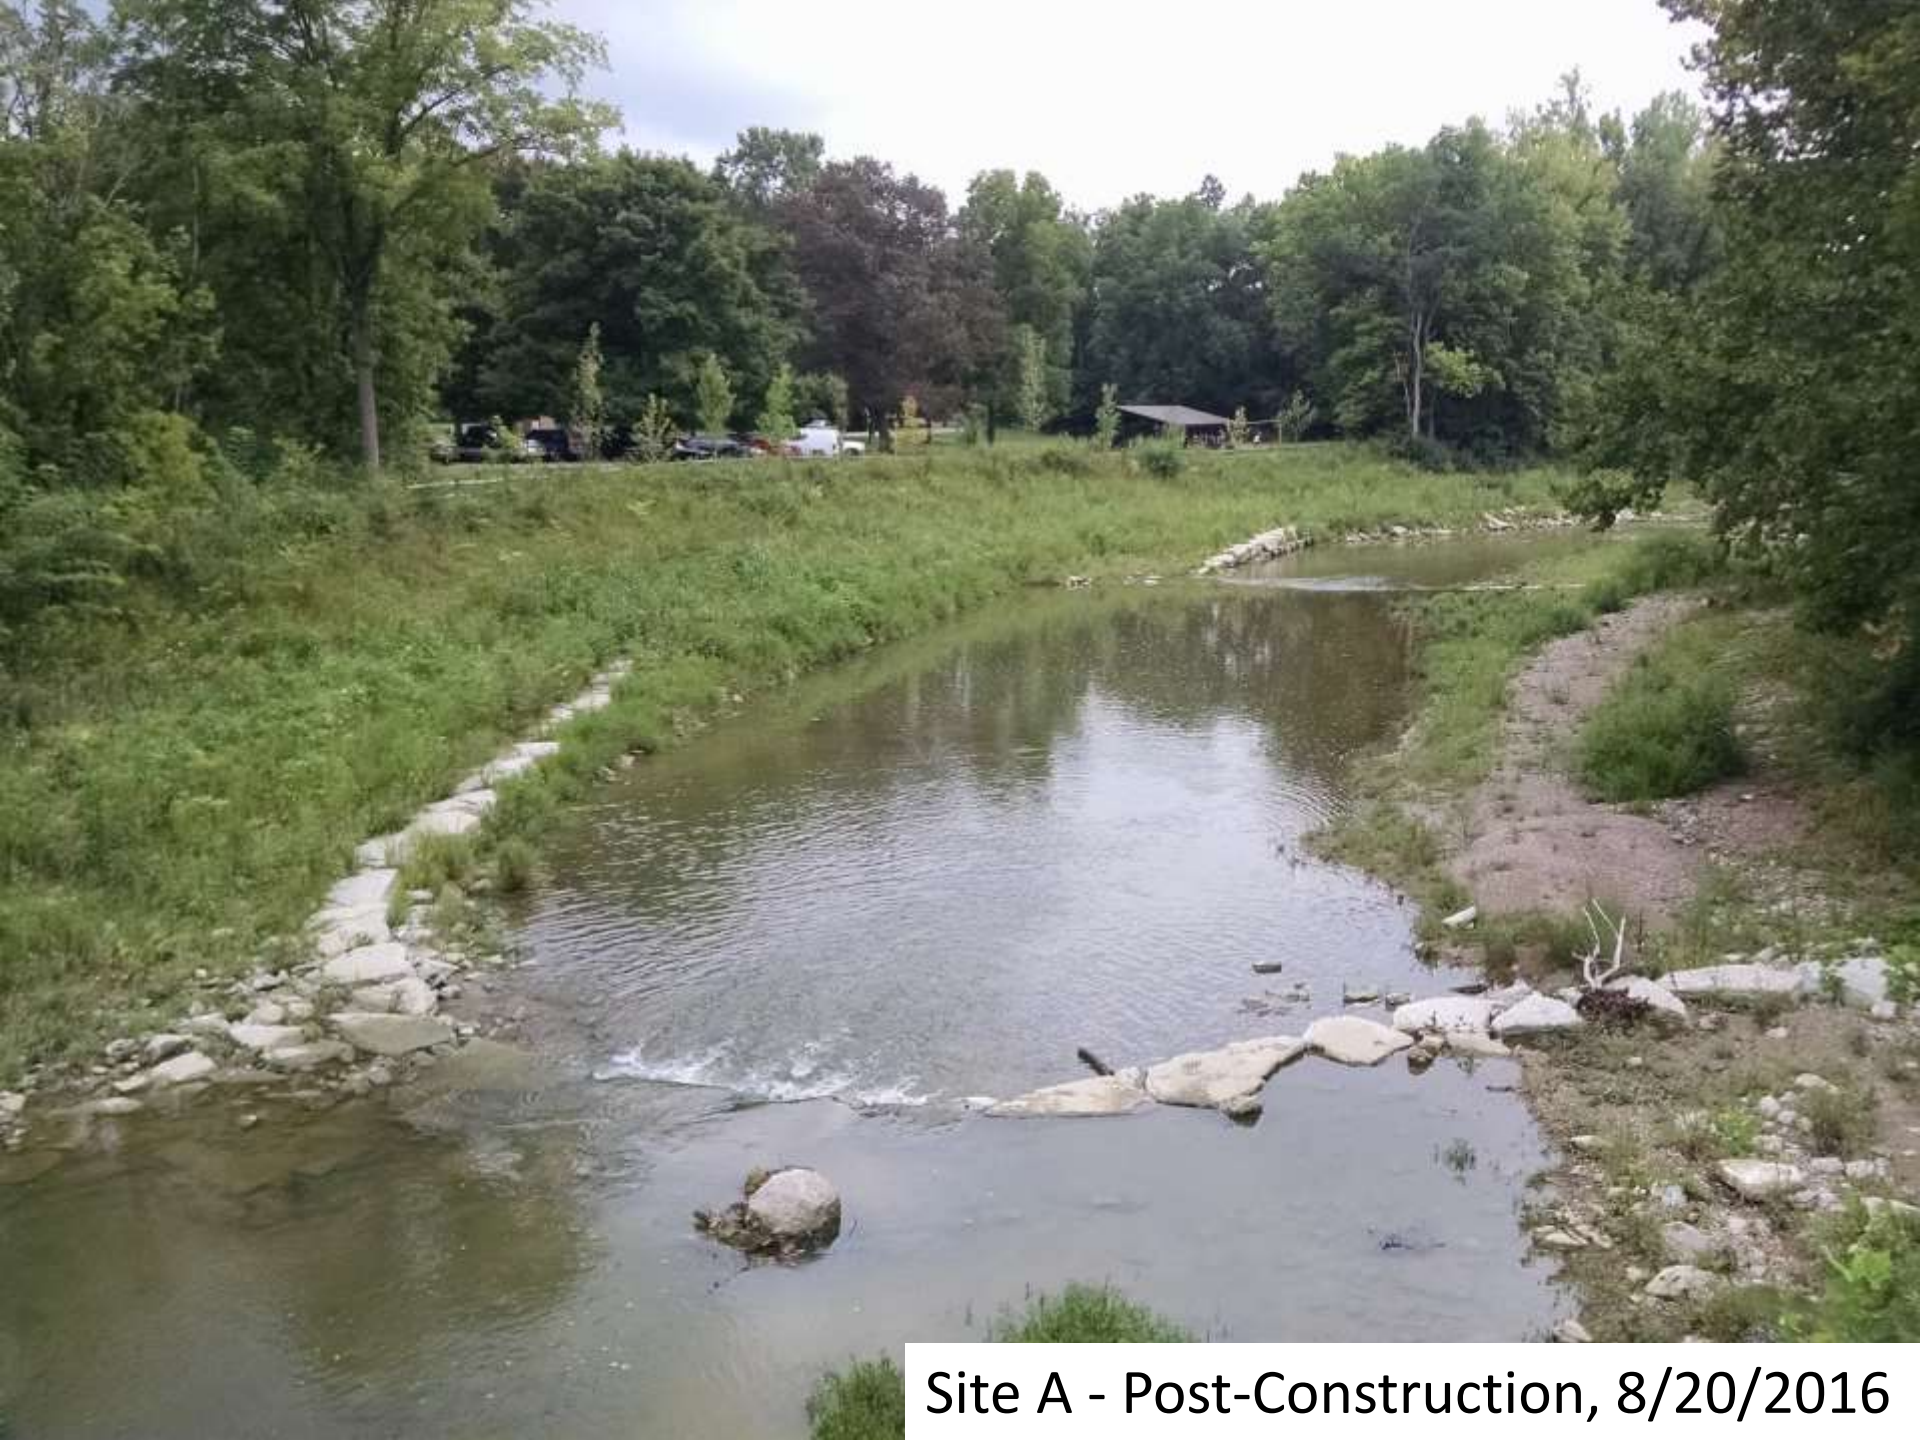
Site A - Post-Construction, 8/20/2016

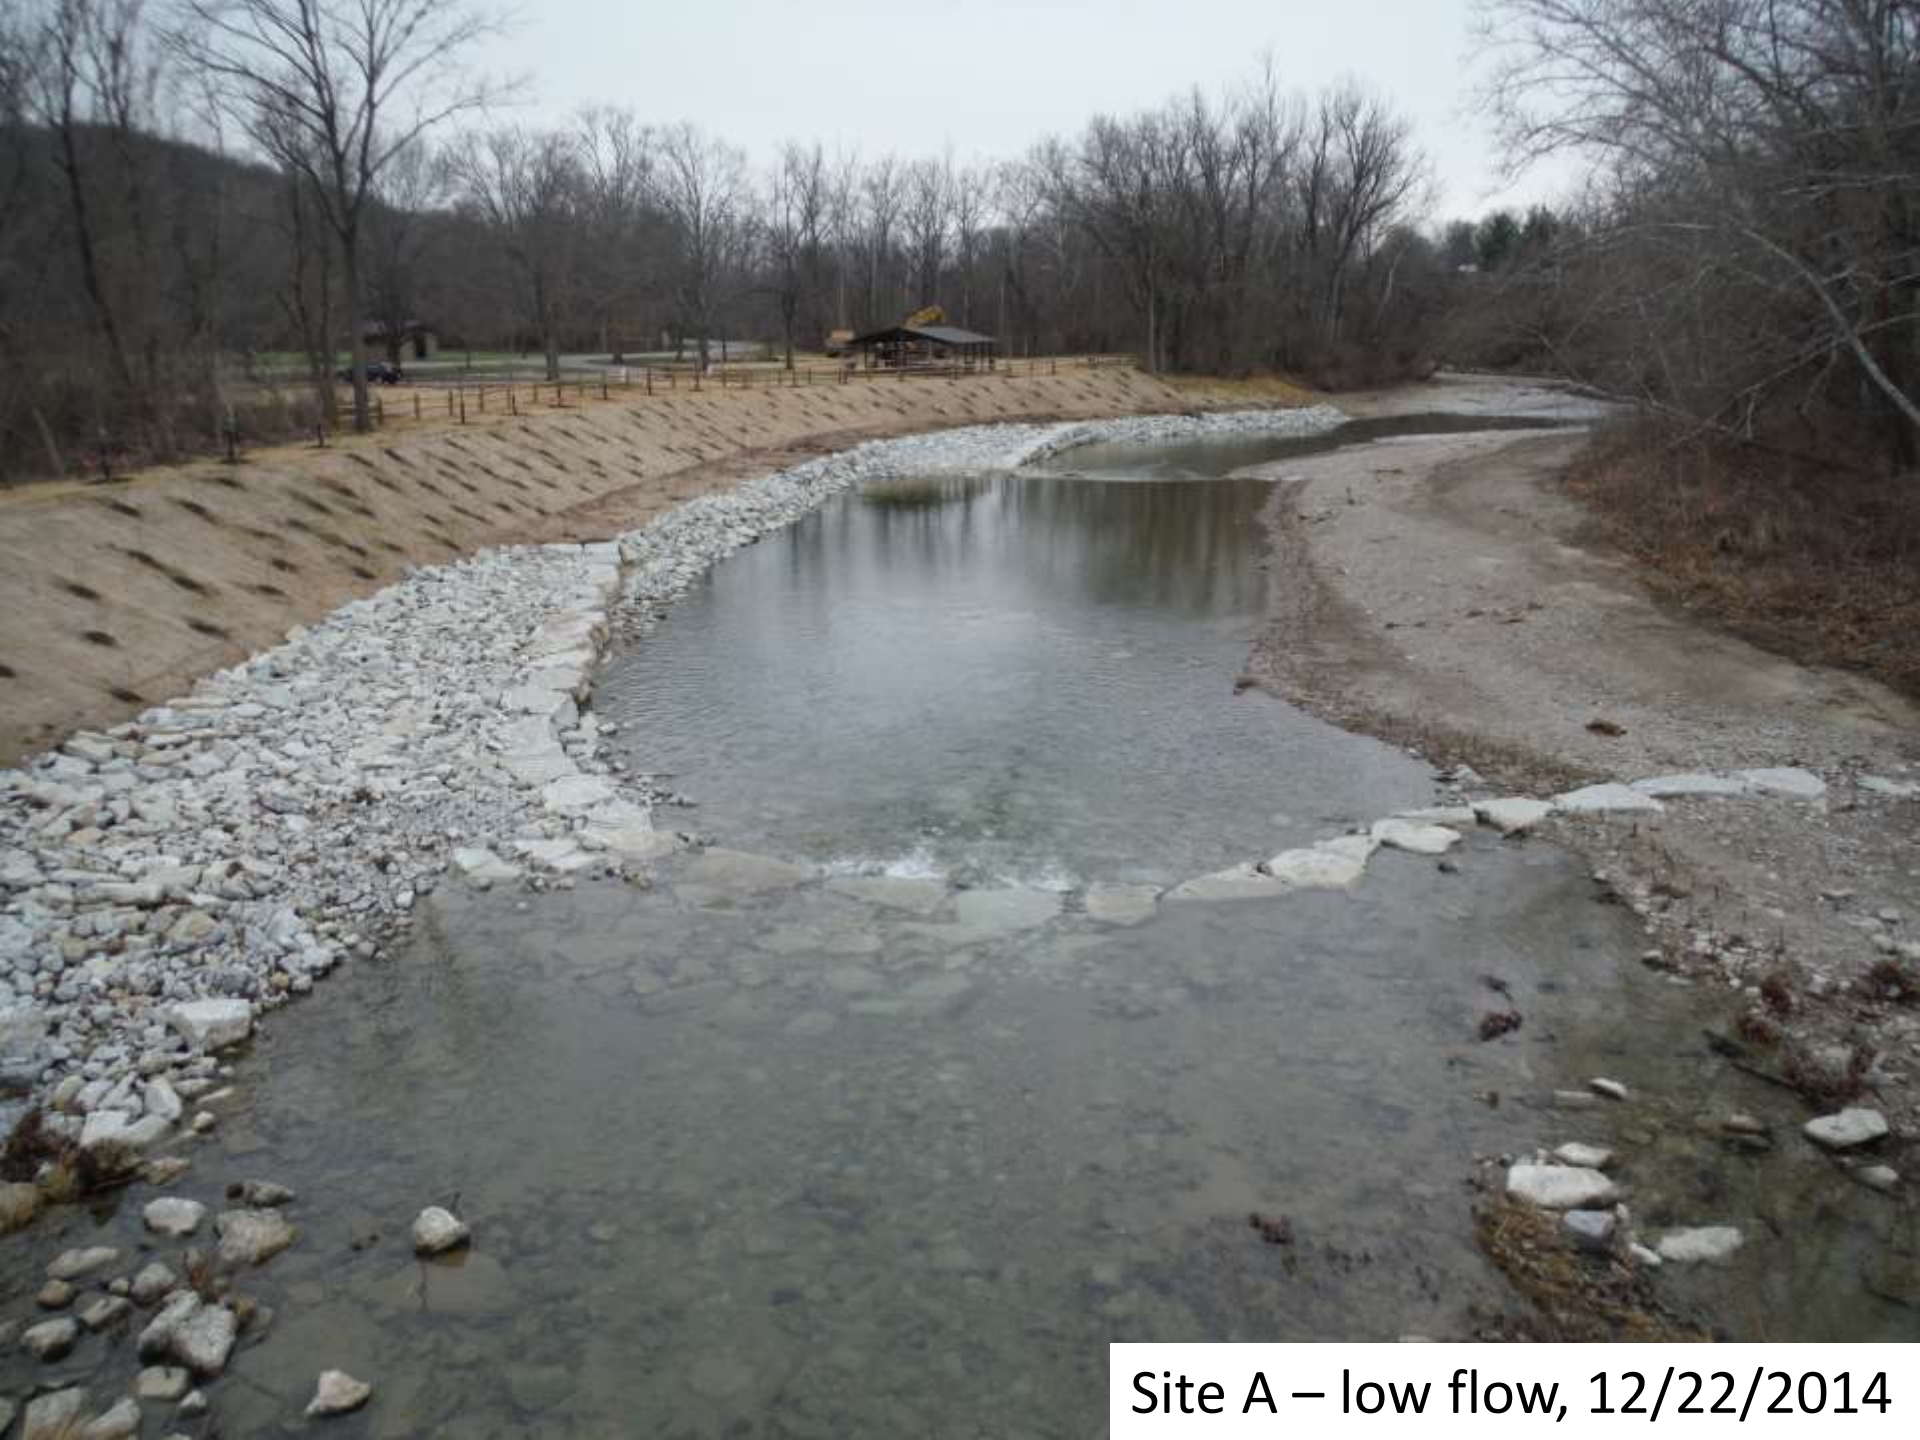
Site A – low flow, 12/22/2014

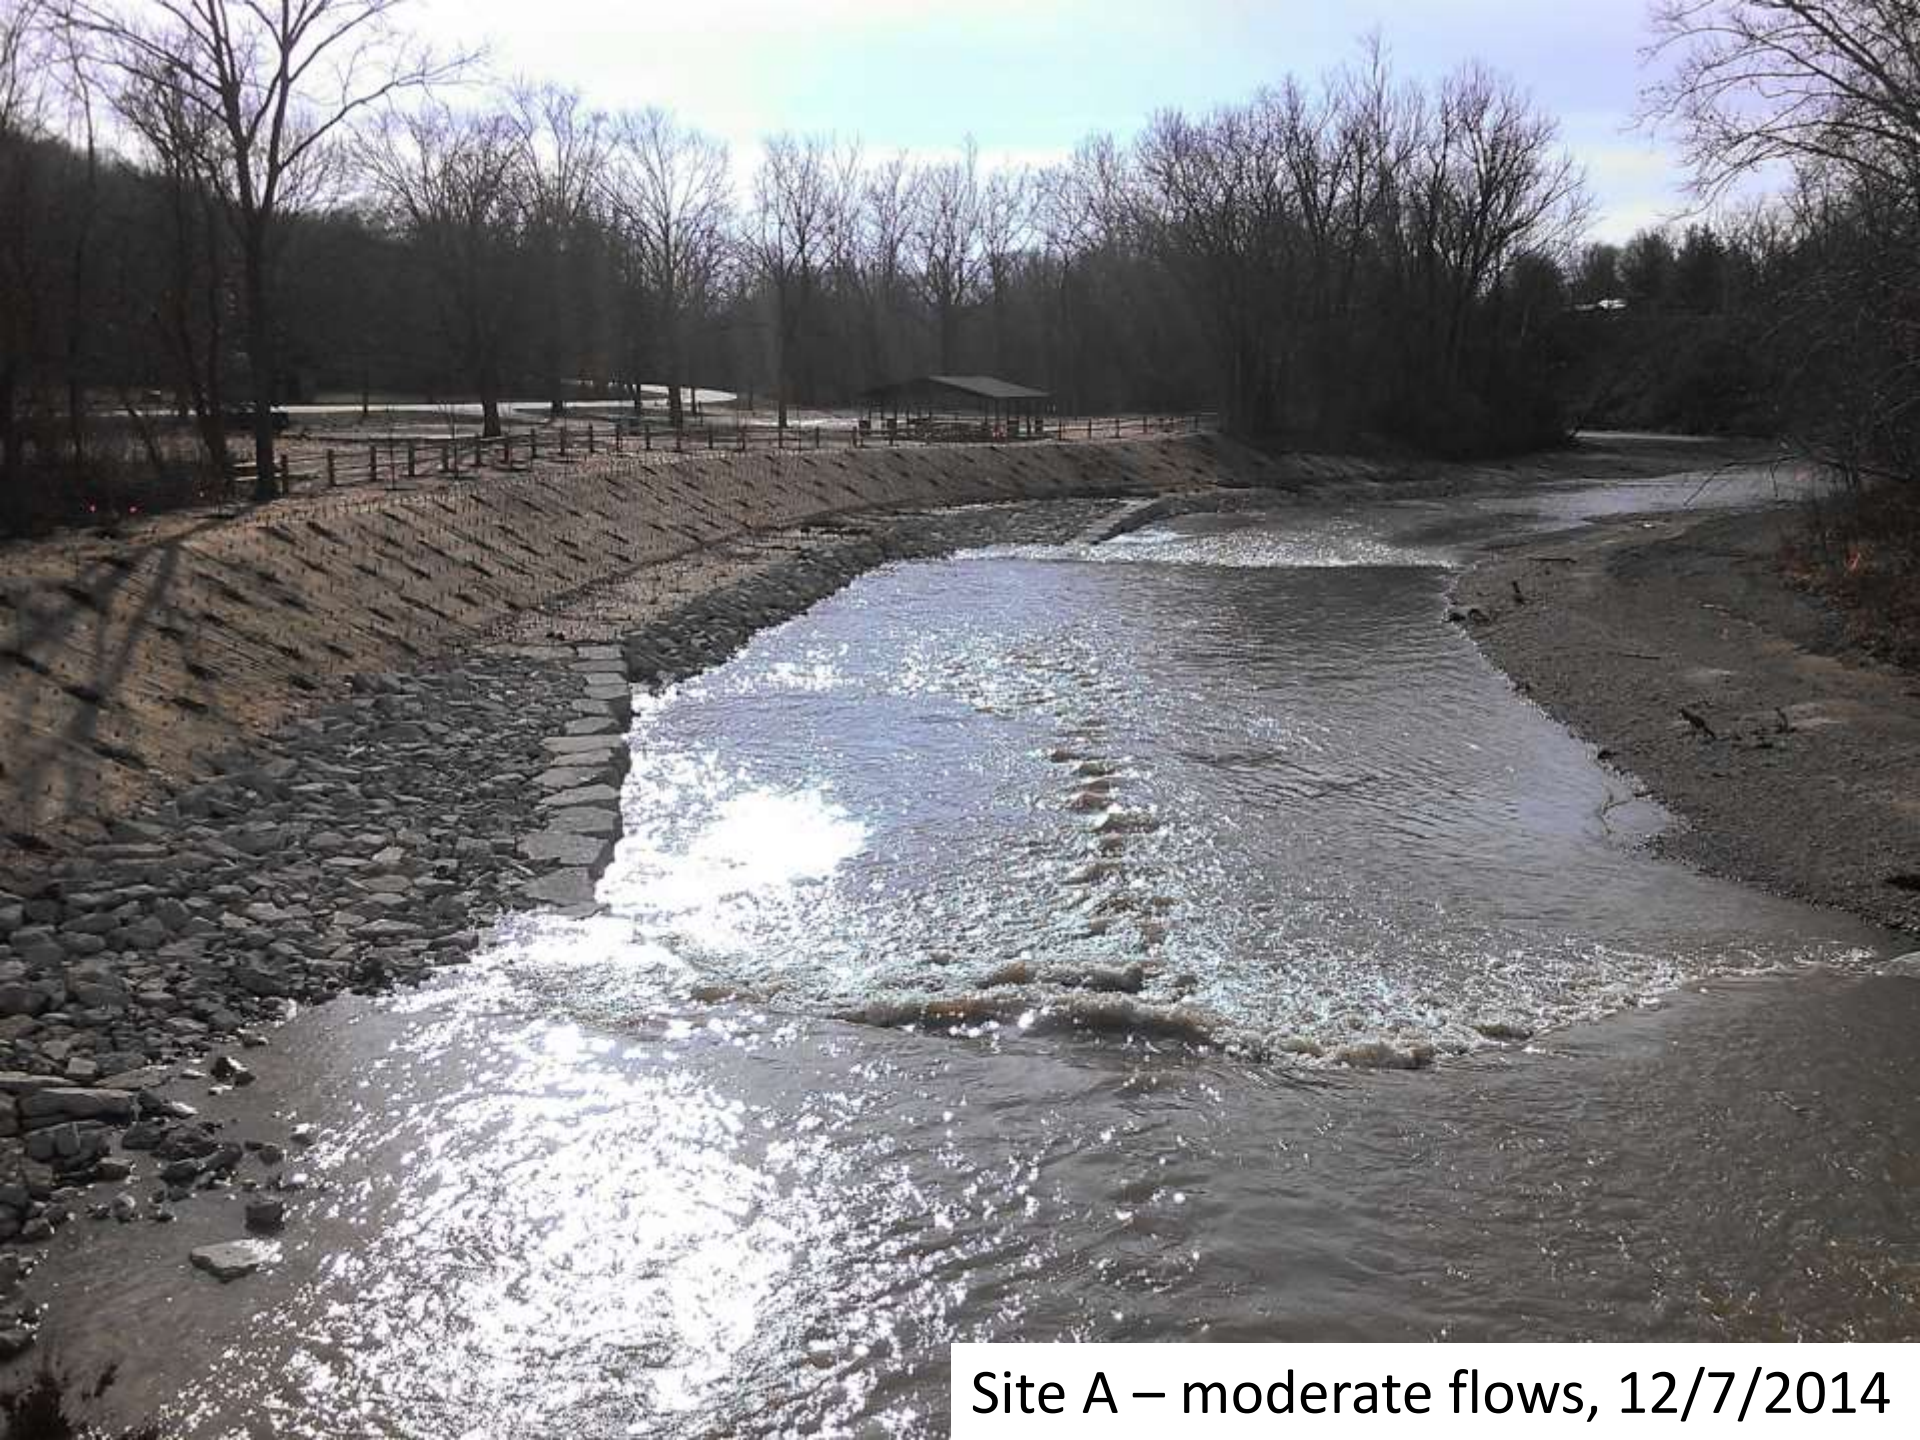
Site A – moderate flows, 12/7/2014

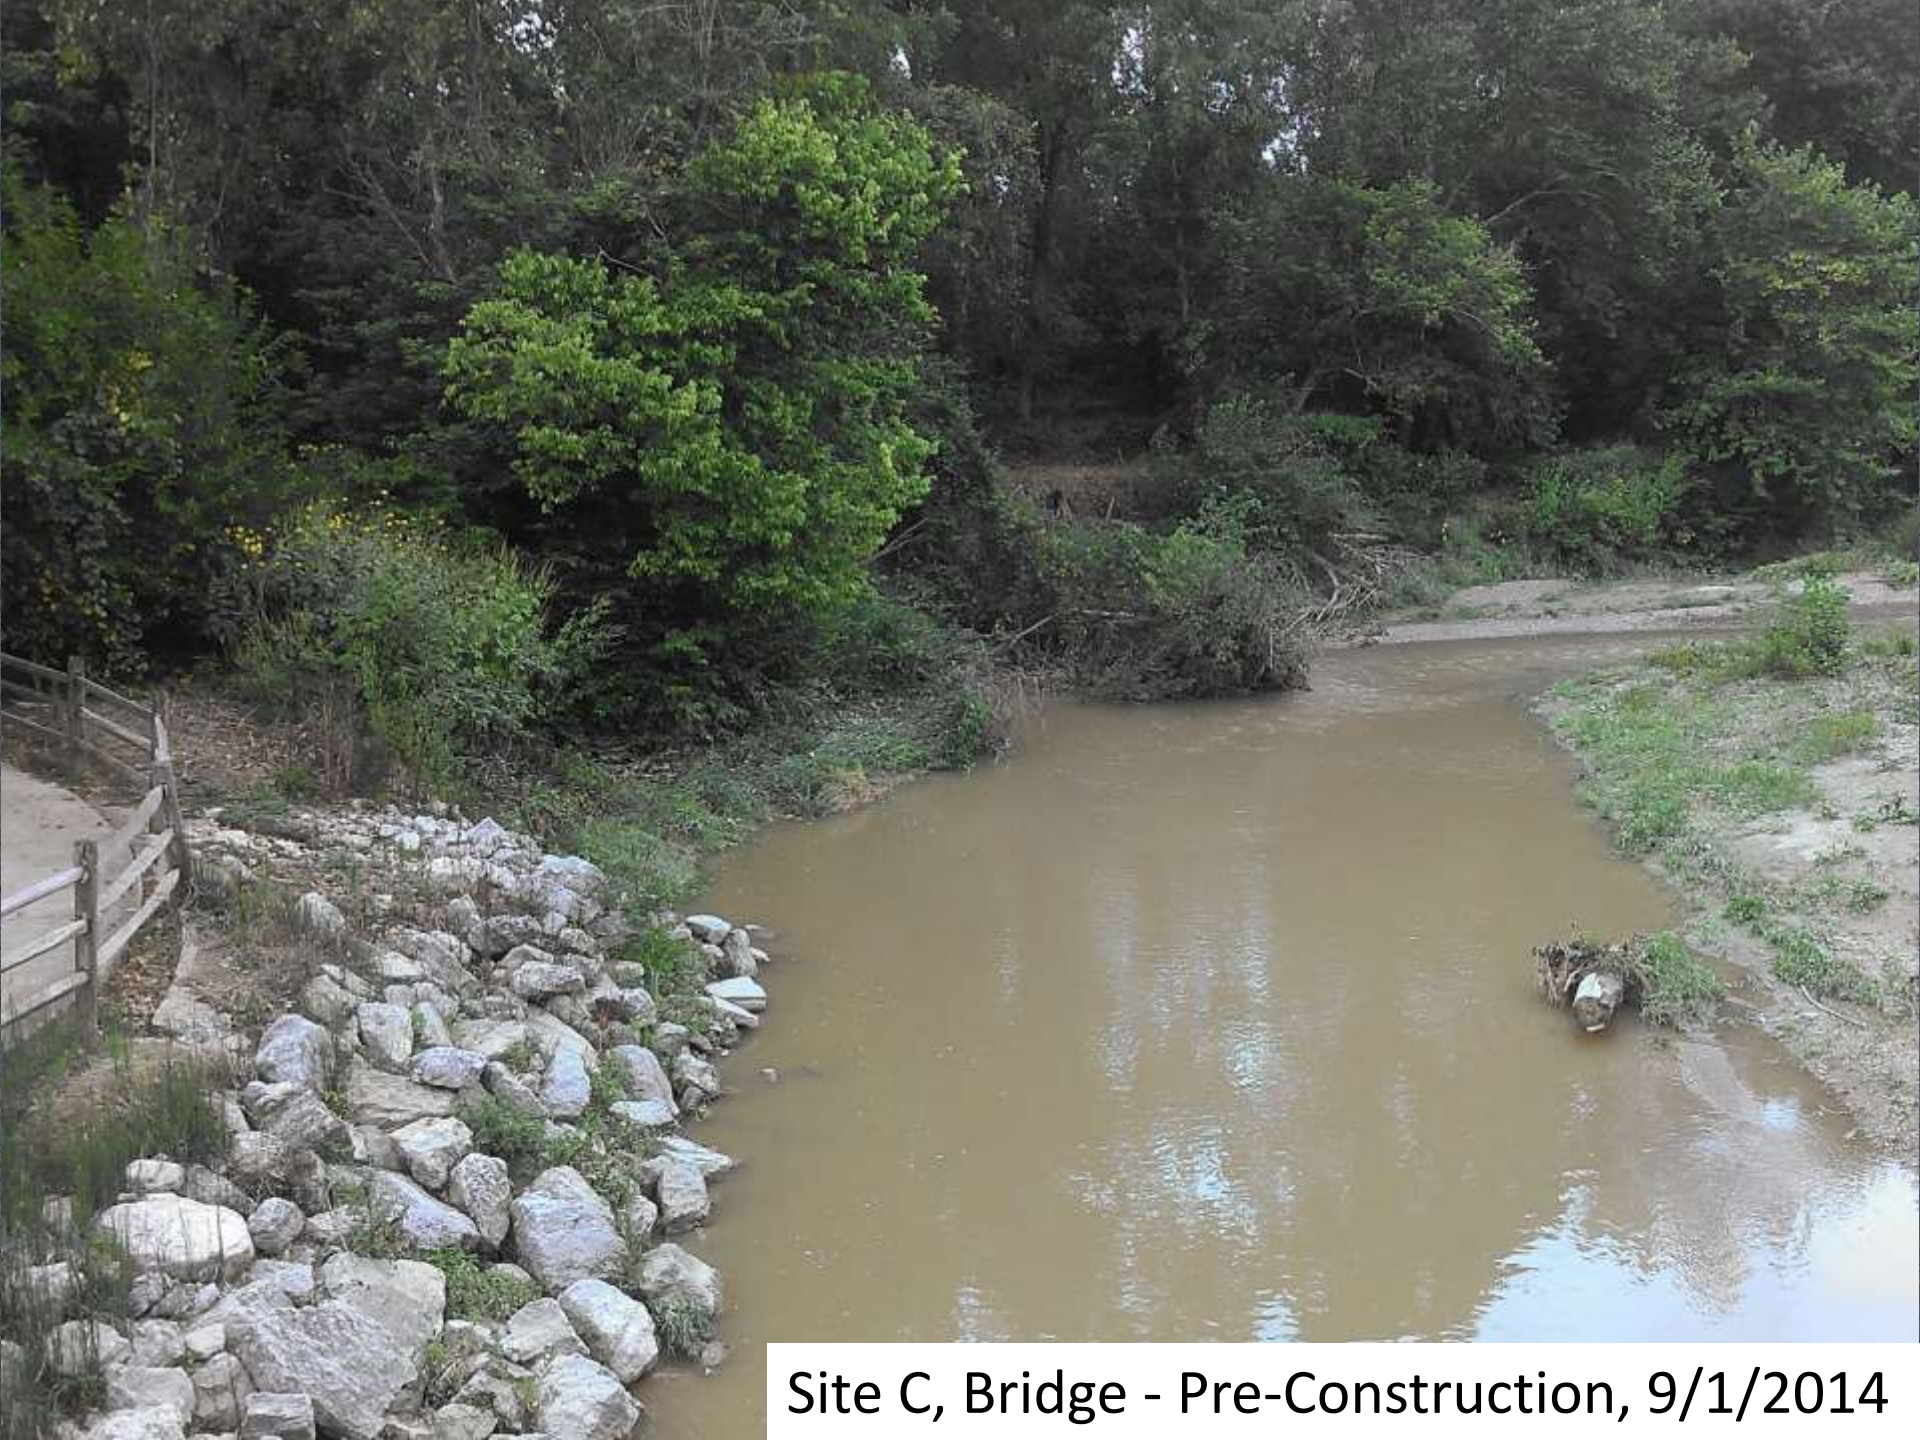
Site C, Bridge - Pre-Construction, 9/1/2014
