Protecting Your Infrastructure from Stream Erosion

Ohio Storm Water Management and
Drainage Conference

March 8, 2017

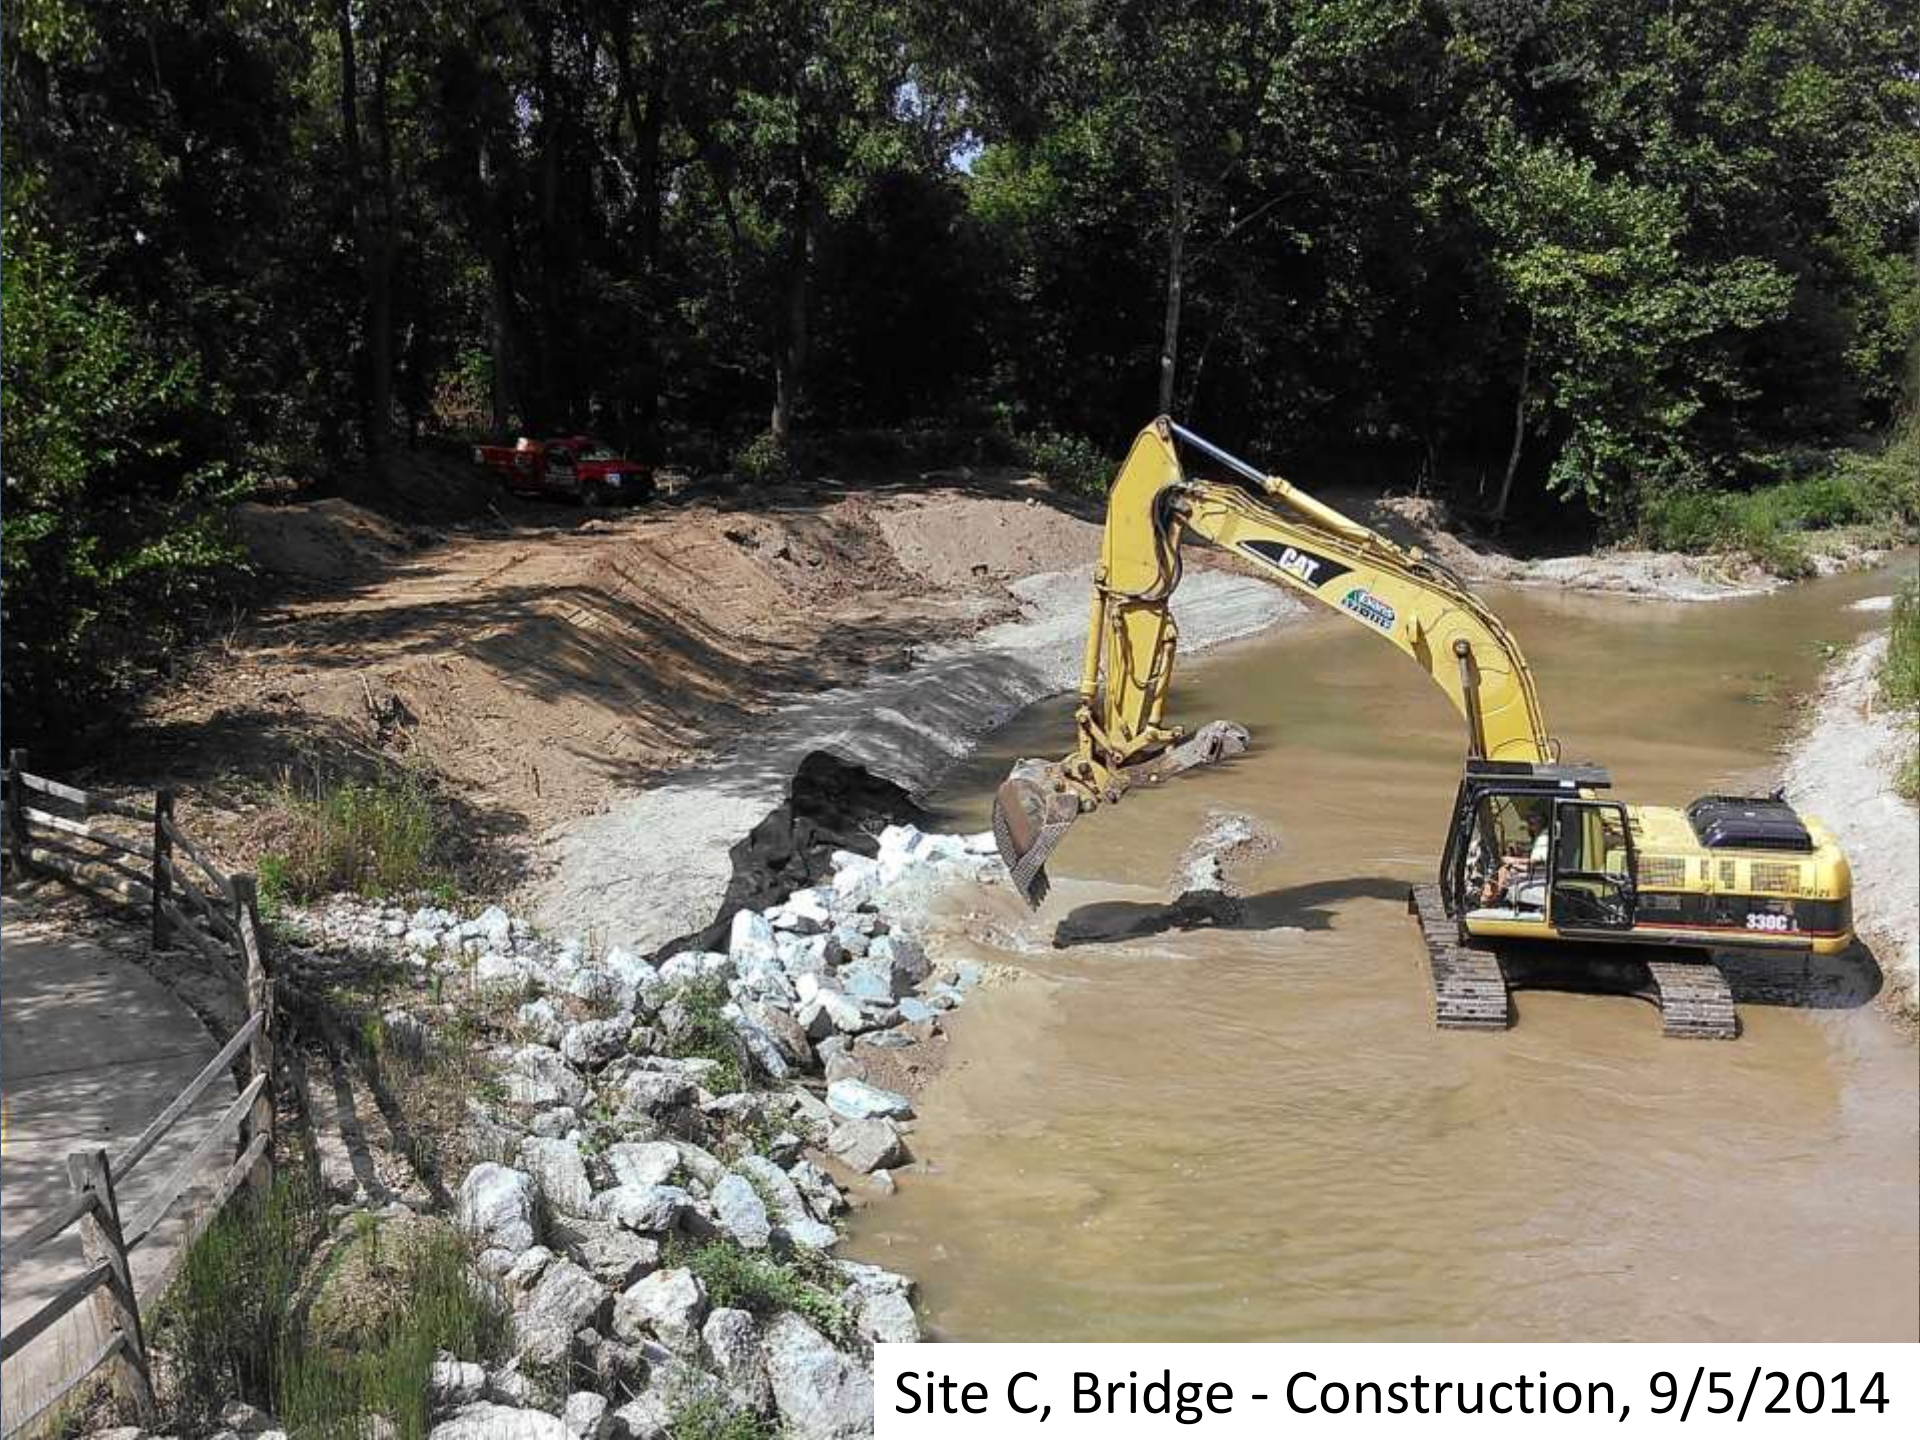
Site C, Bridge - Construction, 9/5/2014

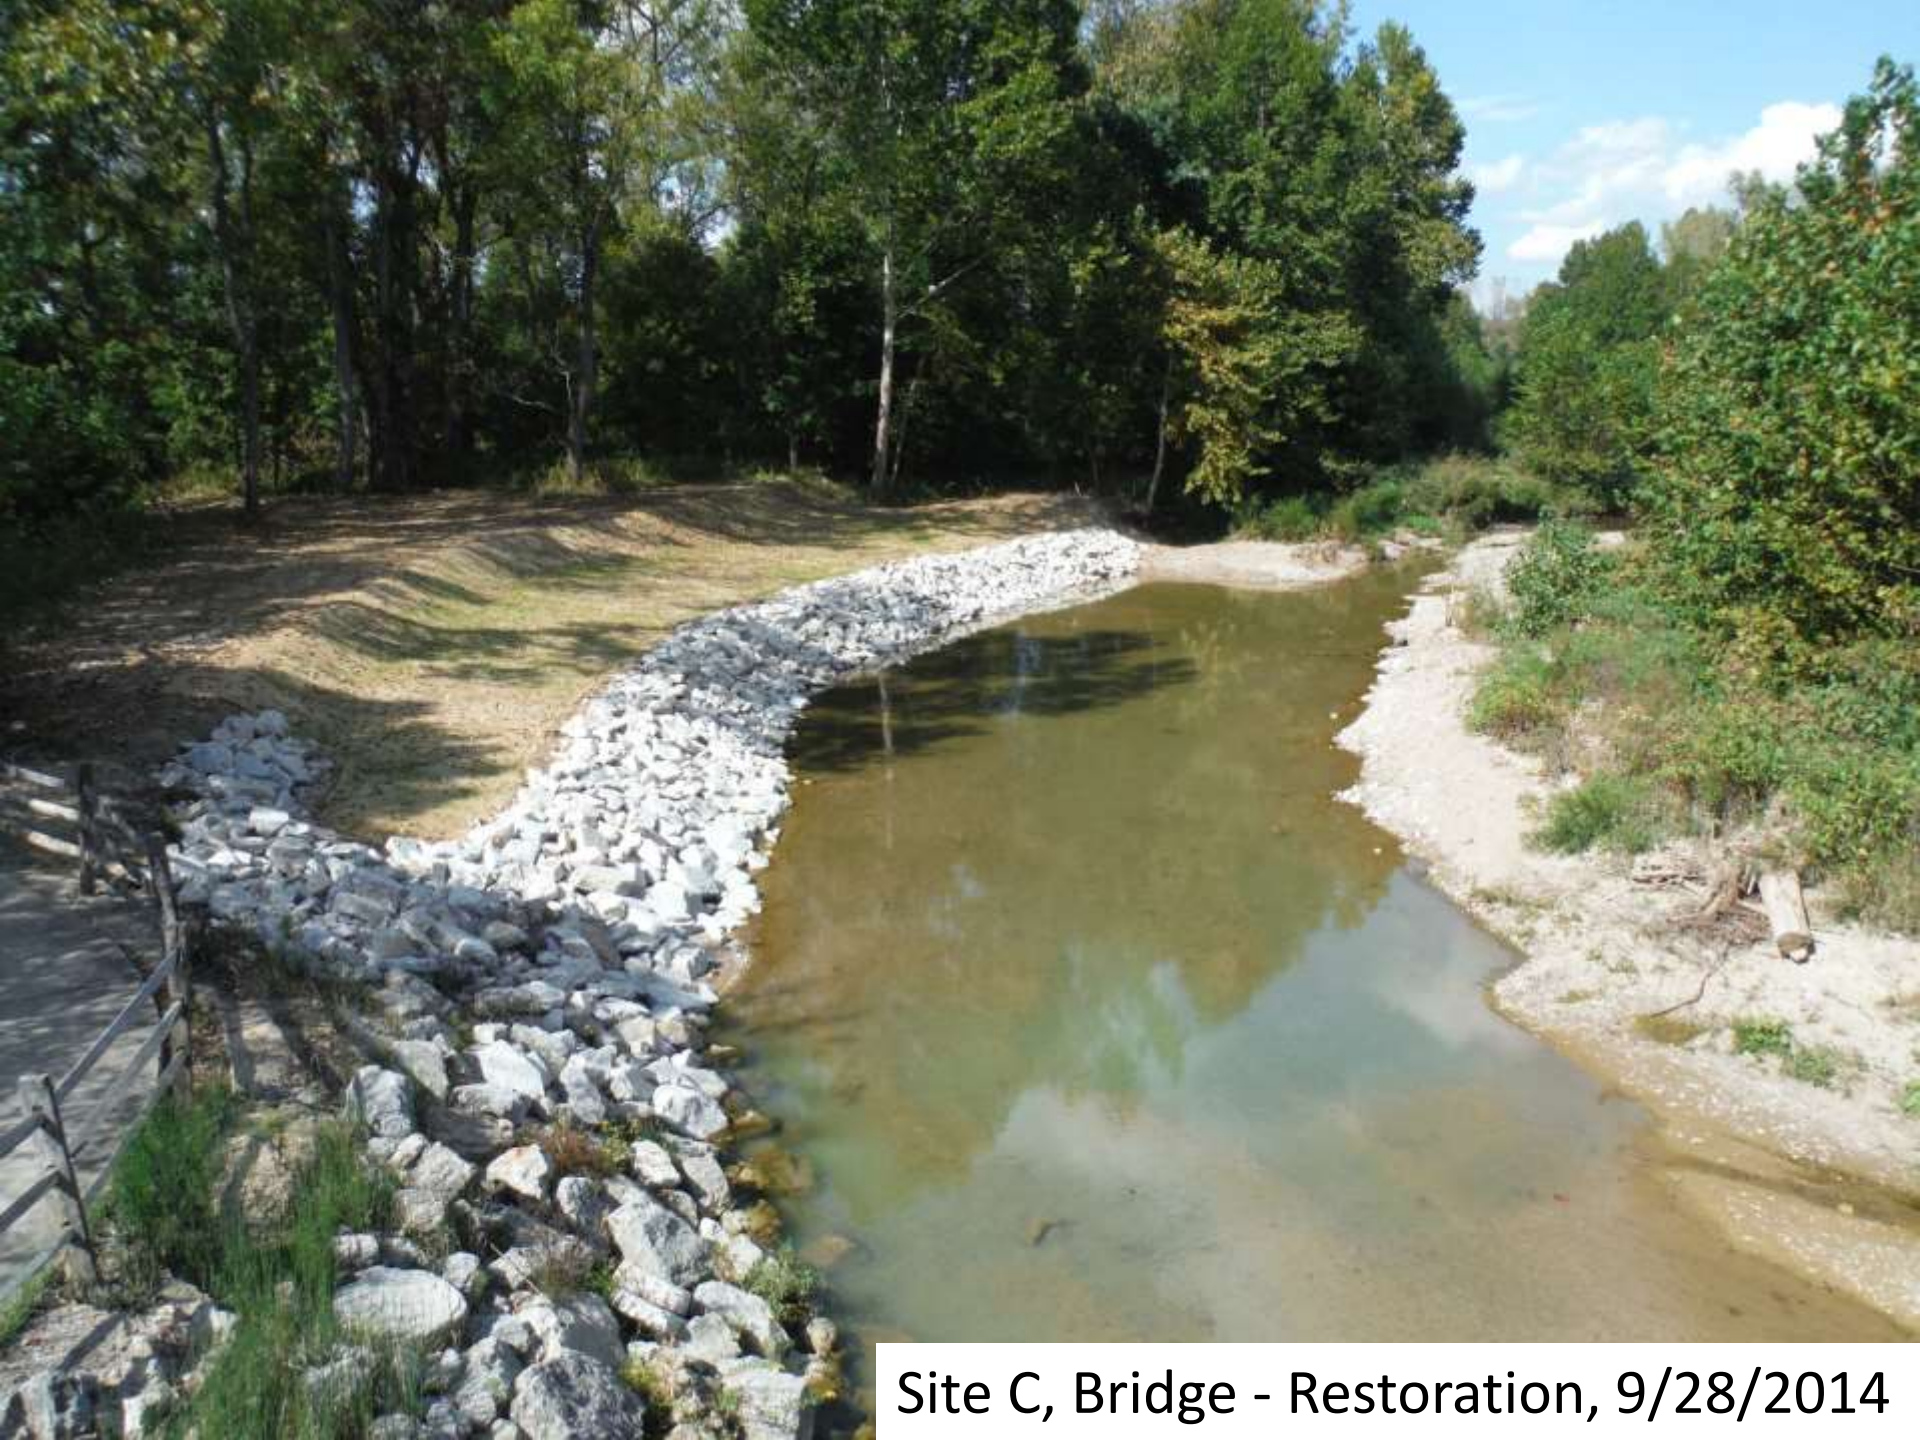
Site C, Bridge - Restoration, 9/28/2014

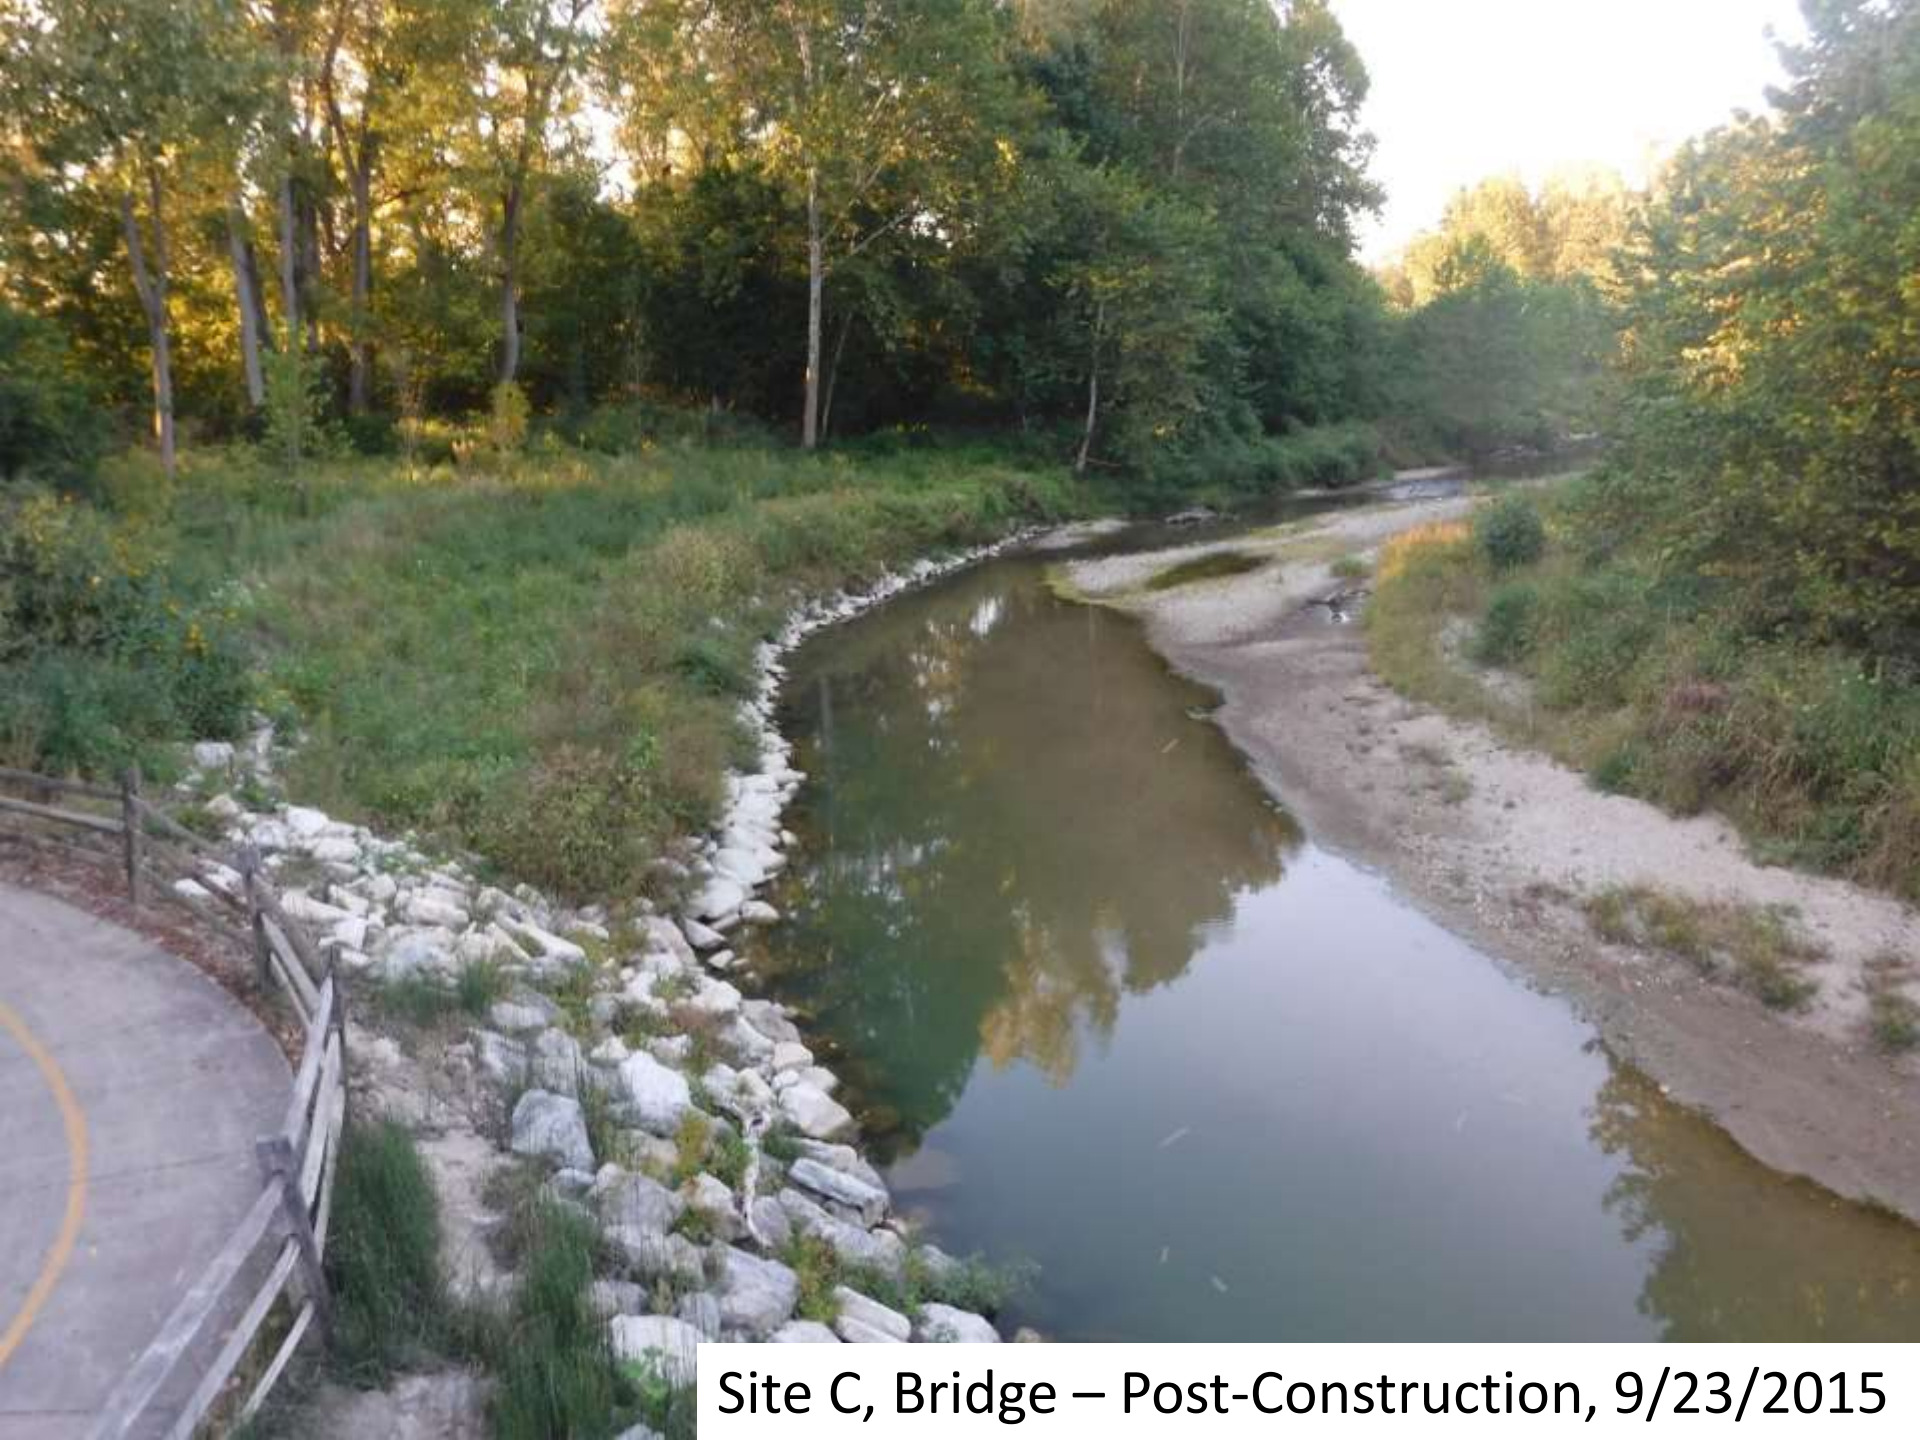
Site C, Bridge – Post-Construction, 9/23/2015

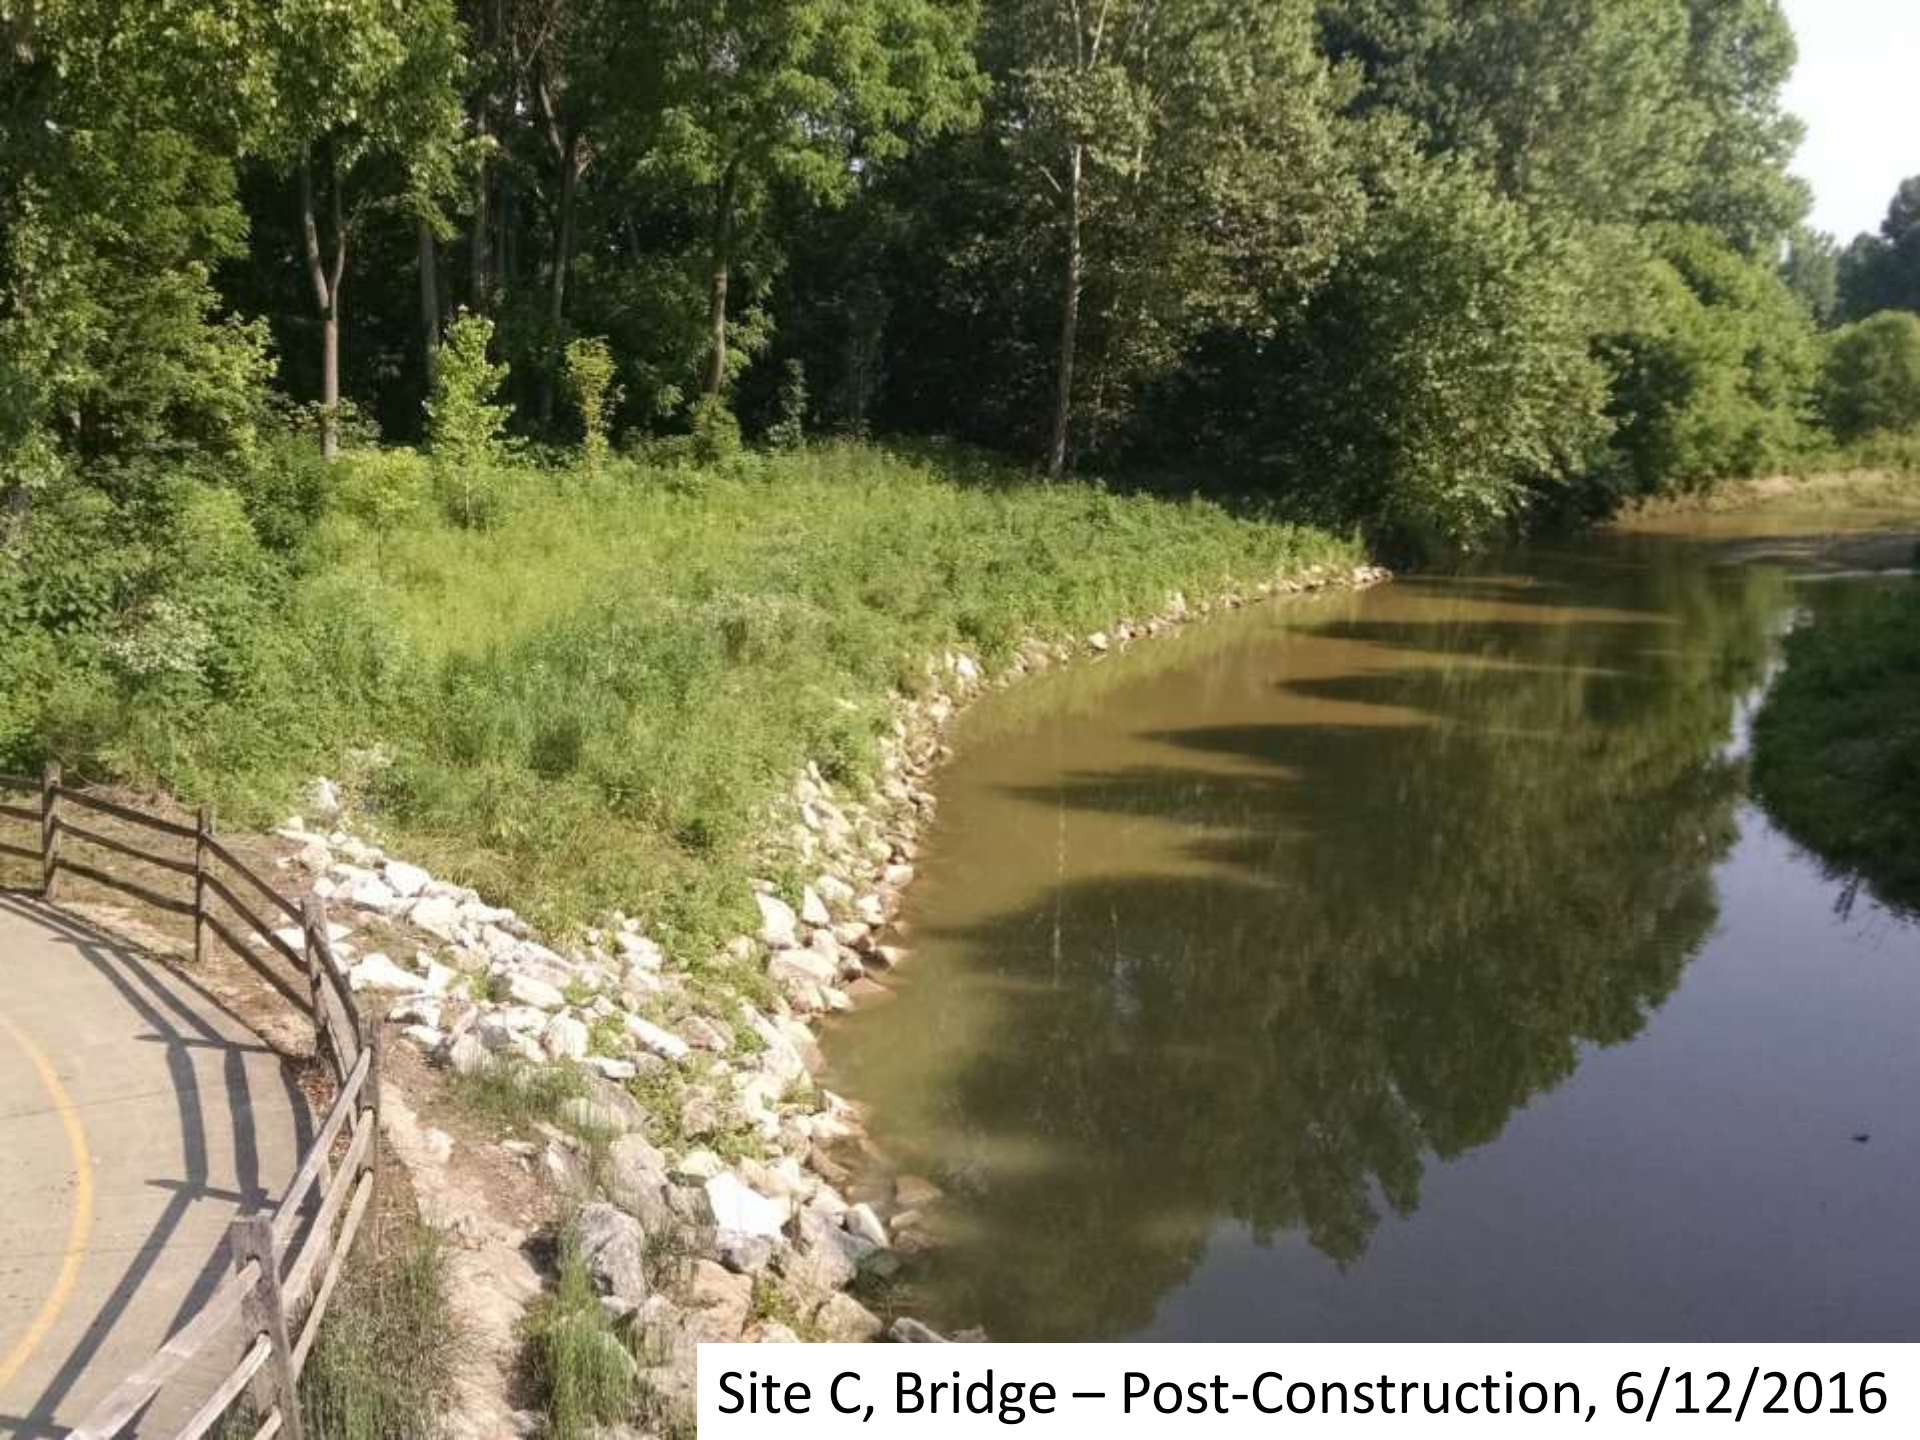
Site C, Bridge – Post-Construction, 6/12/2016

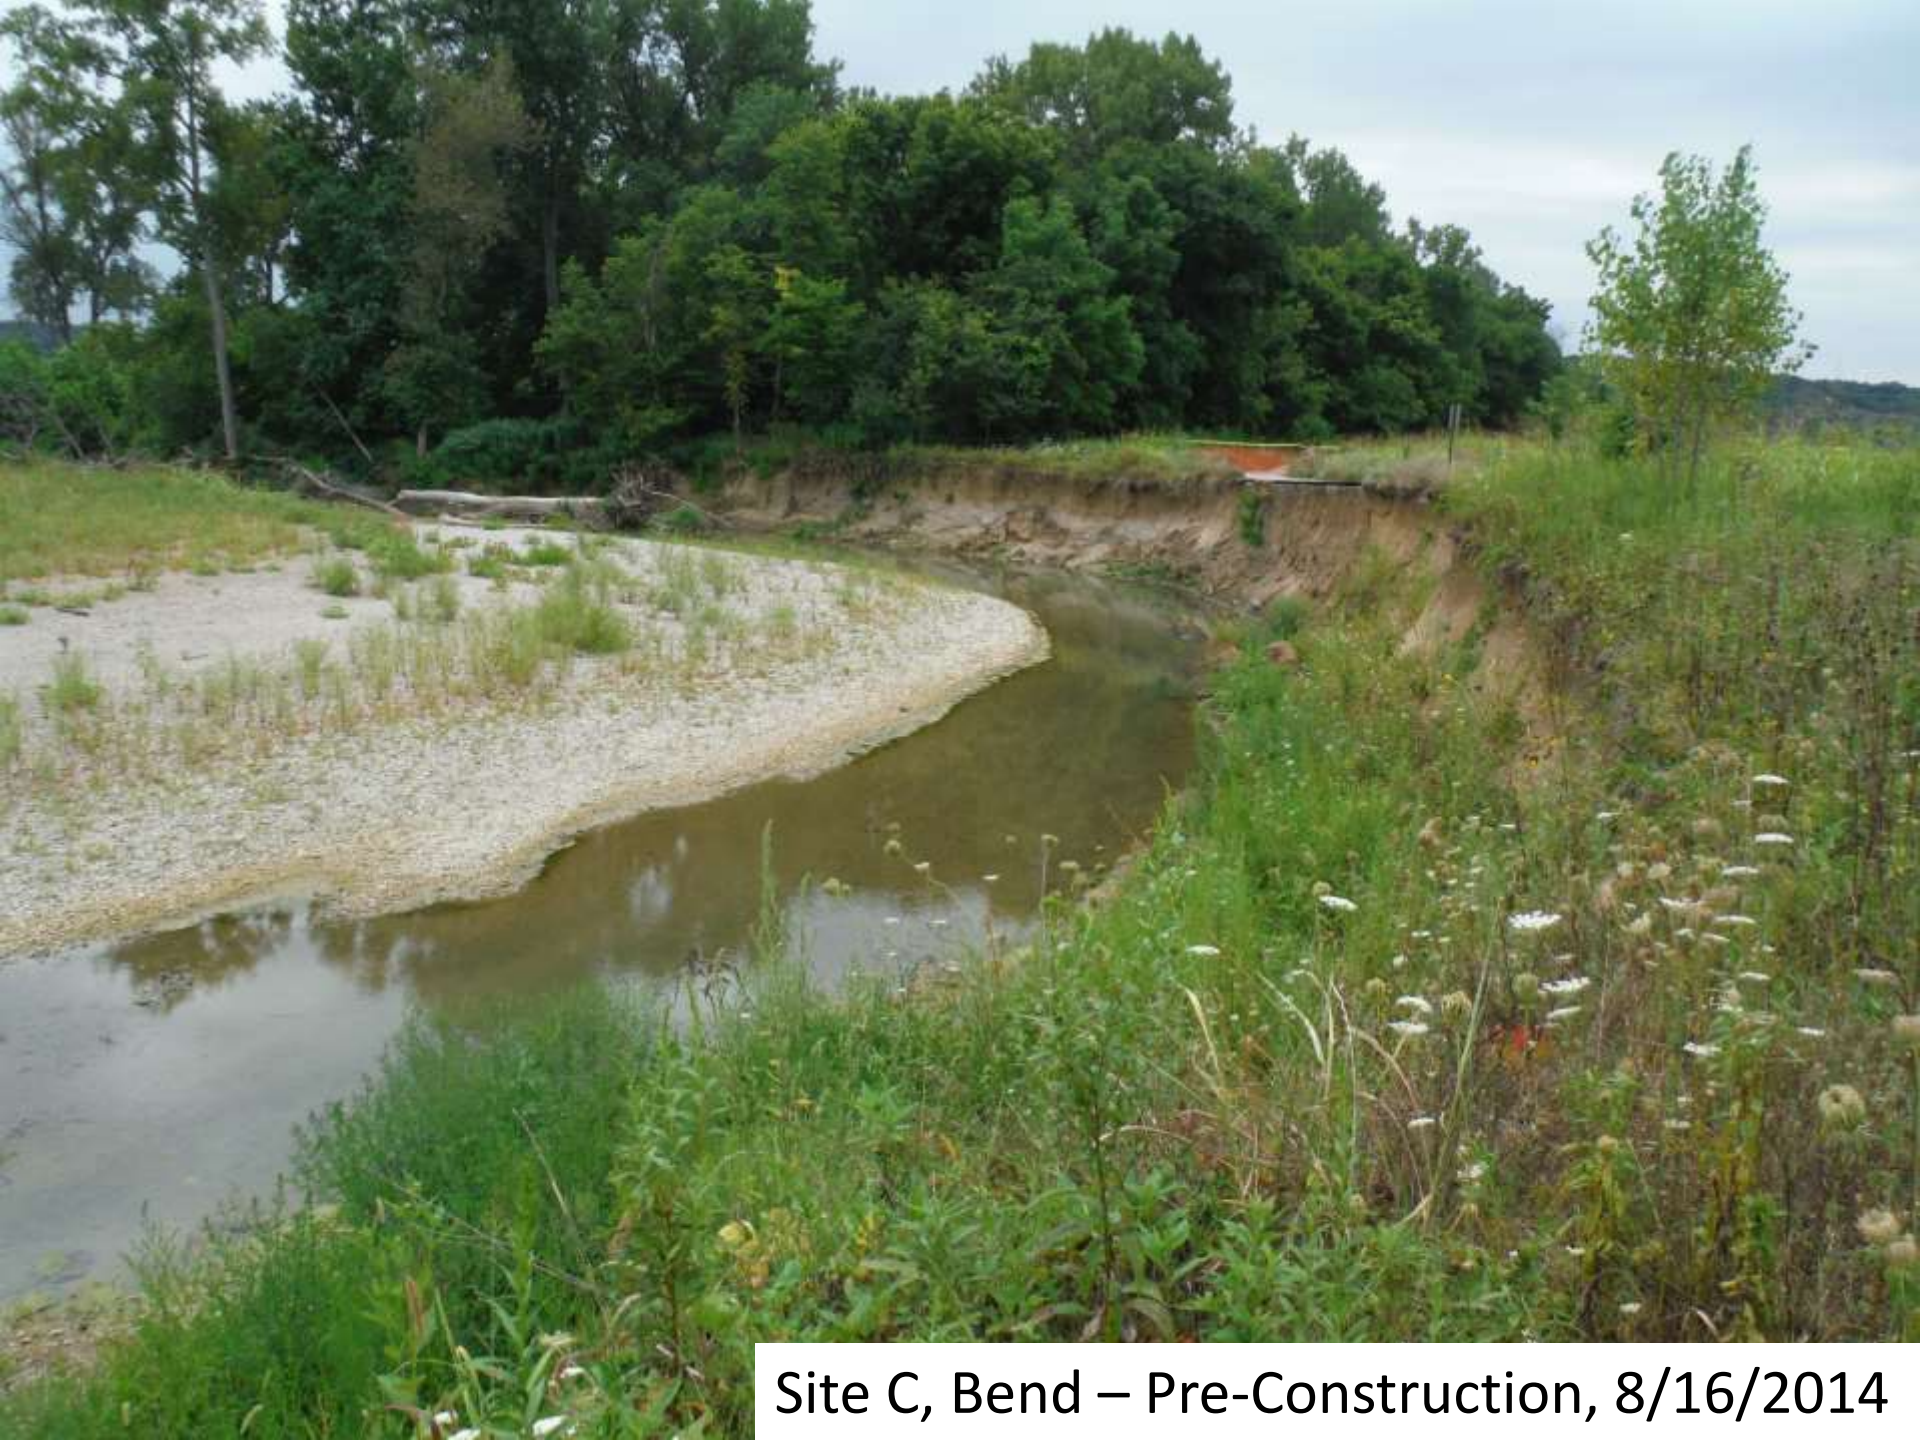
Site C, Bend – Pre-Construction, 8/16/2014

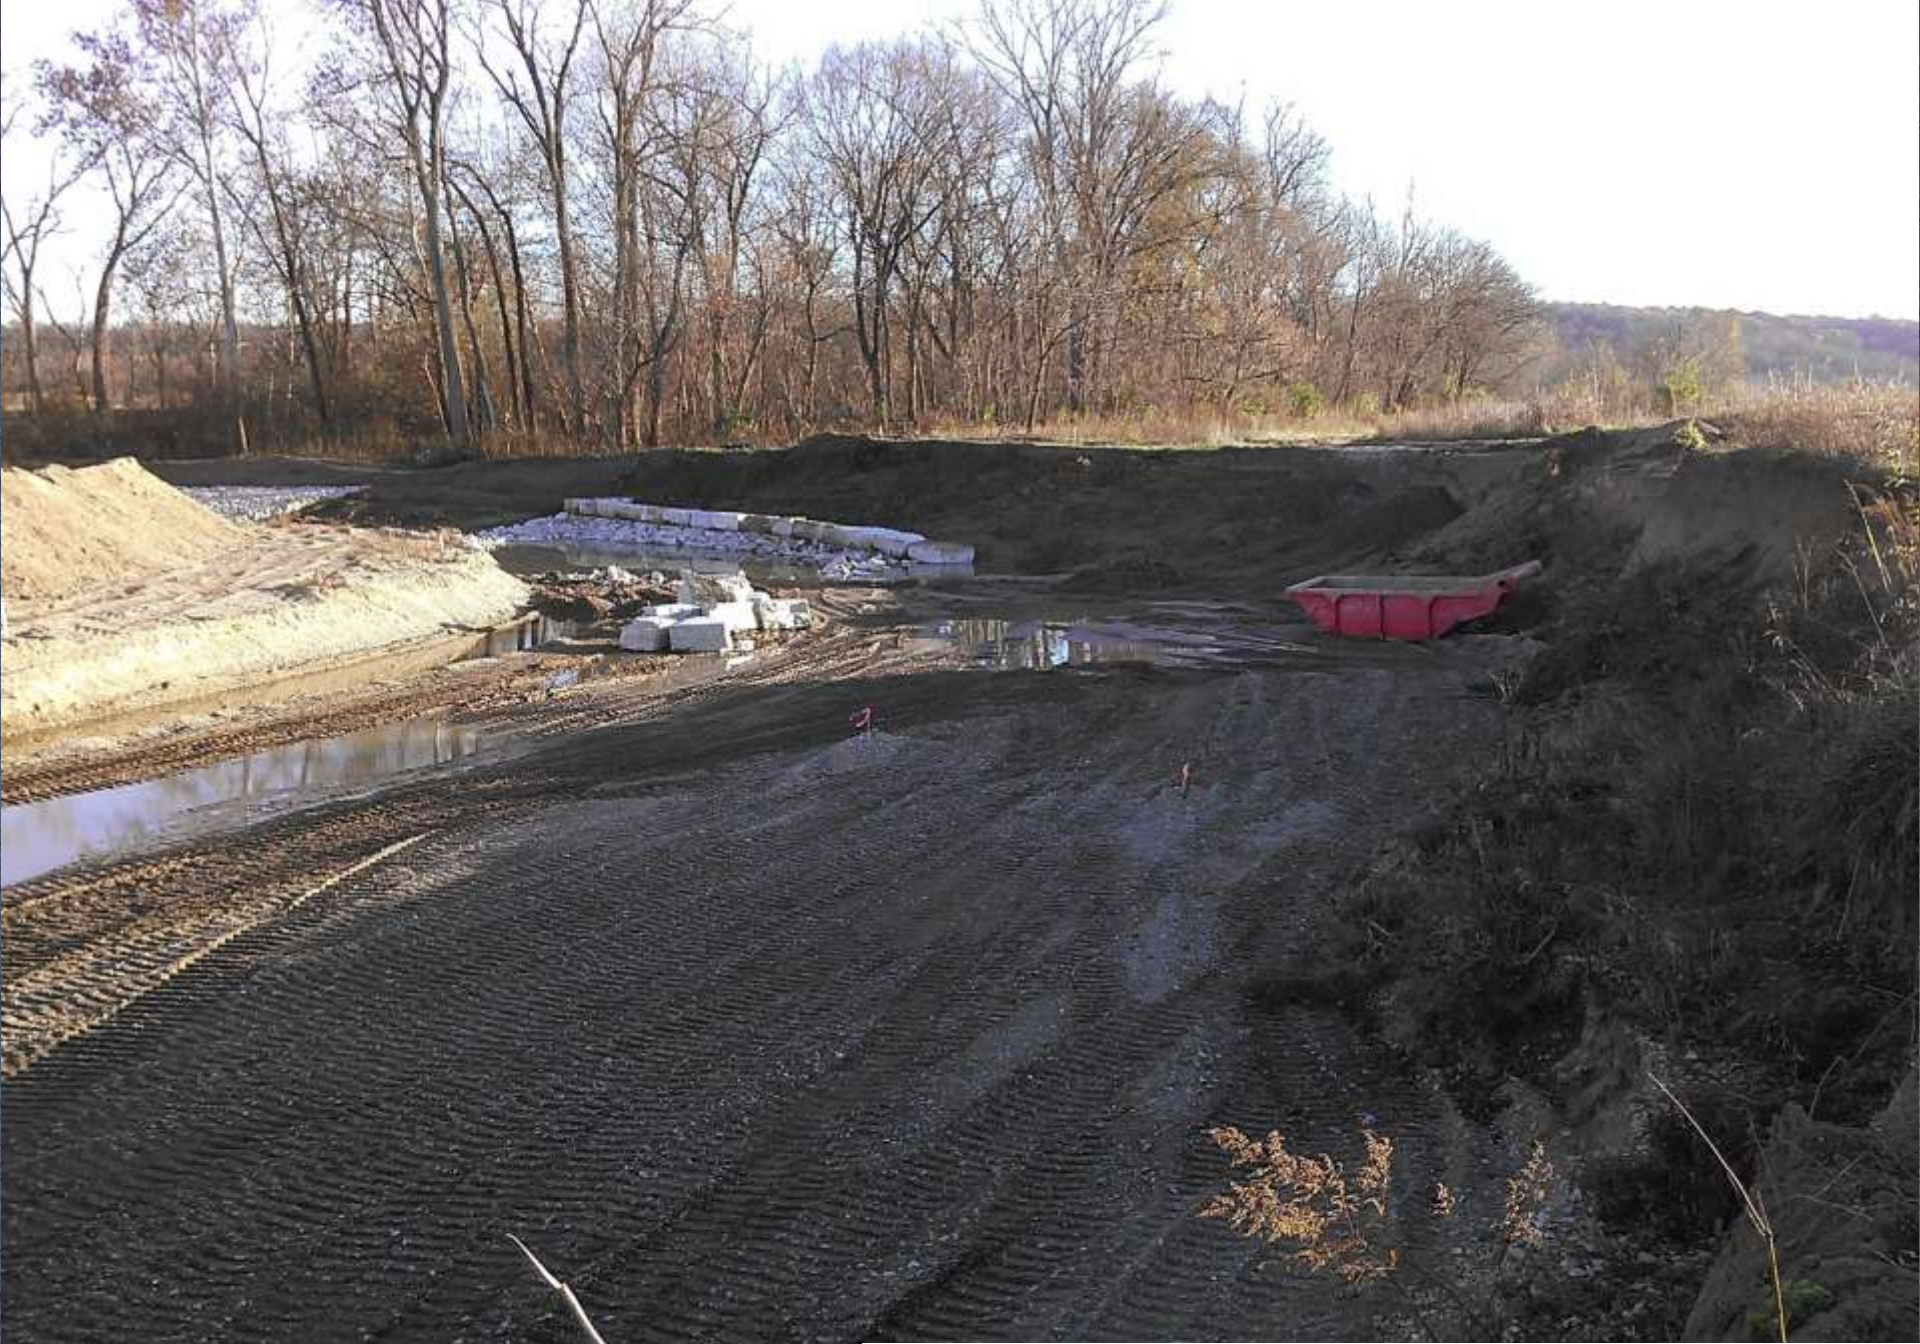
Site C, Bend – Construction, 11/2/2014

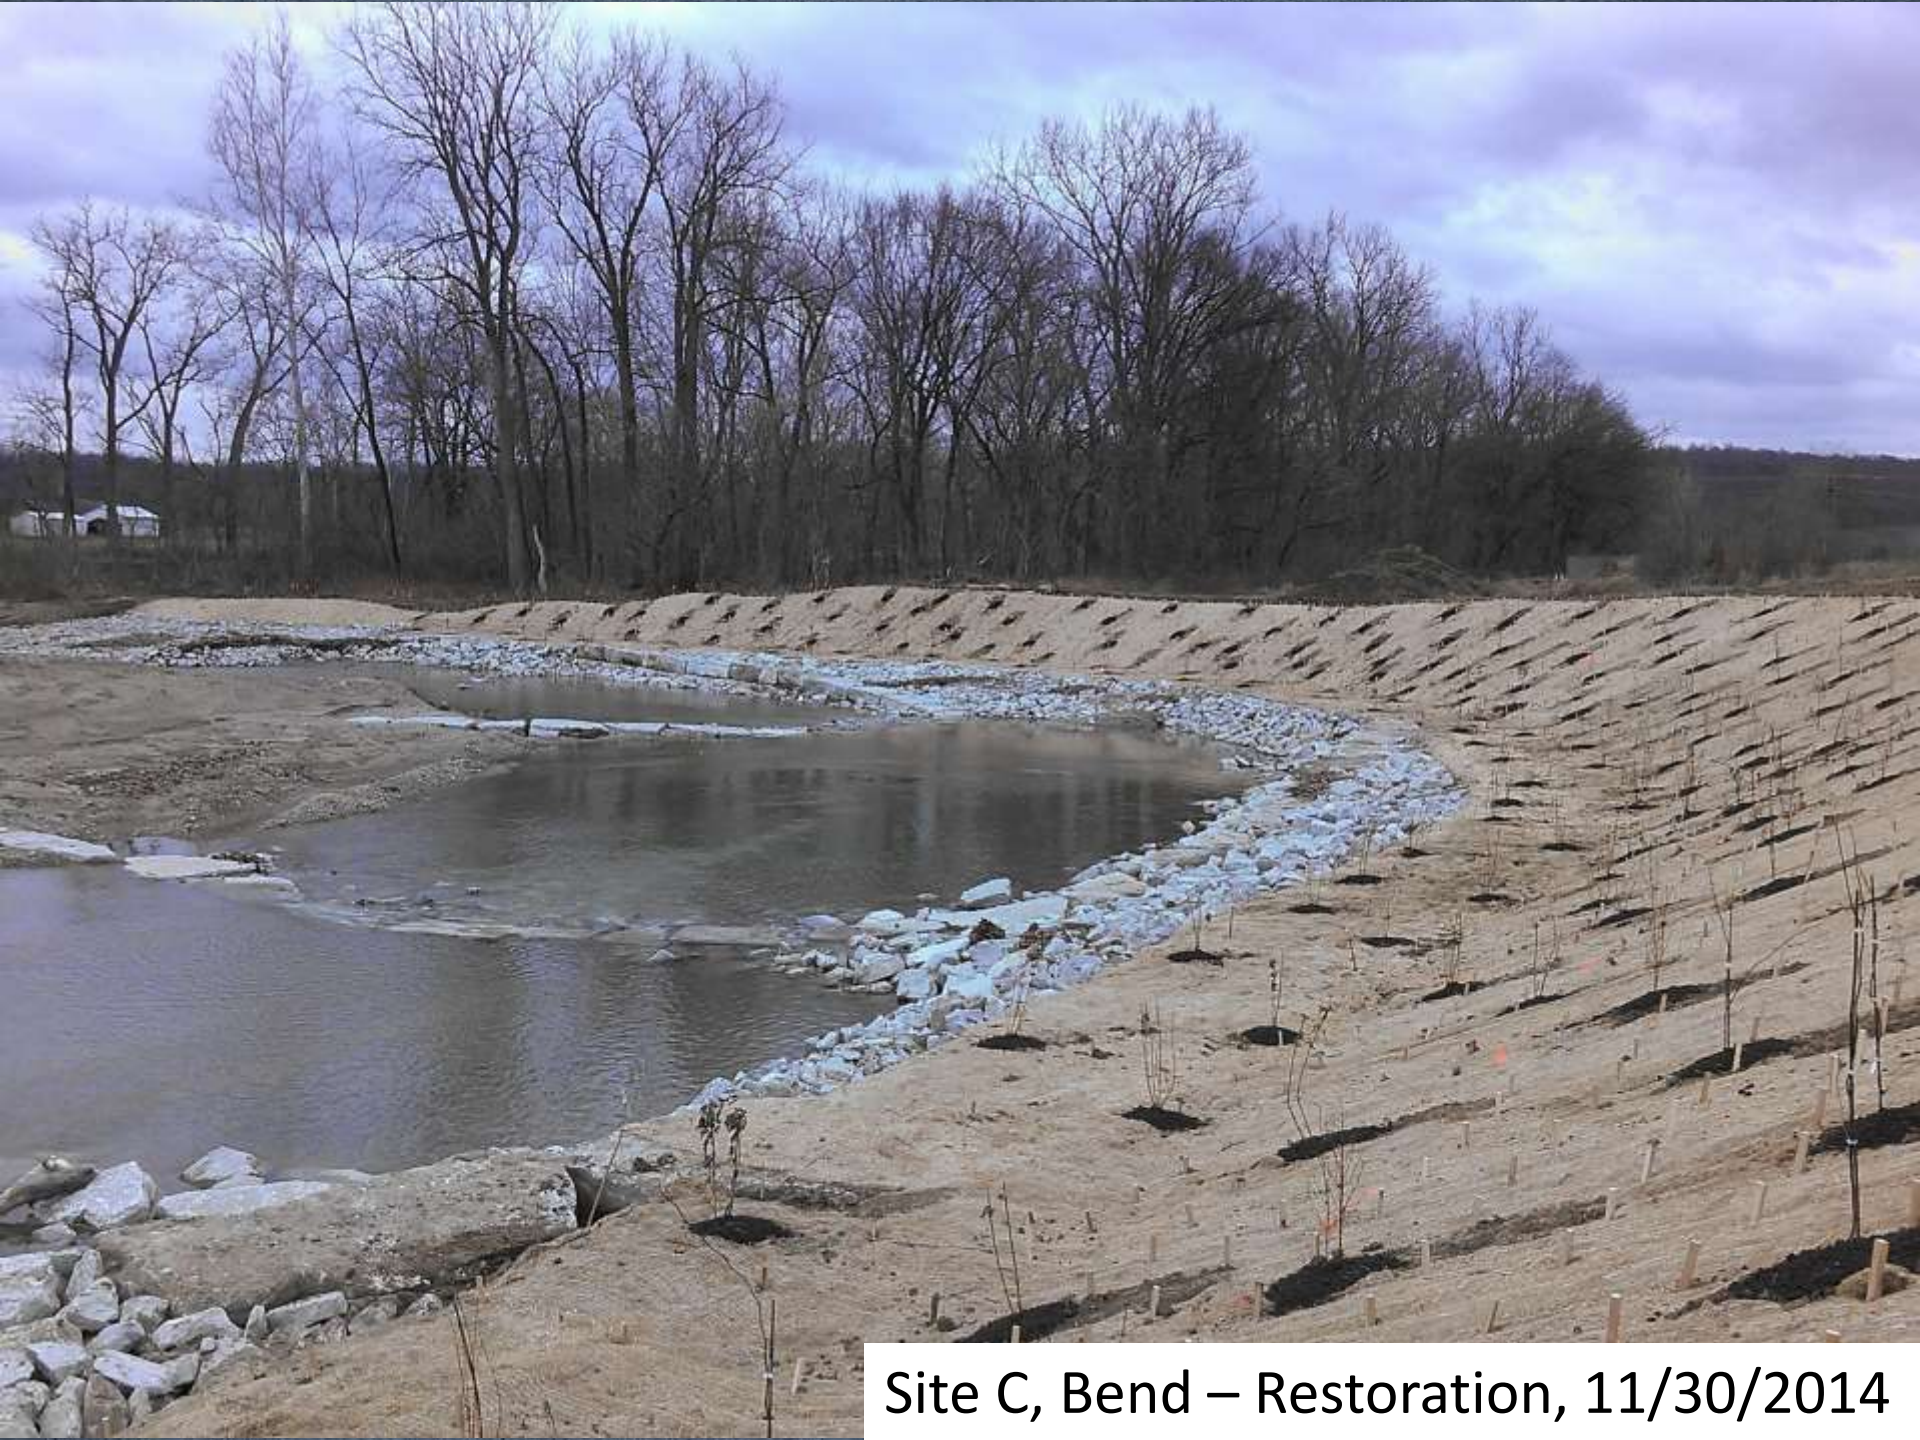
Site C, Bend – Restoration, 11/30/2014

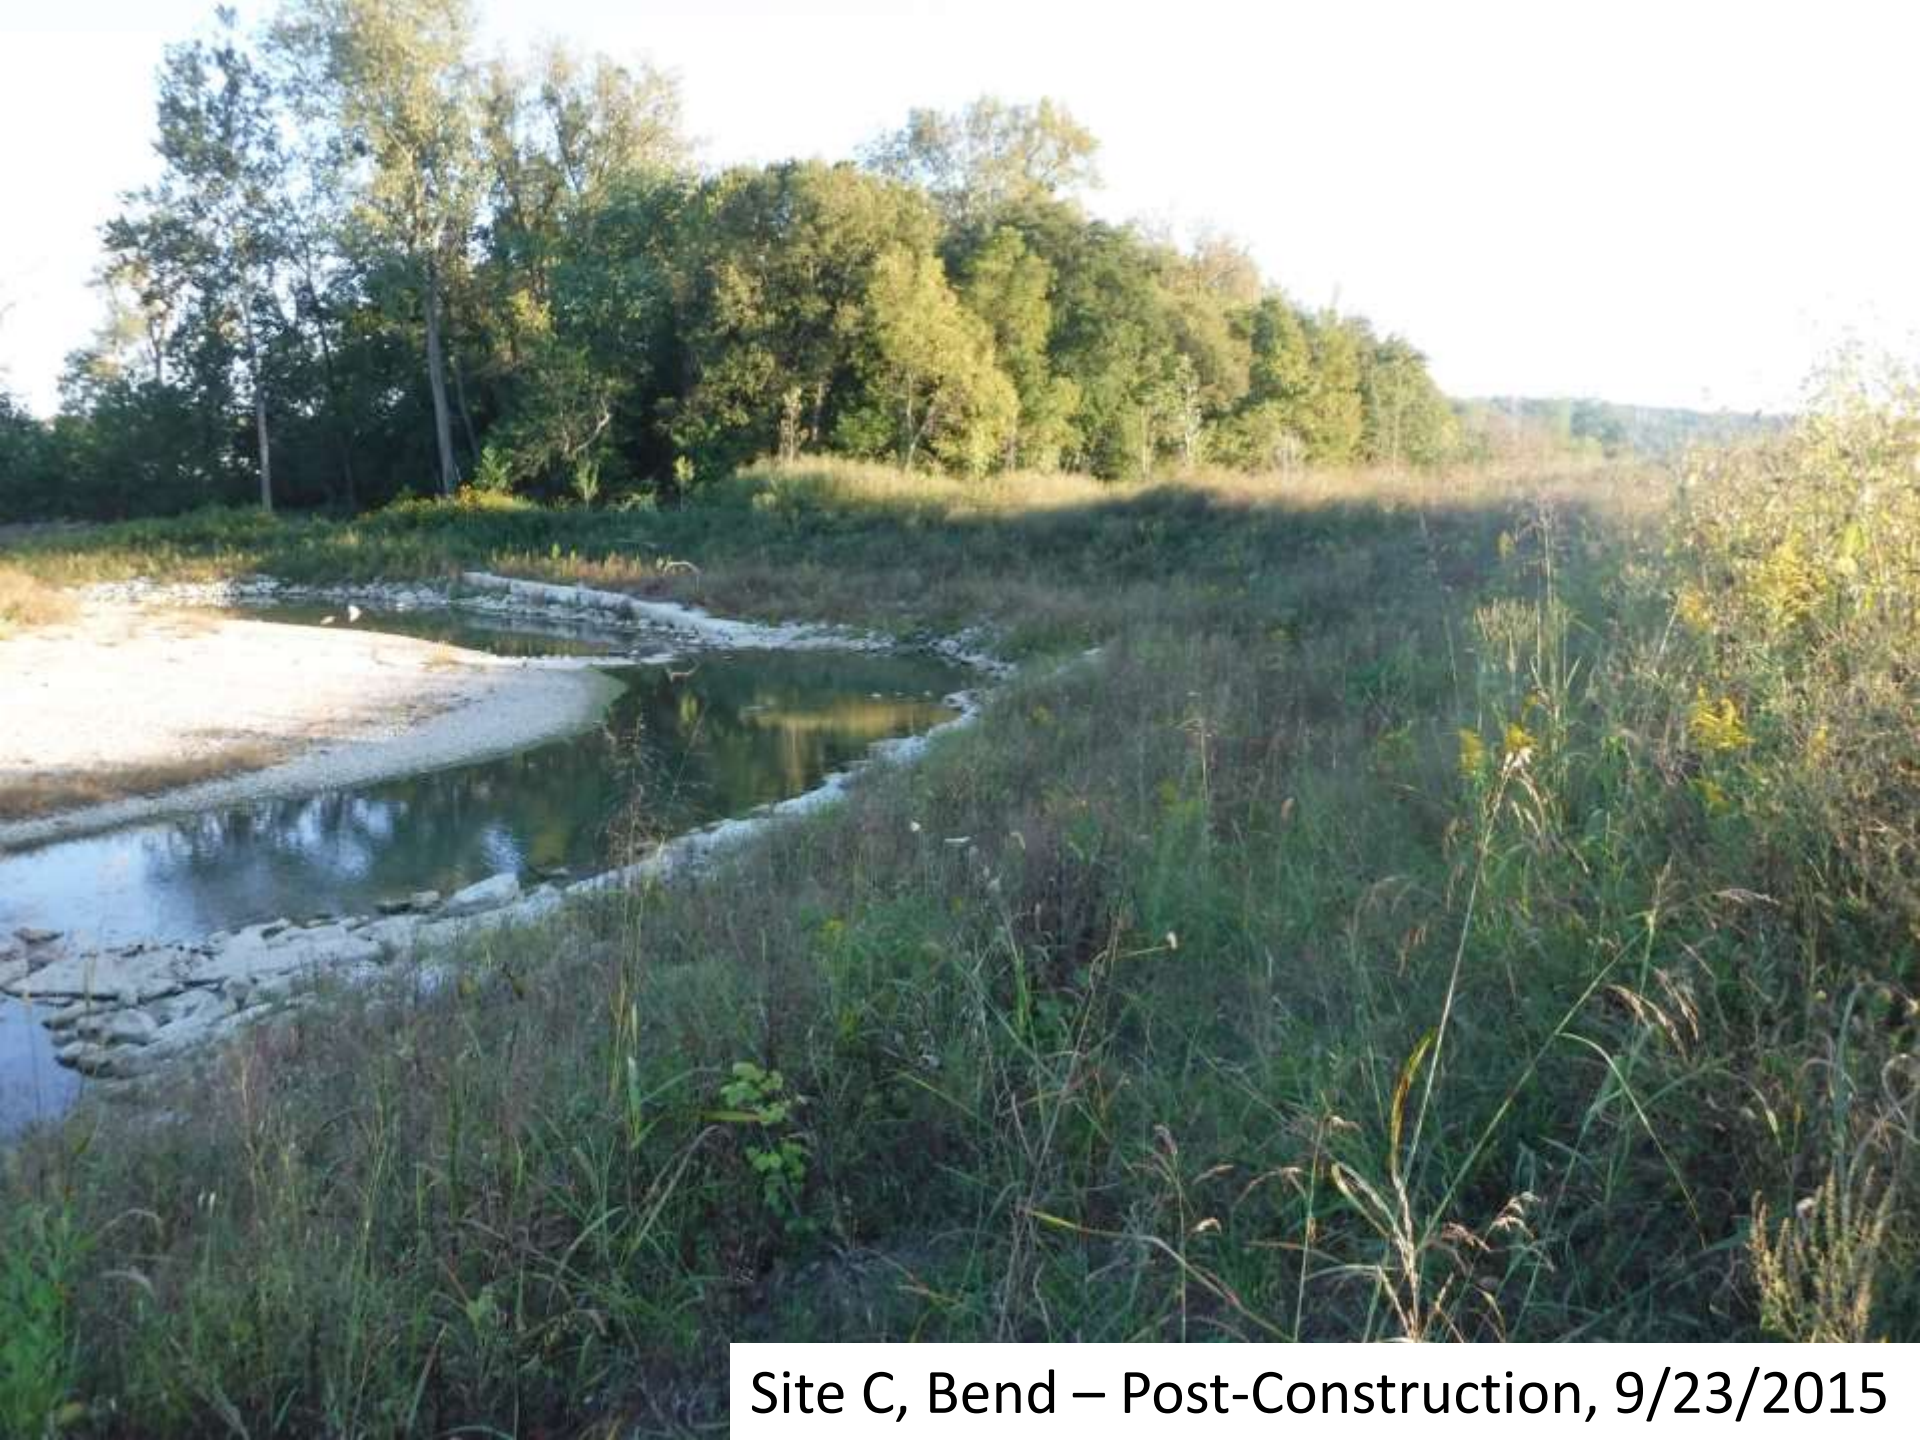
Site C, Bend – Post-Construction, 9/23/2015
