Protecting Your Infrastructure from Stream Erosion

Ohio Storm Water Management and
Drainage Conference

March 8, 2017

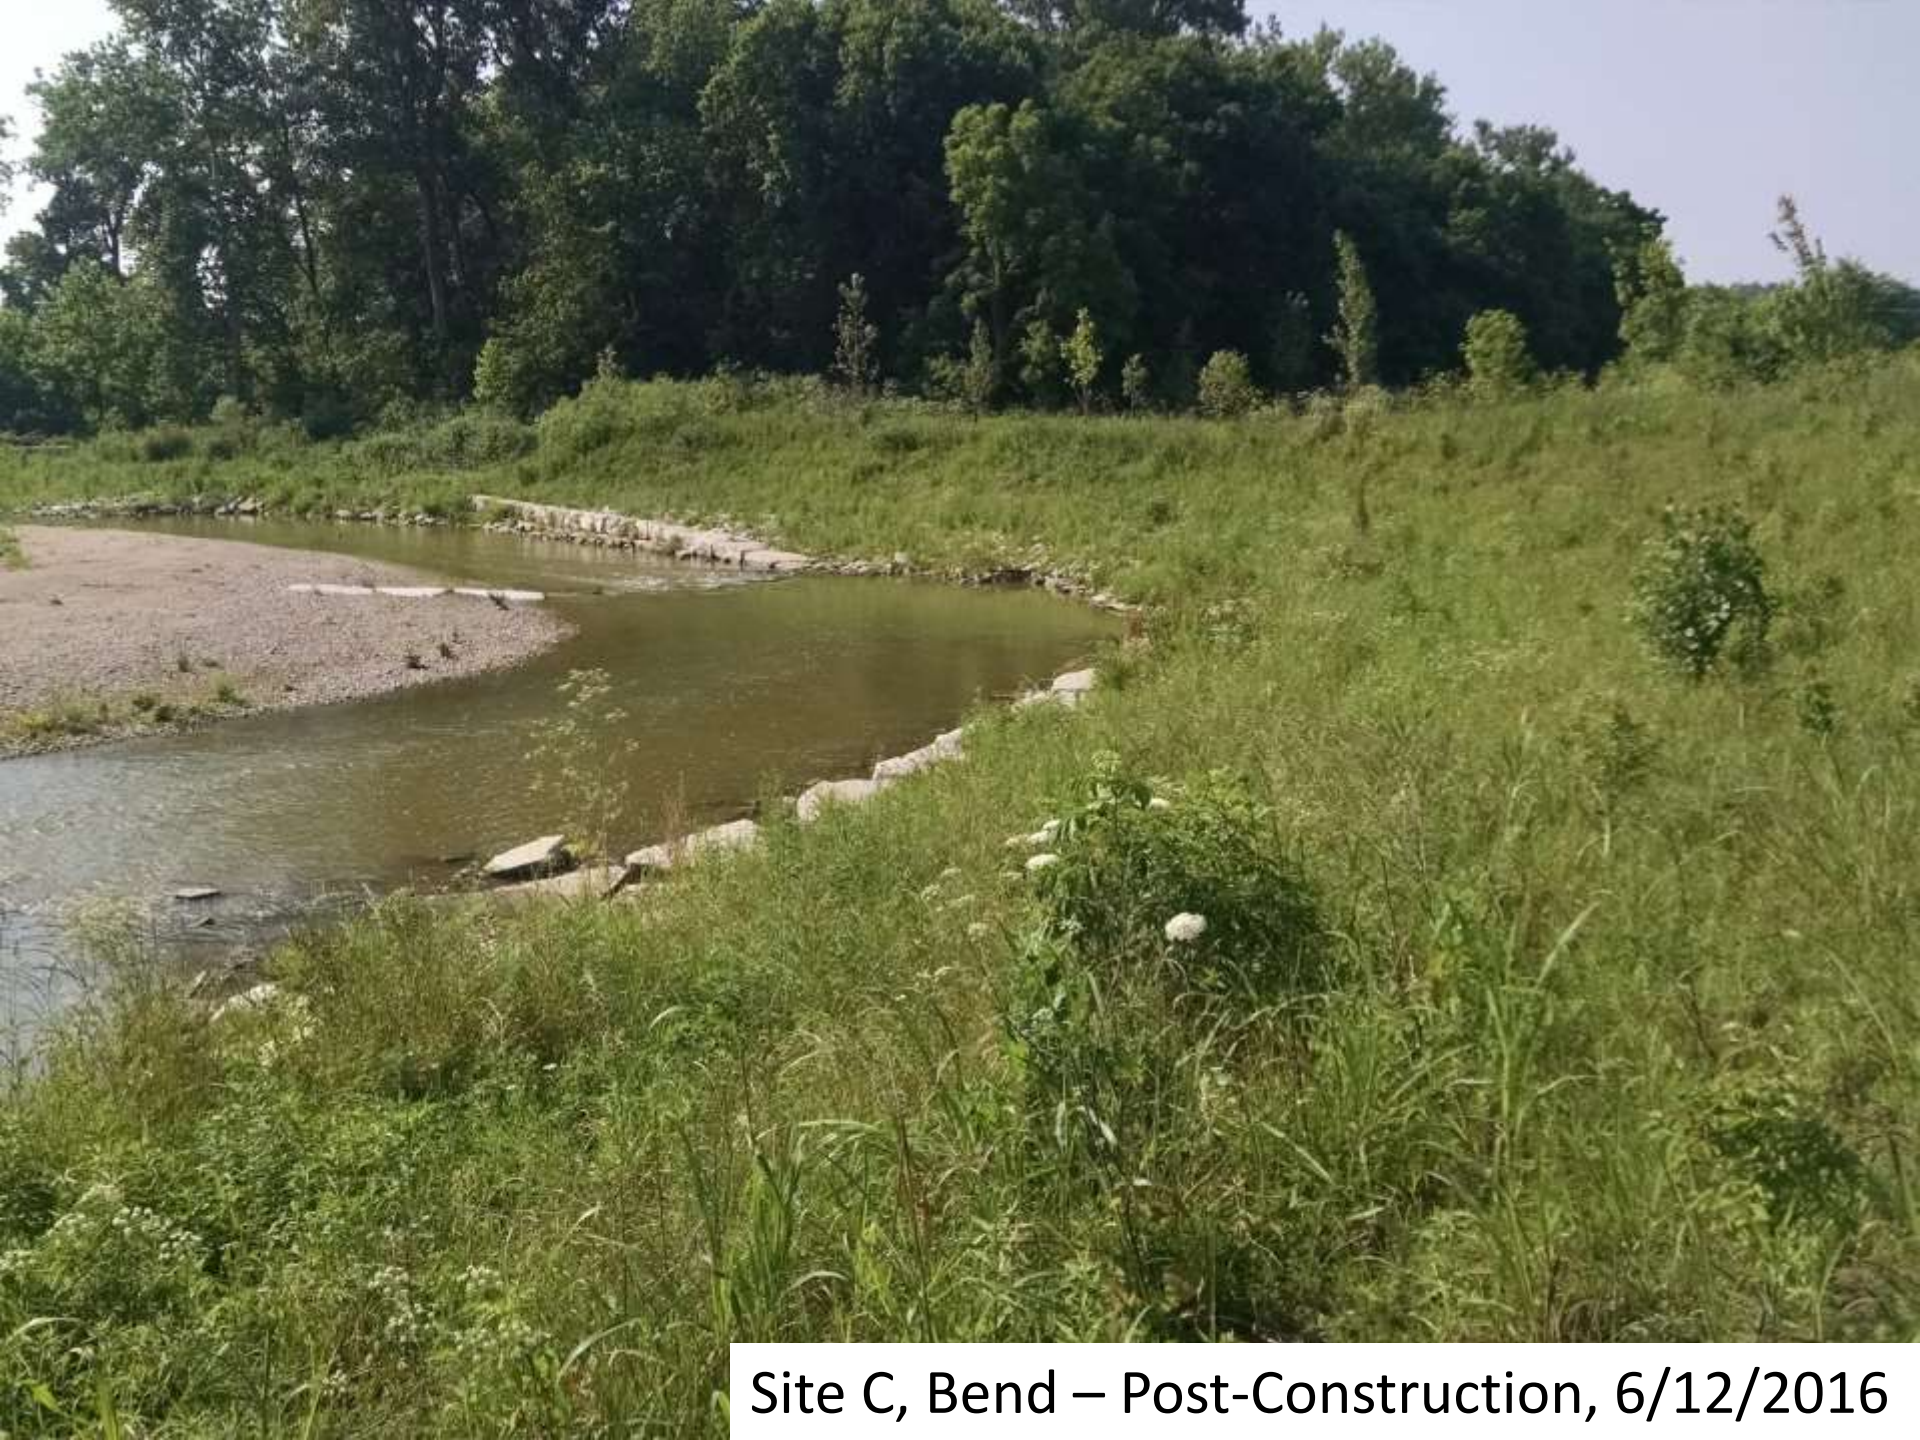
Site C, Bend – Post-Construction, 6/12/2016

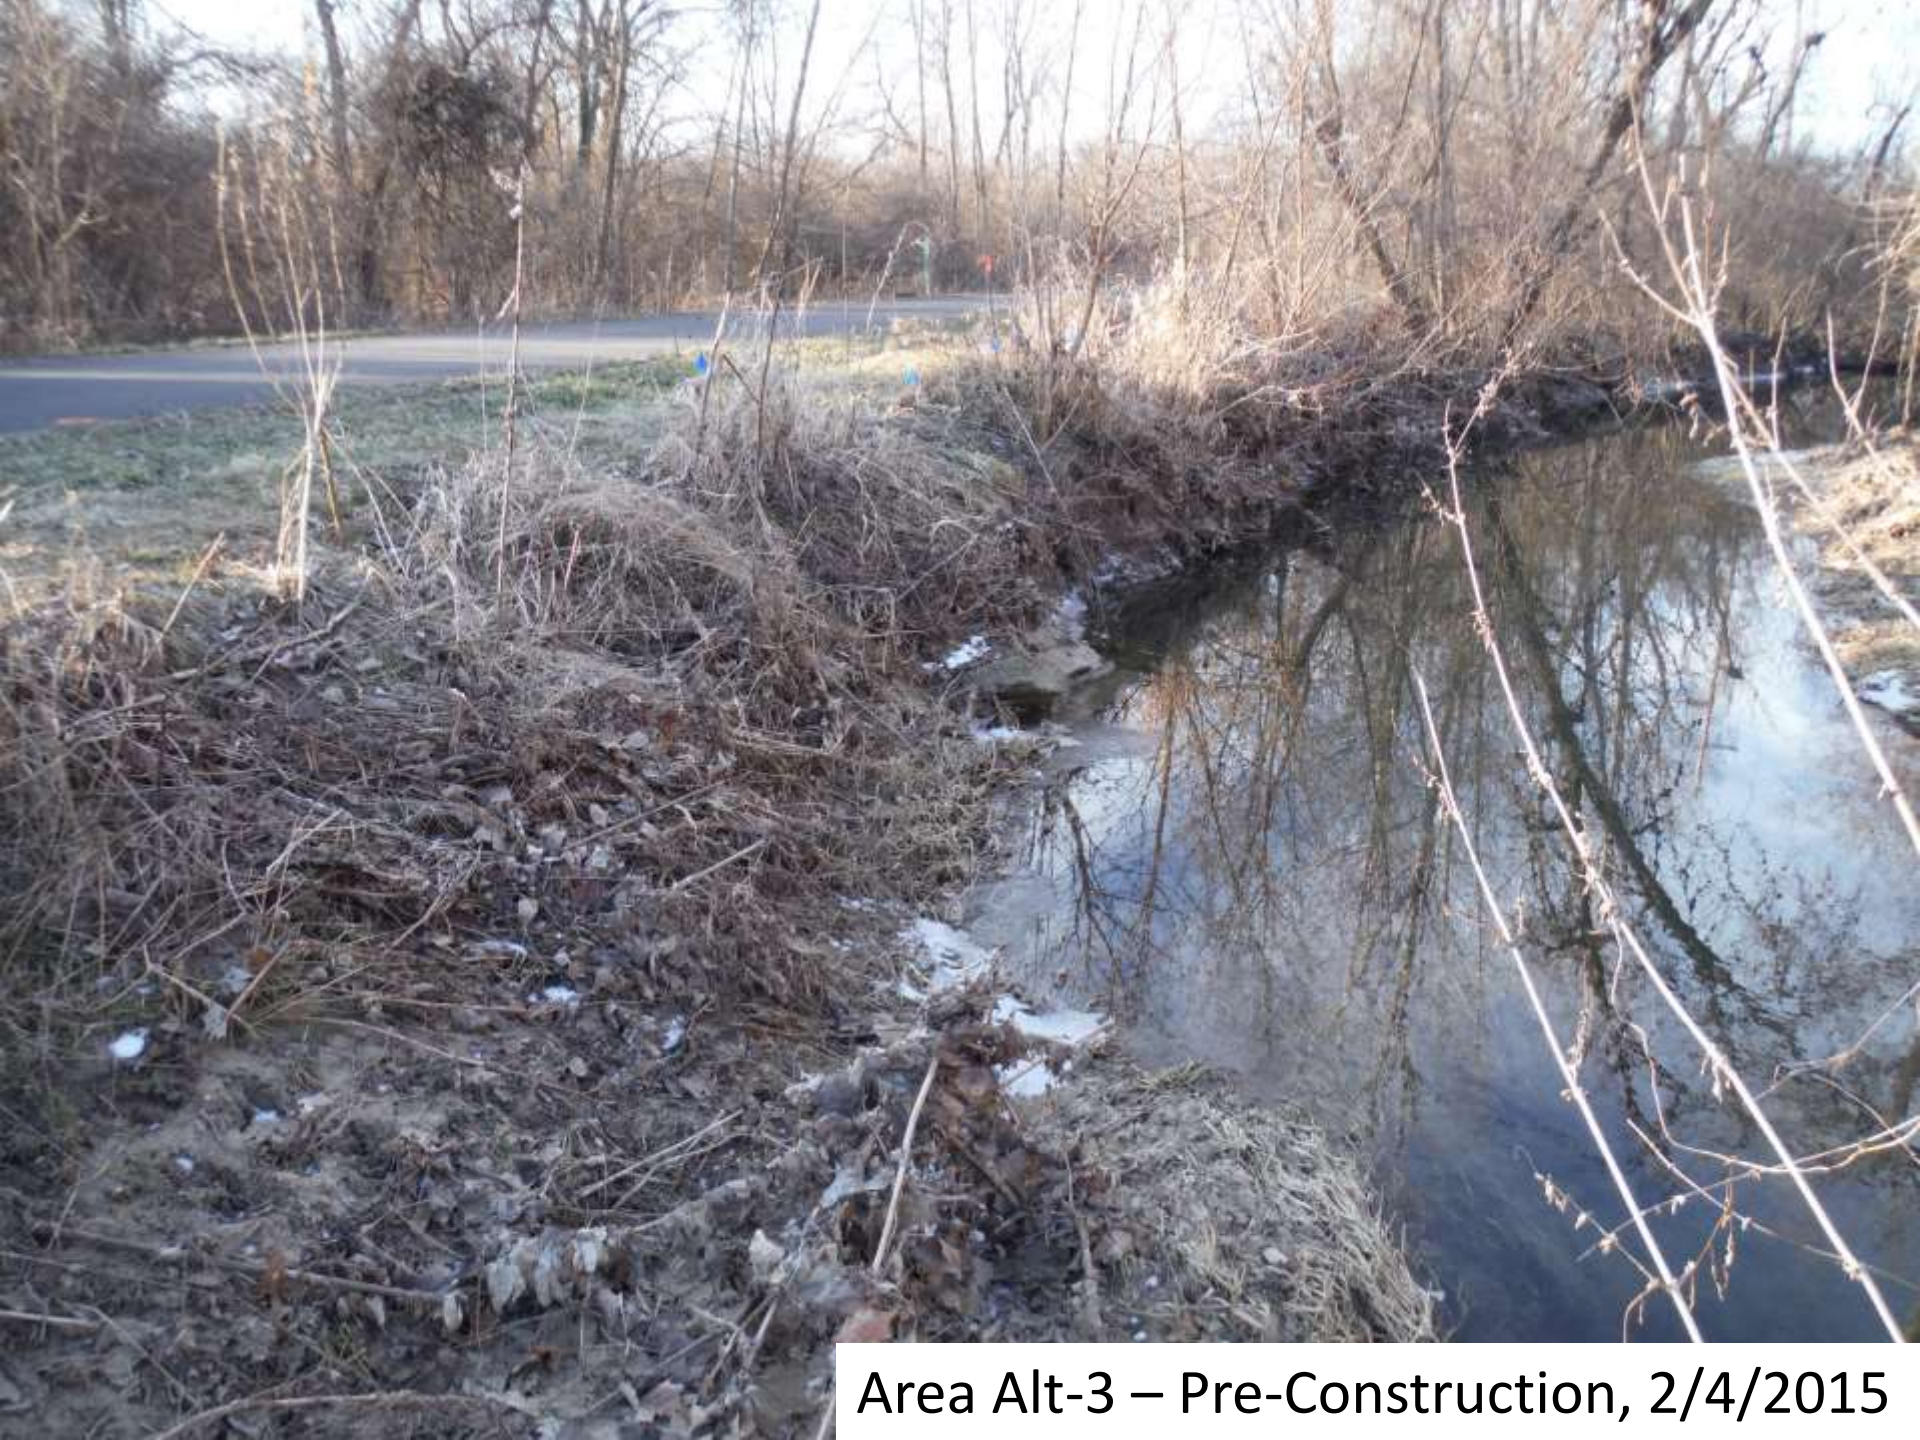
Area Alt-3 – Pre-Construction, 2/4/2015

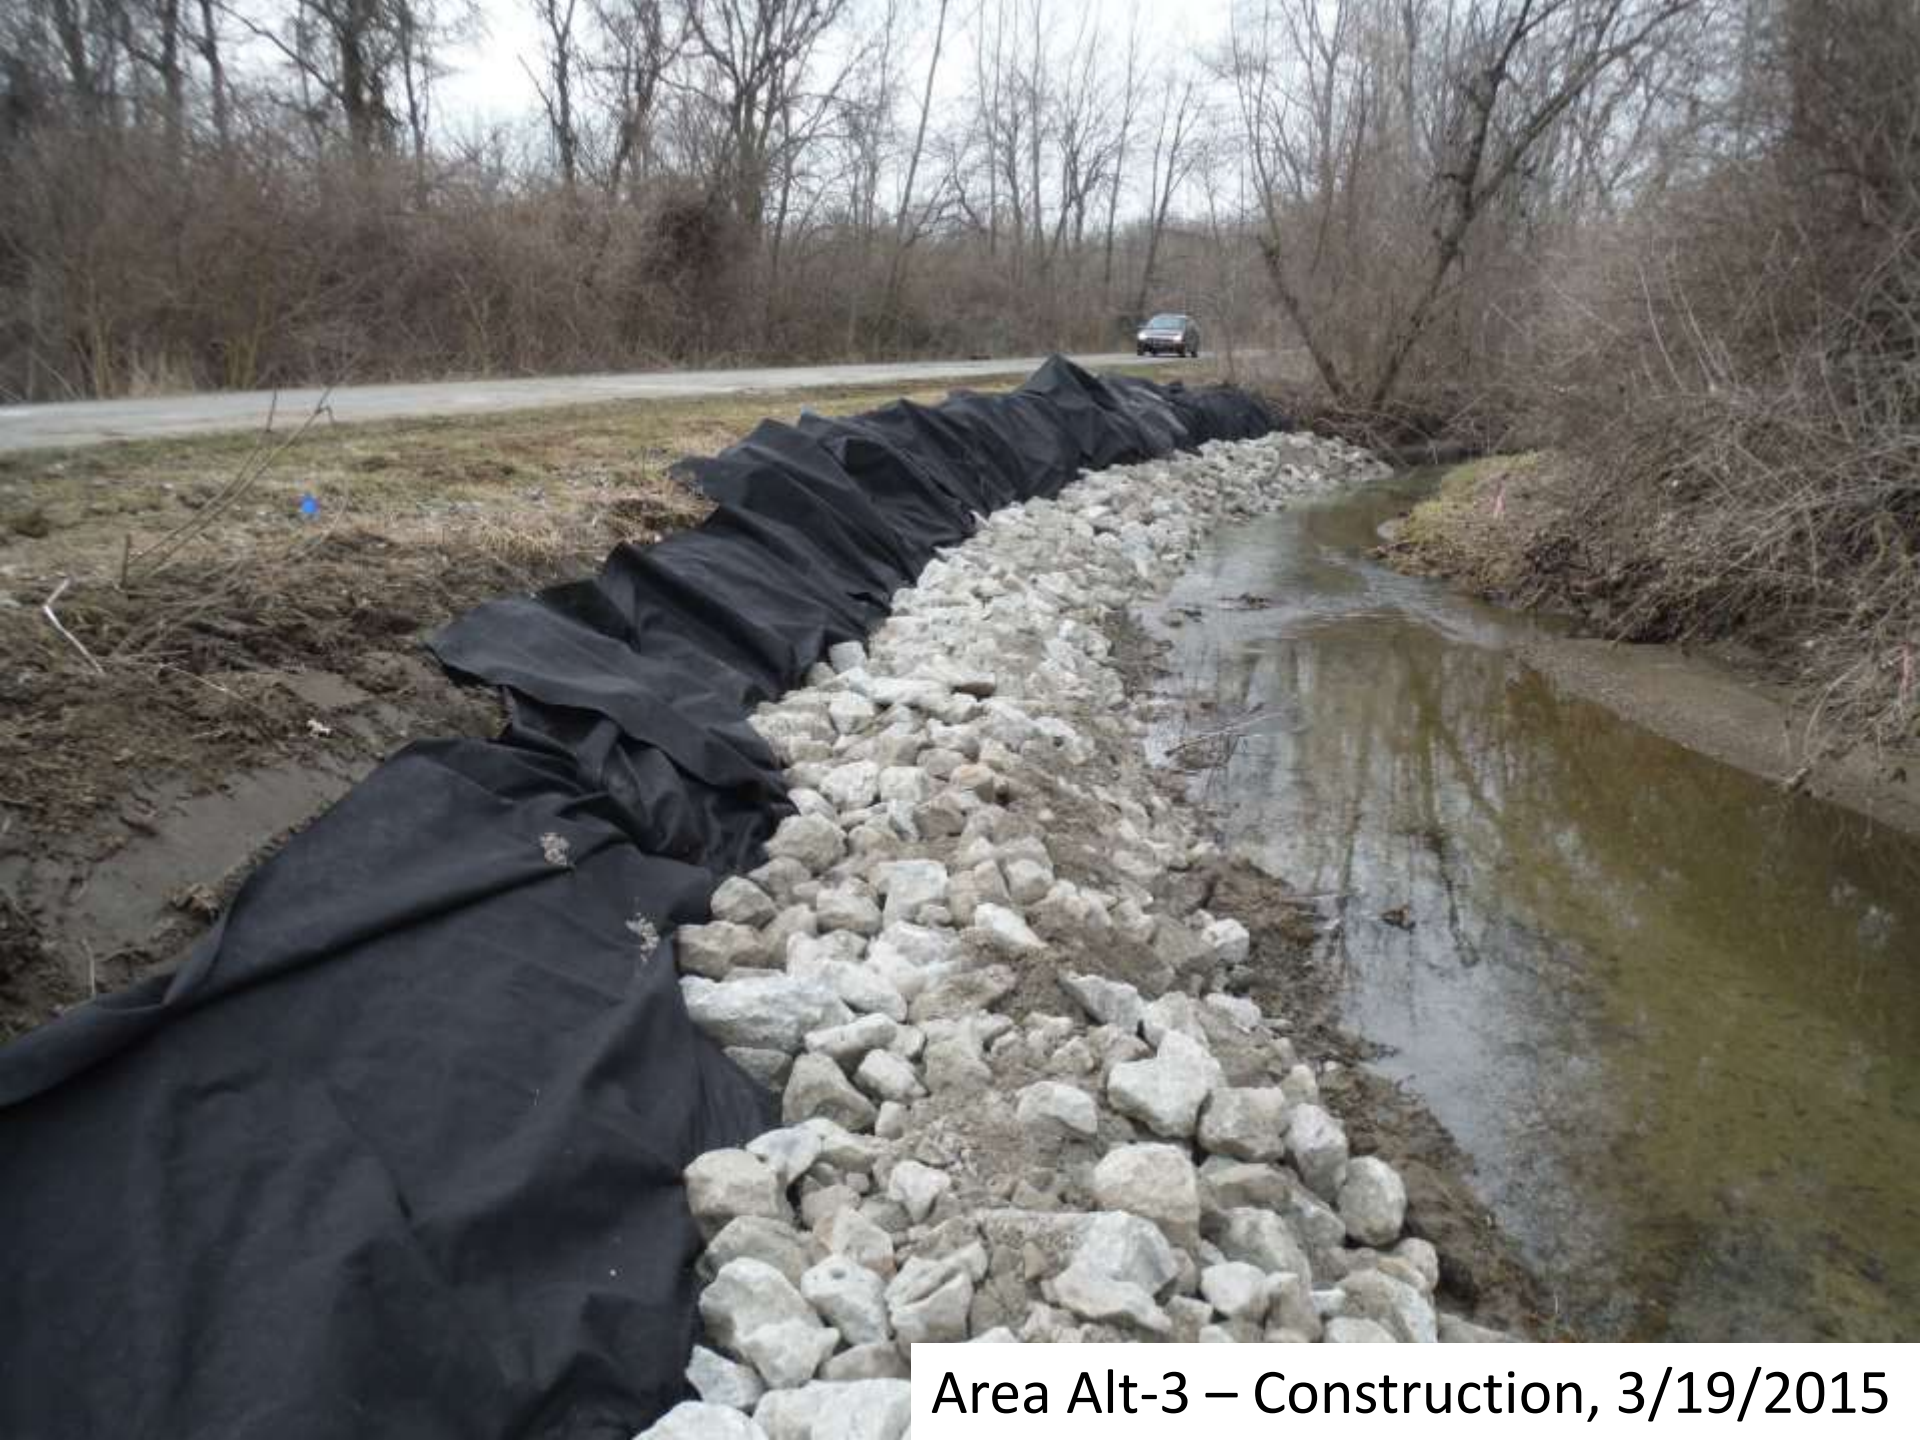
Area Alt-3 – Construction, 3/19/2015

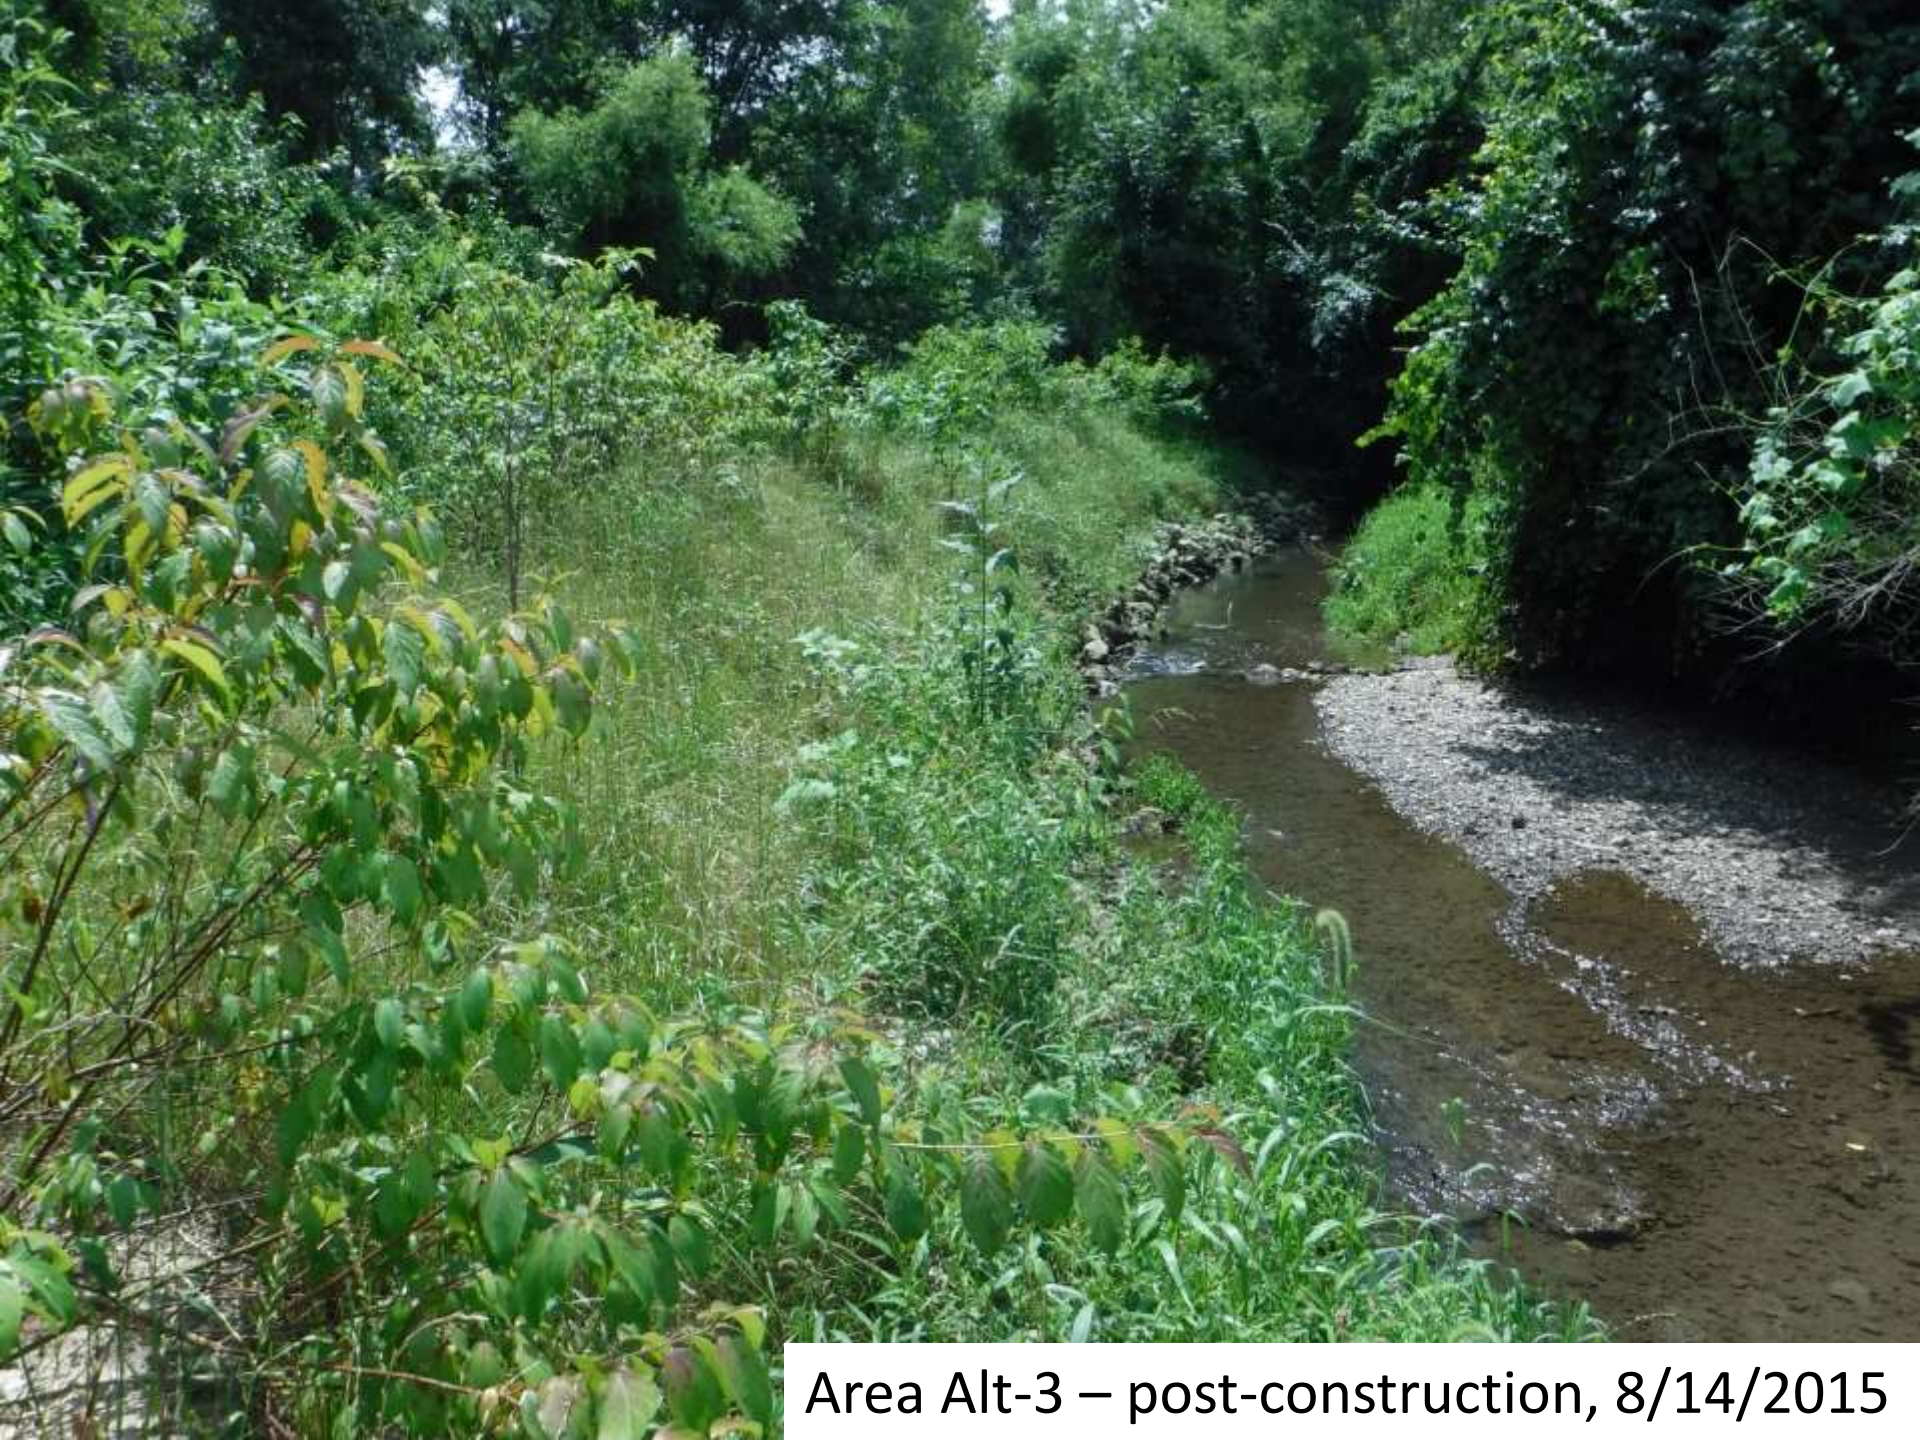
Area Alt-3 – post-construction, 8/14/2015

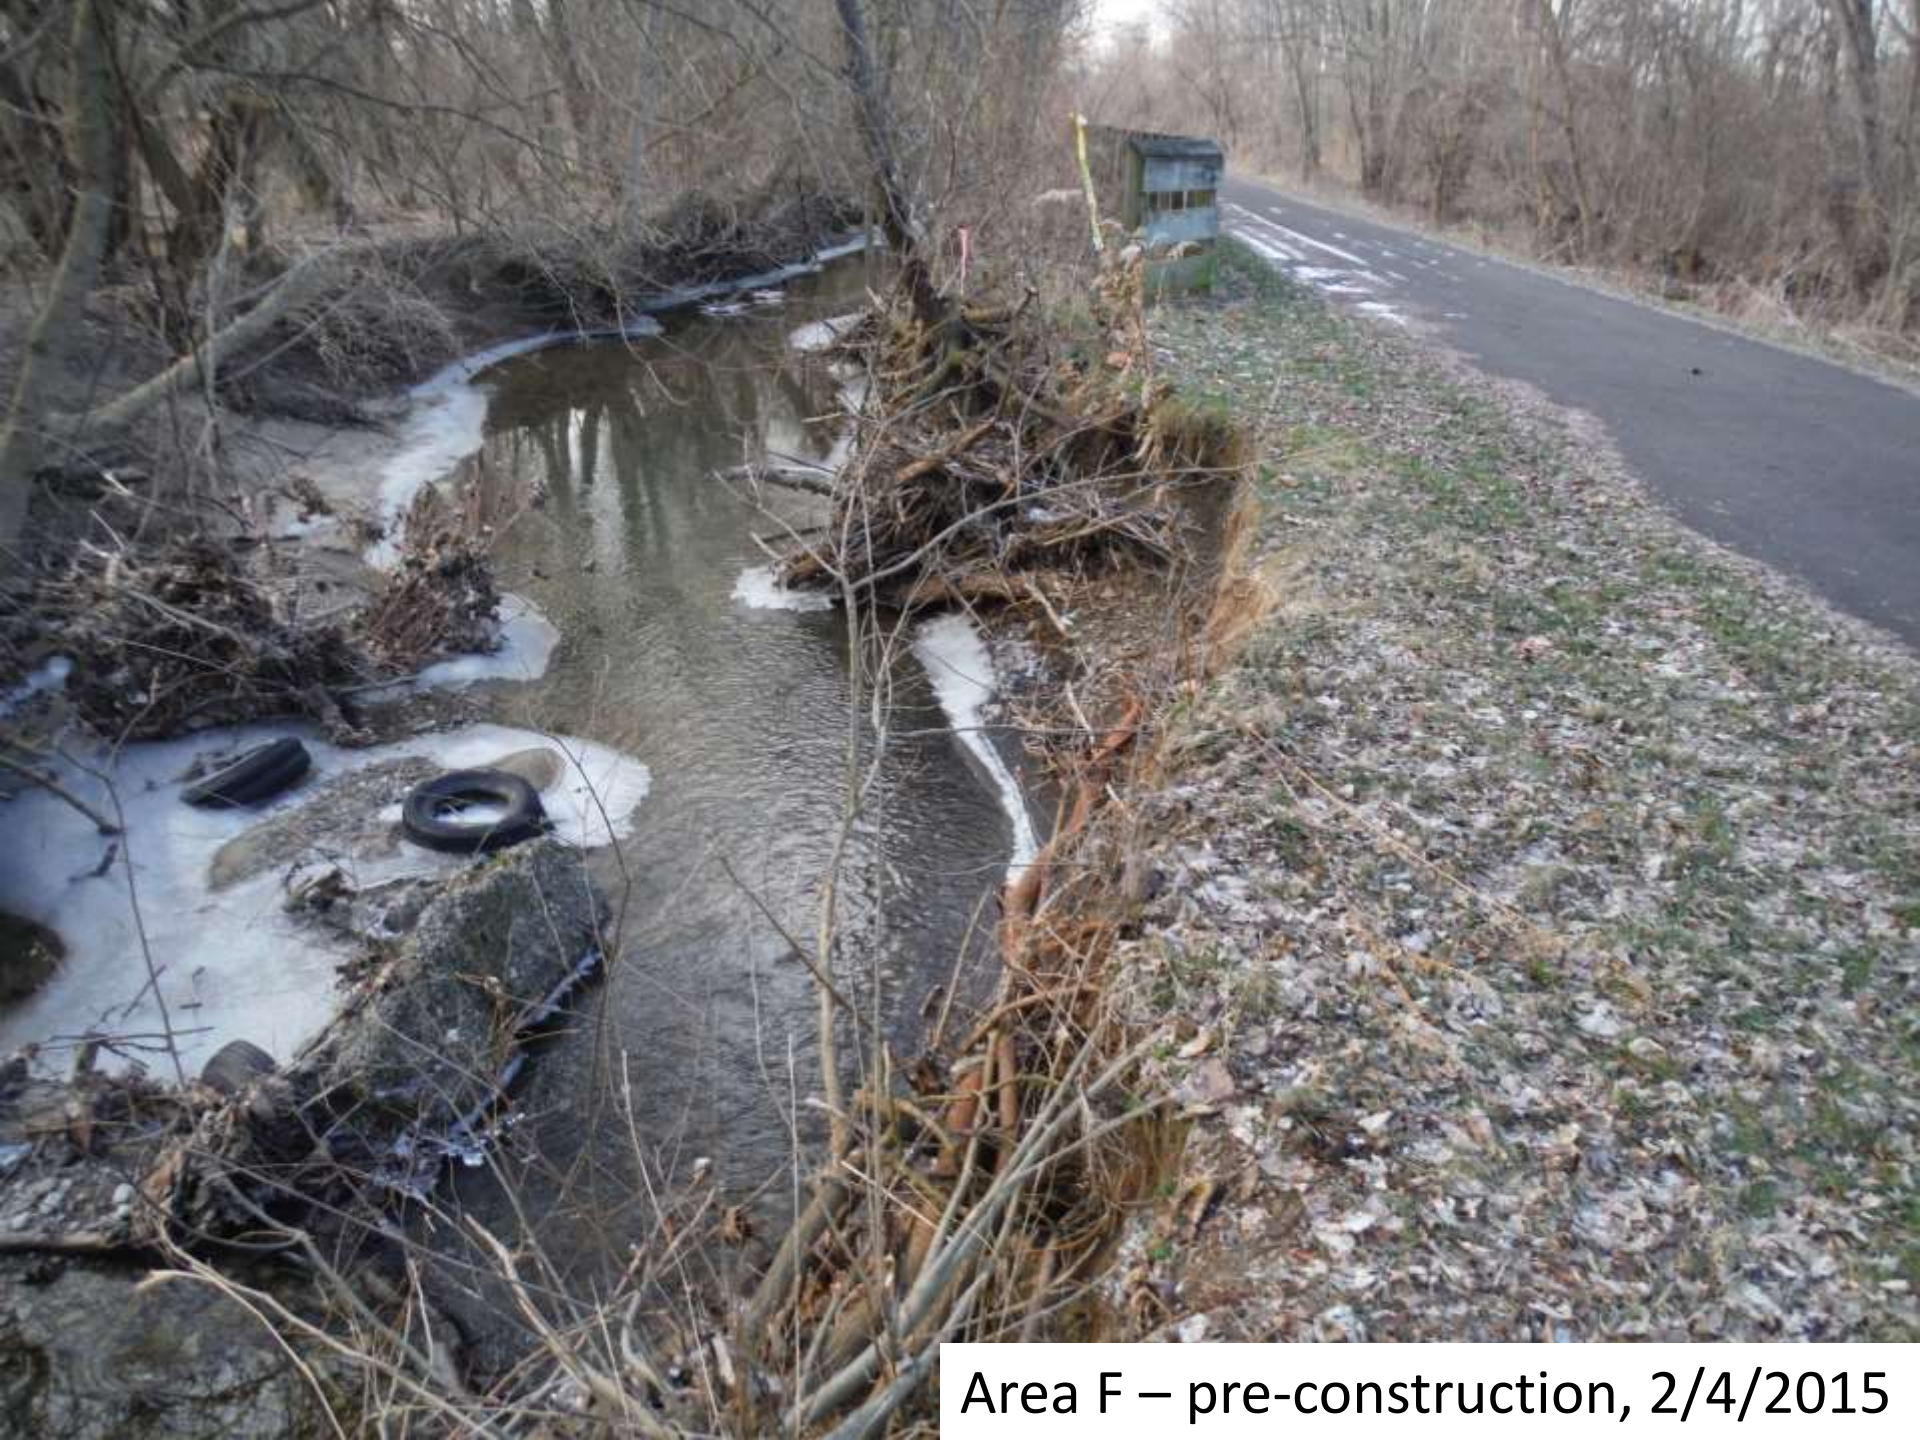
Area F – pre-construction, 2/4/2015

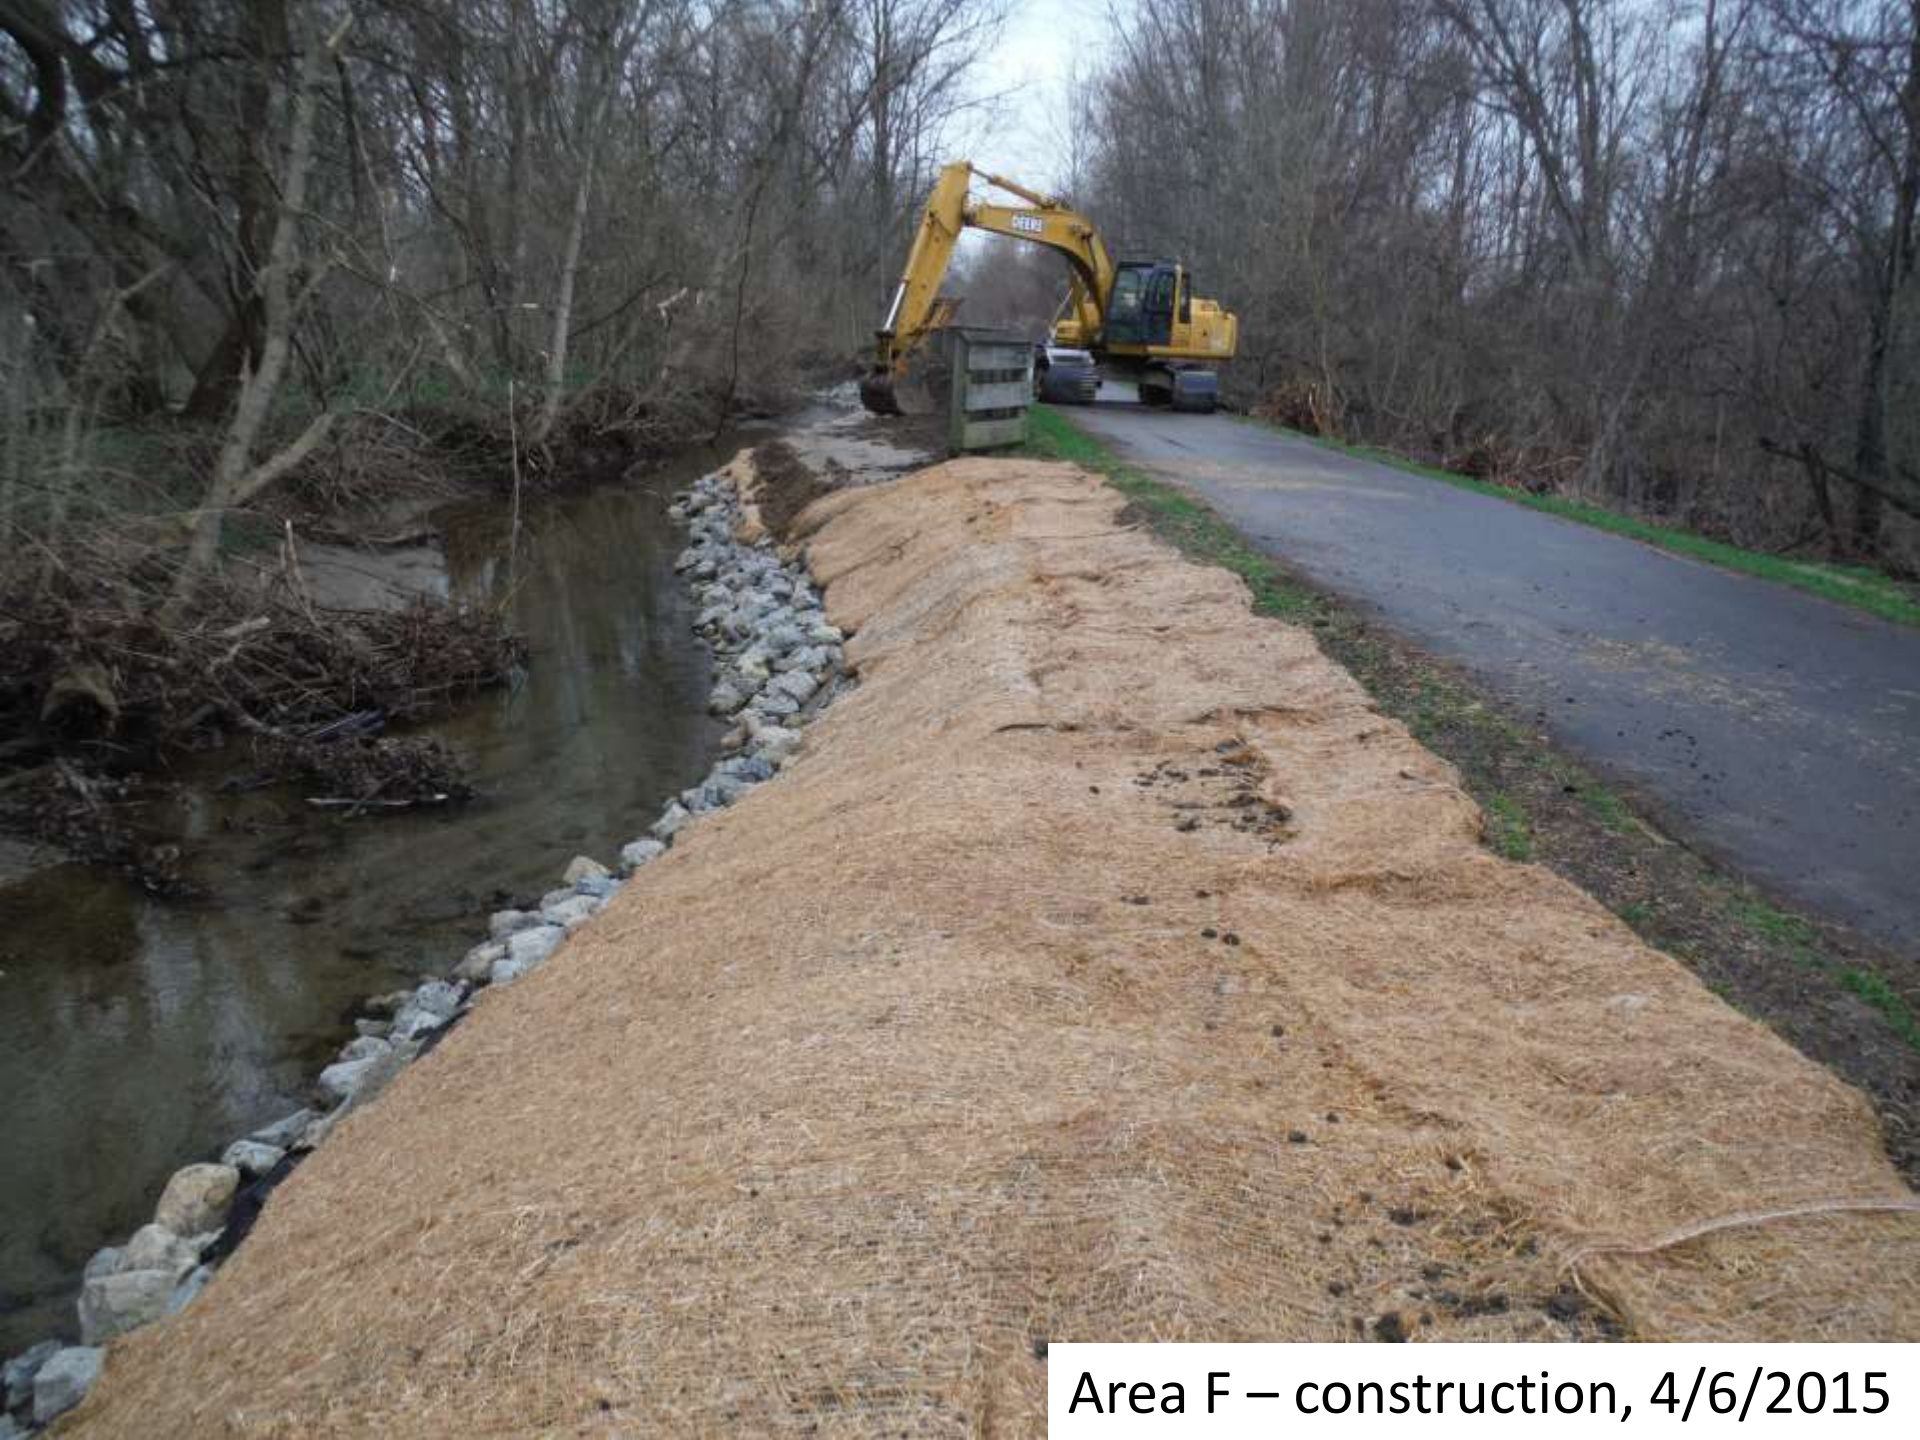
Area F – construction, 4/6/2015

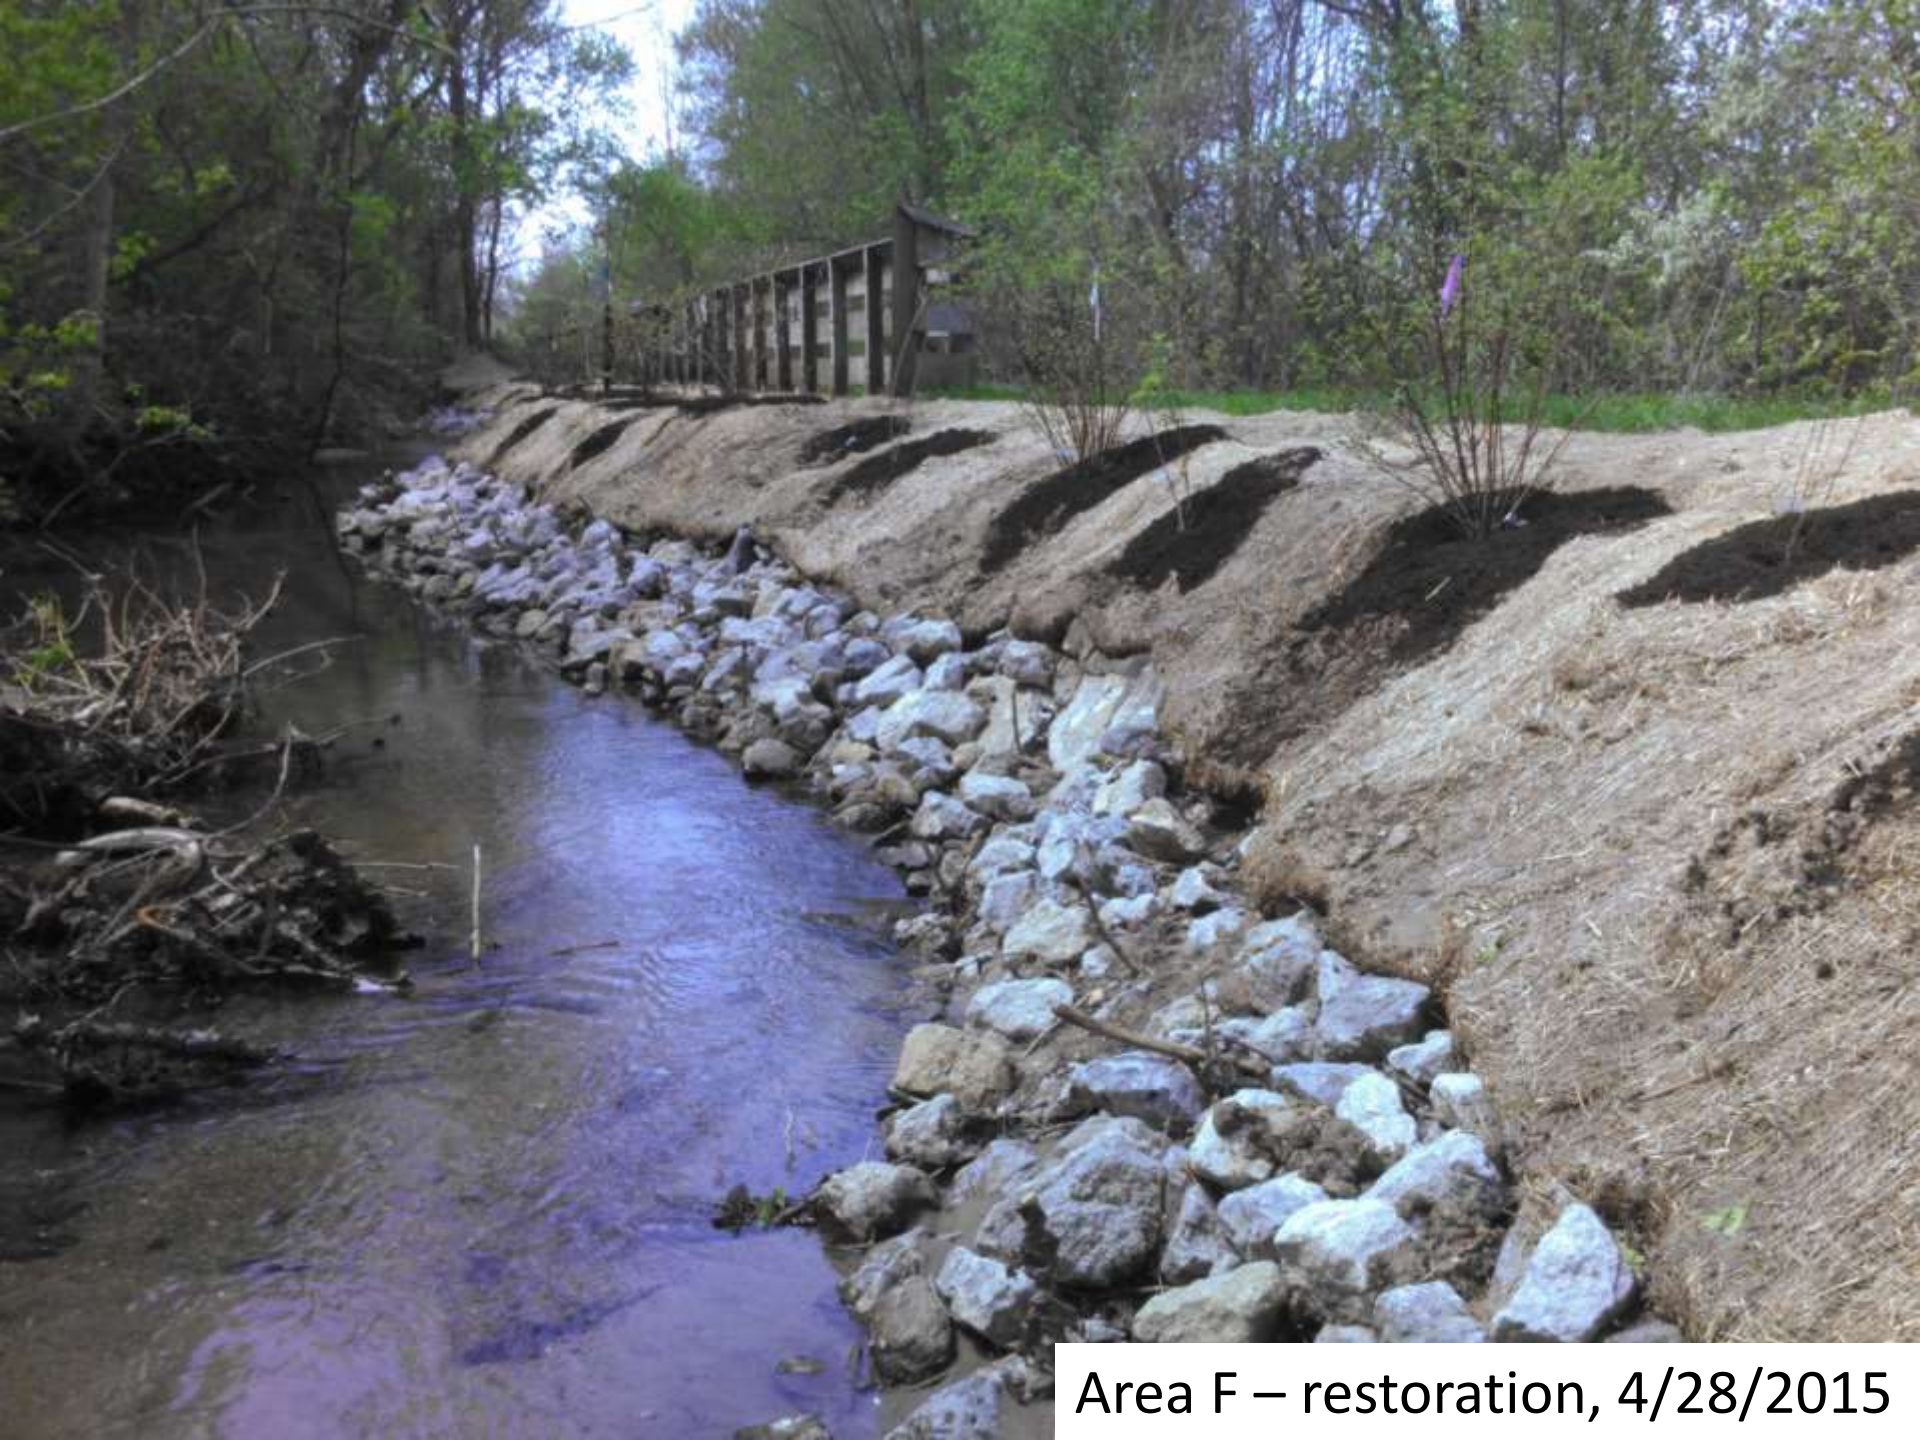
Area F – restoration, 4/28/2015

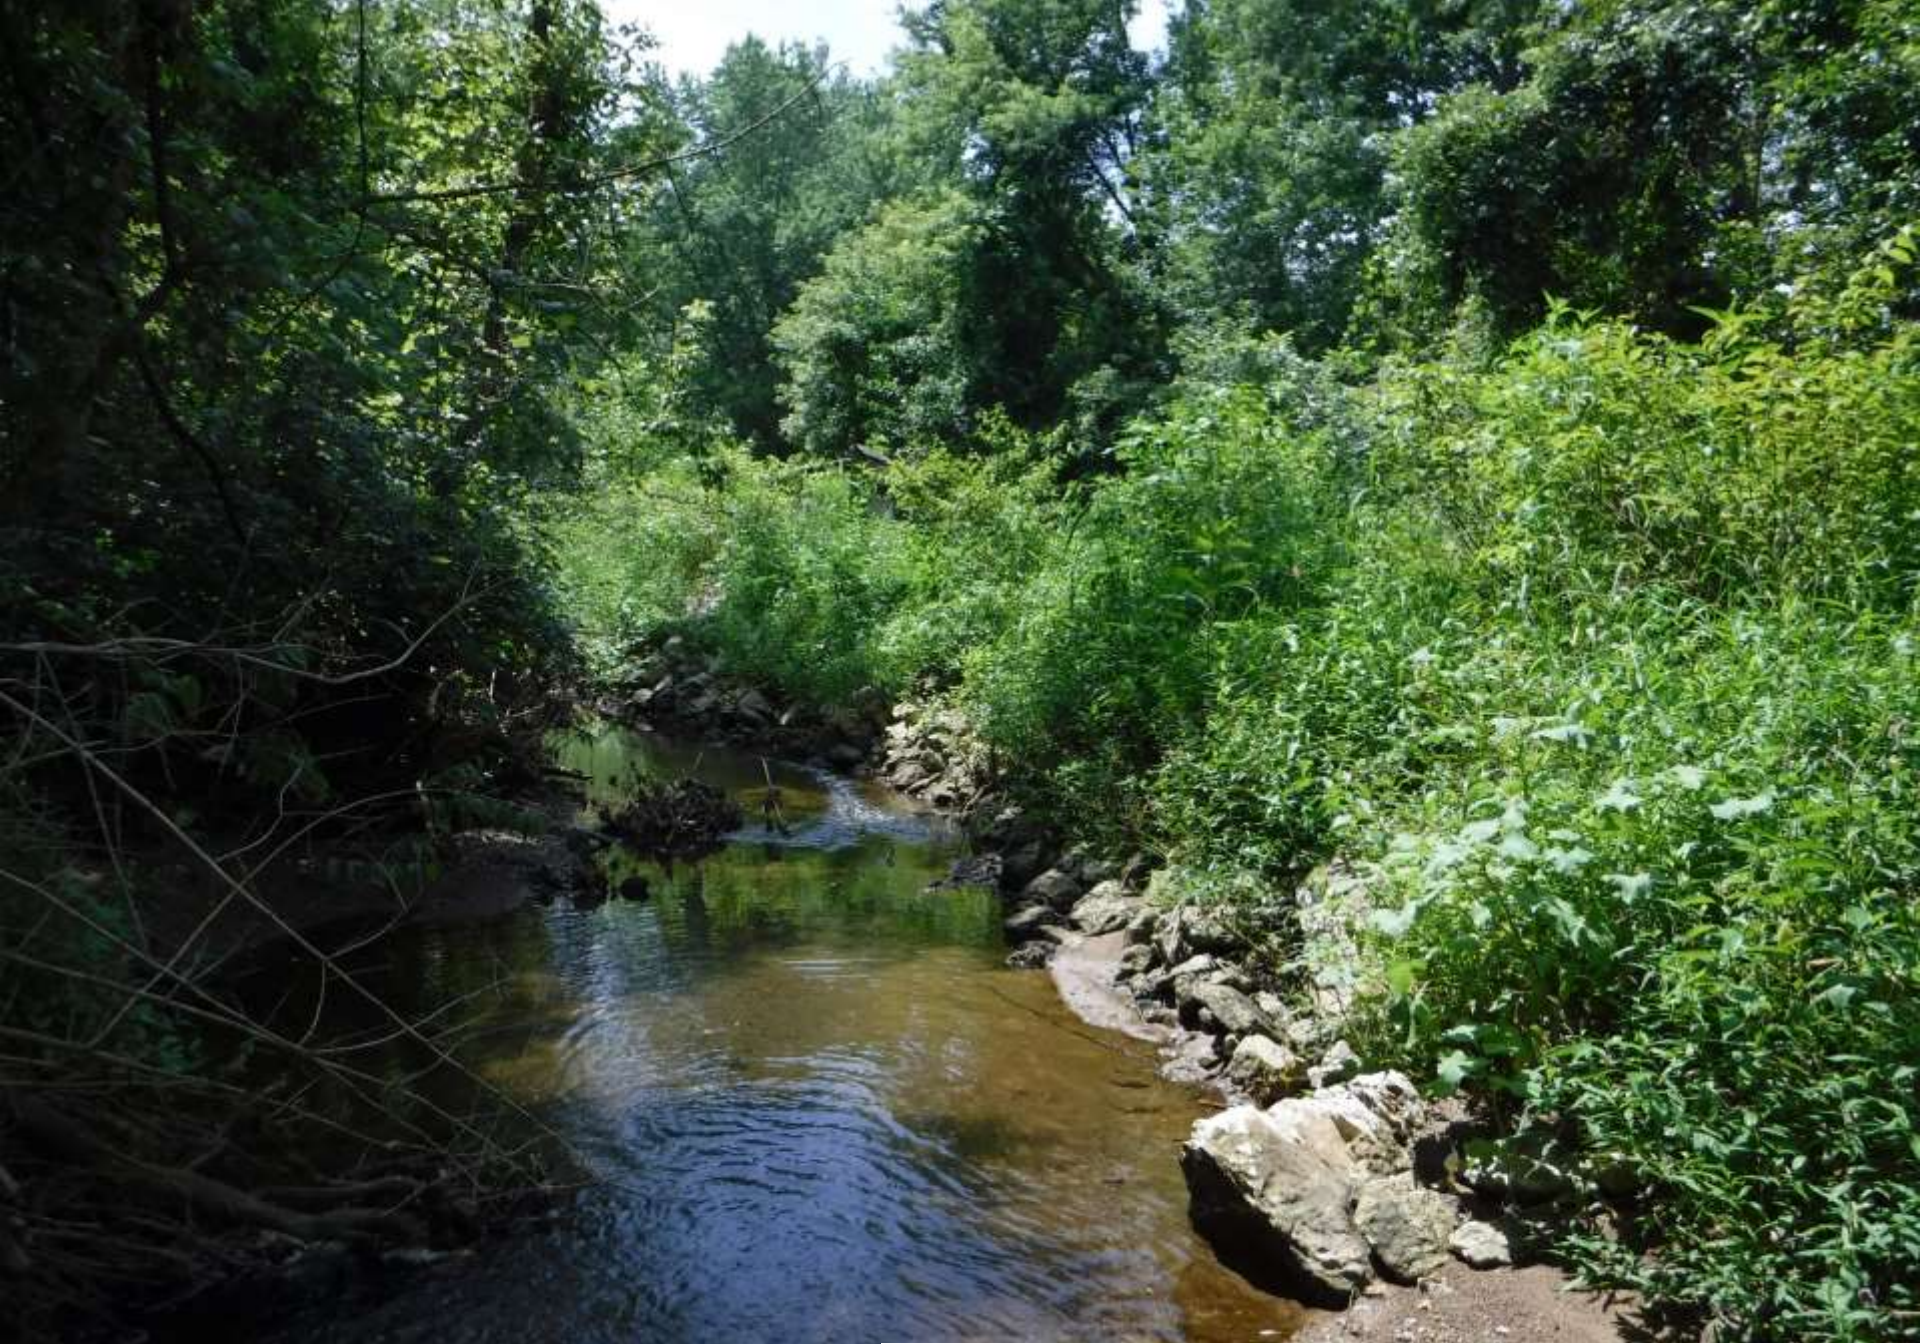
Area F – post-construction, 8/14/2015

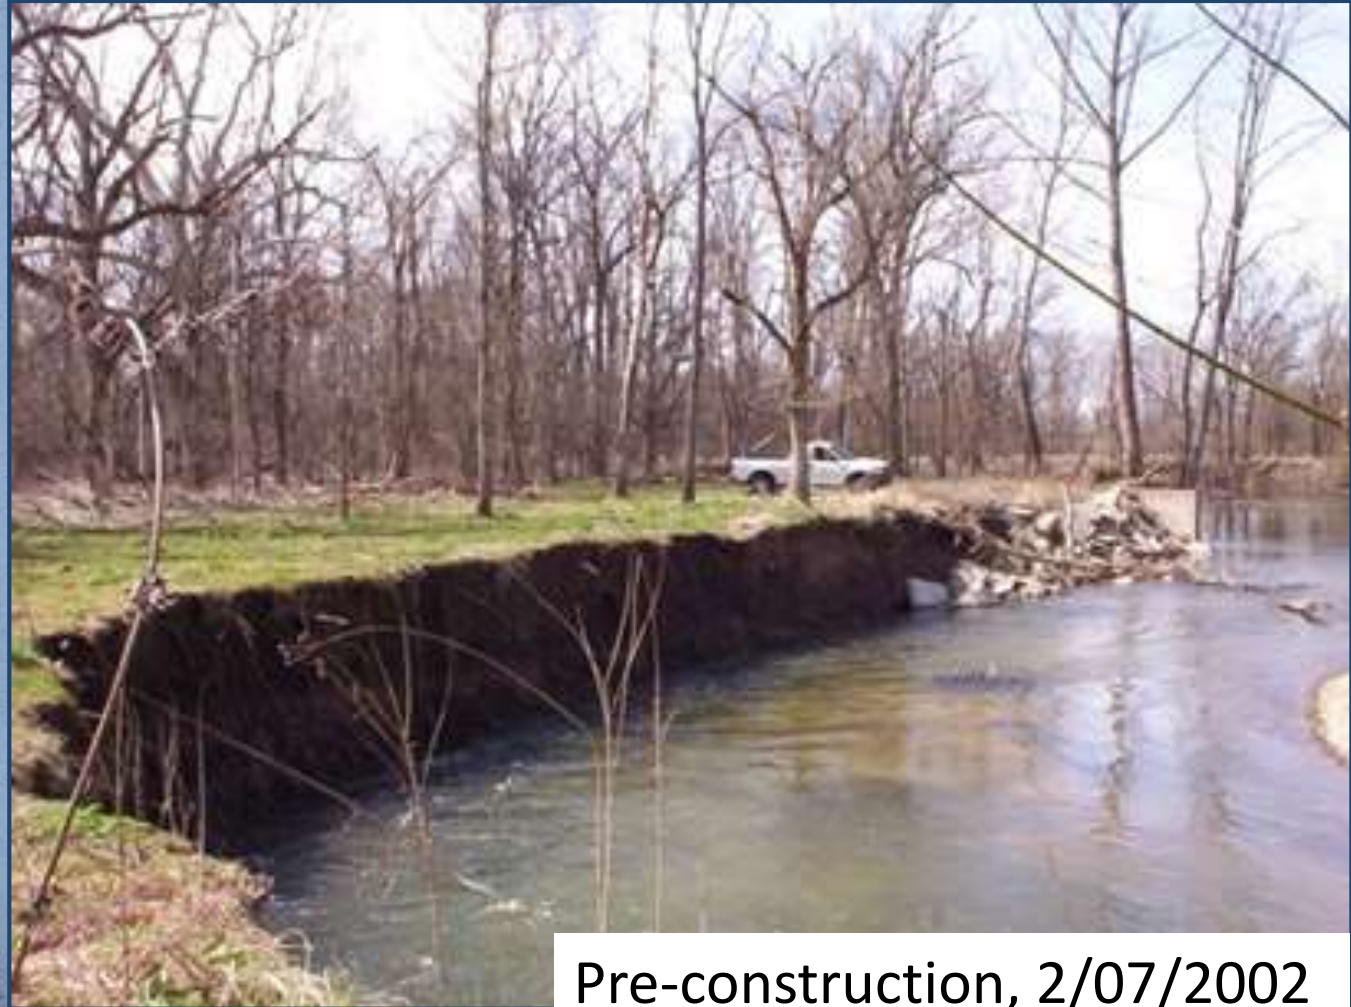
Two years of
excessive
streambank
erosion (35 feet)
put Xenia's Ford
Road WWTP
outfall in
jeopardy

Pre-construction, 2/07/2002
