Protecting Your Infrastructure from Stream Erosion

Ohio Storm Water Management and
Drainage Conference

March 8, 2017

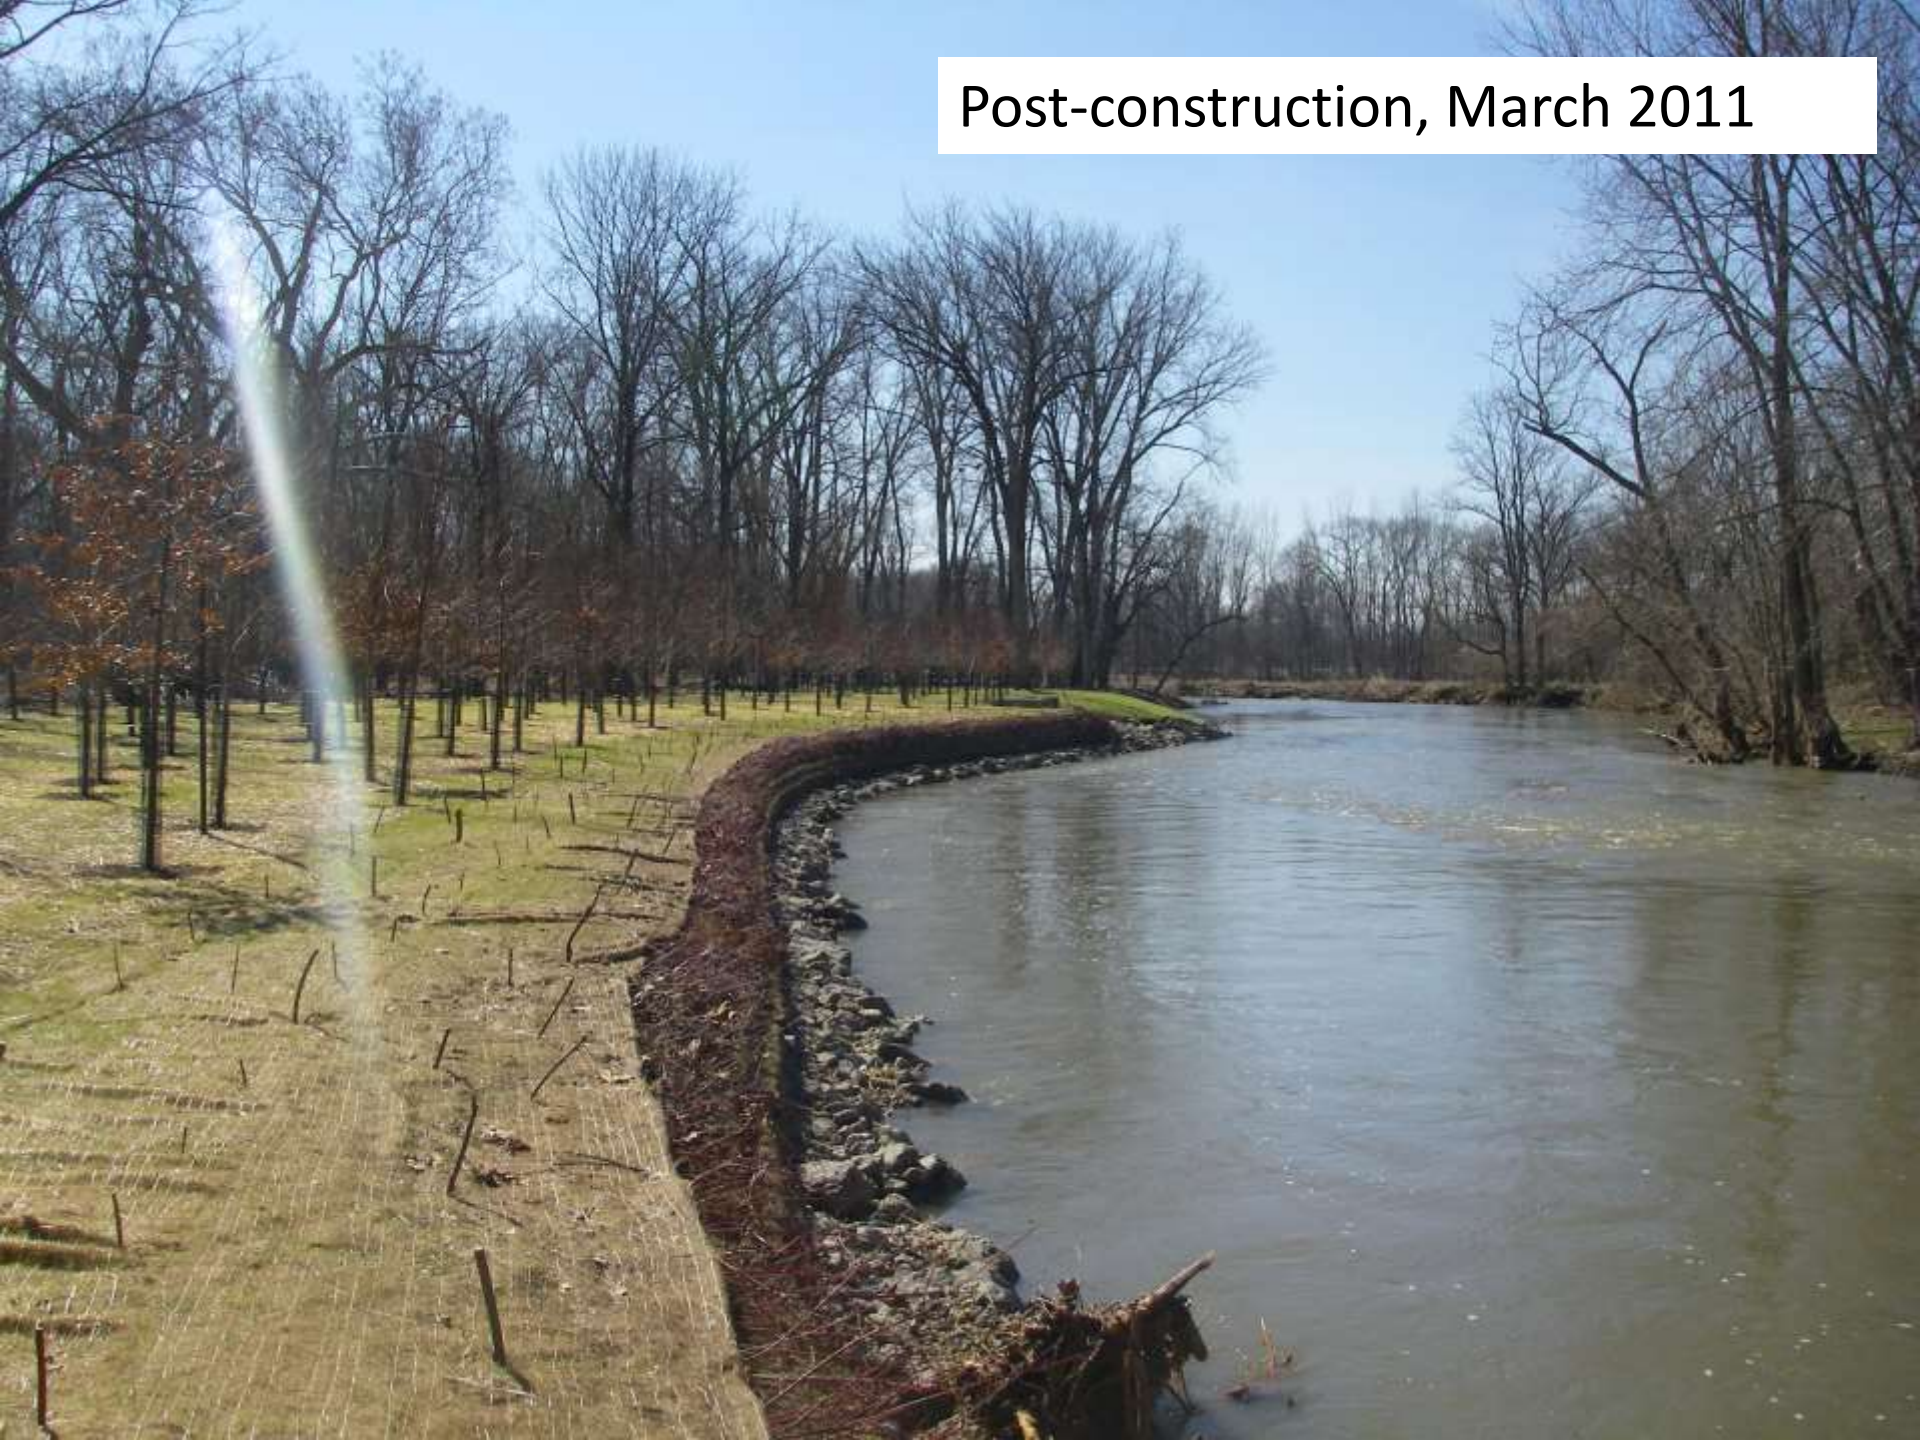
Post-construction June 2011

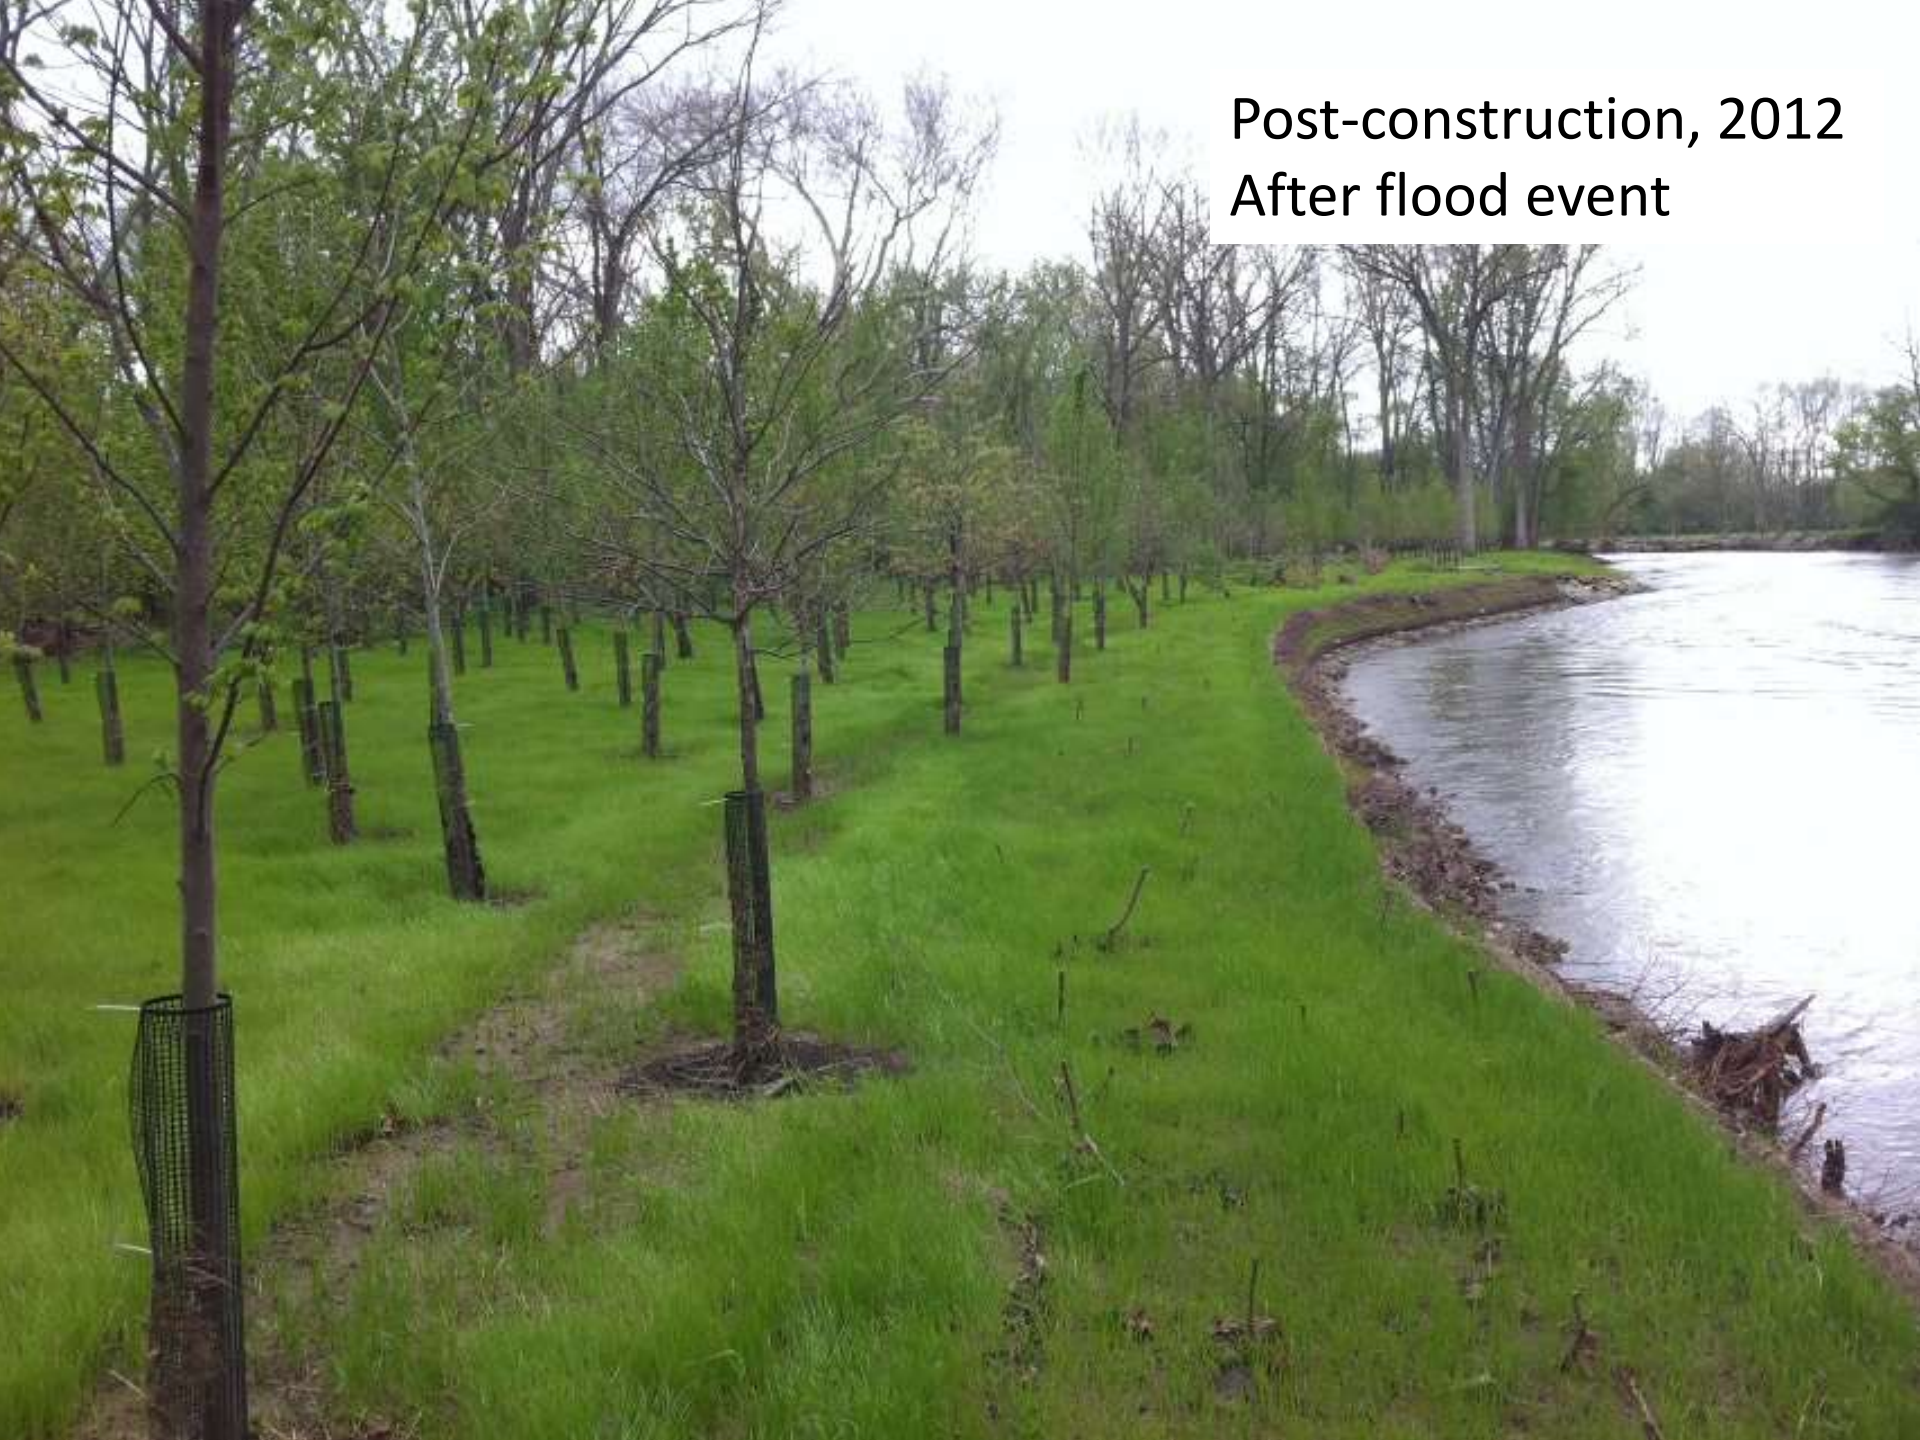
Post-construction, 2012
After flood event

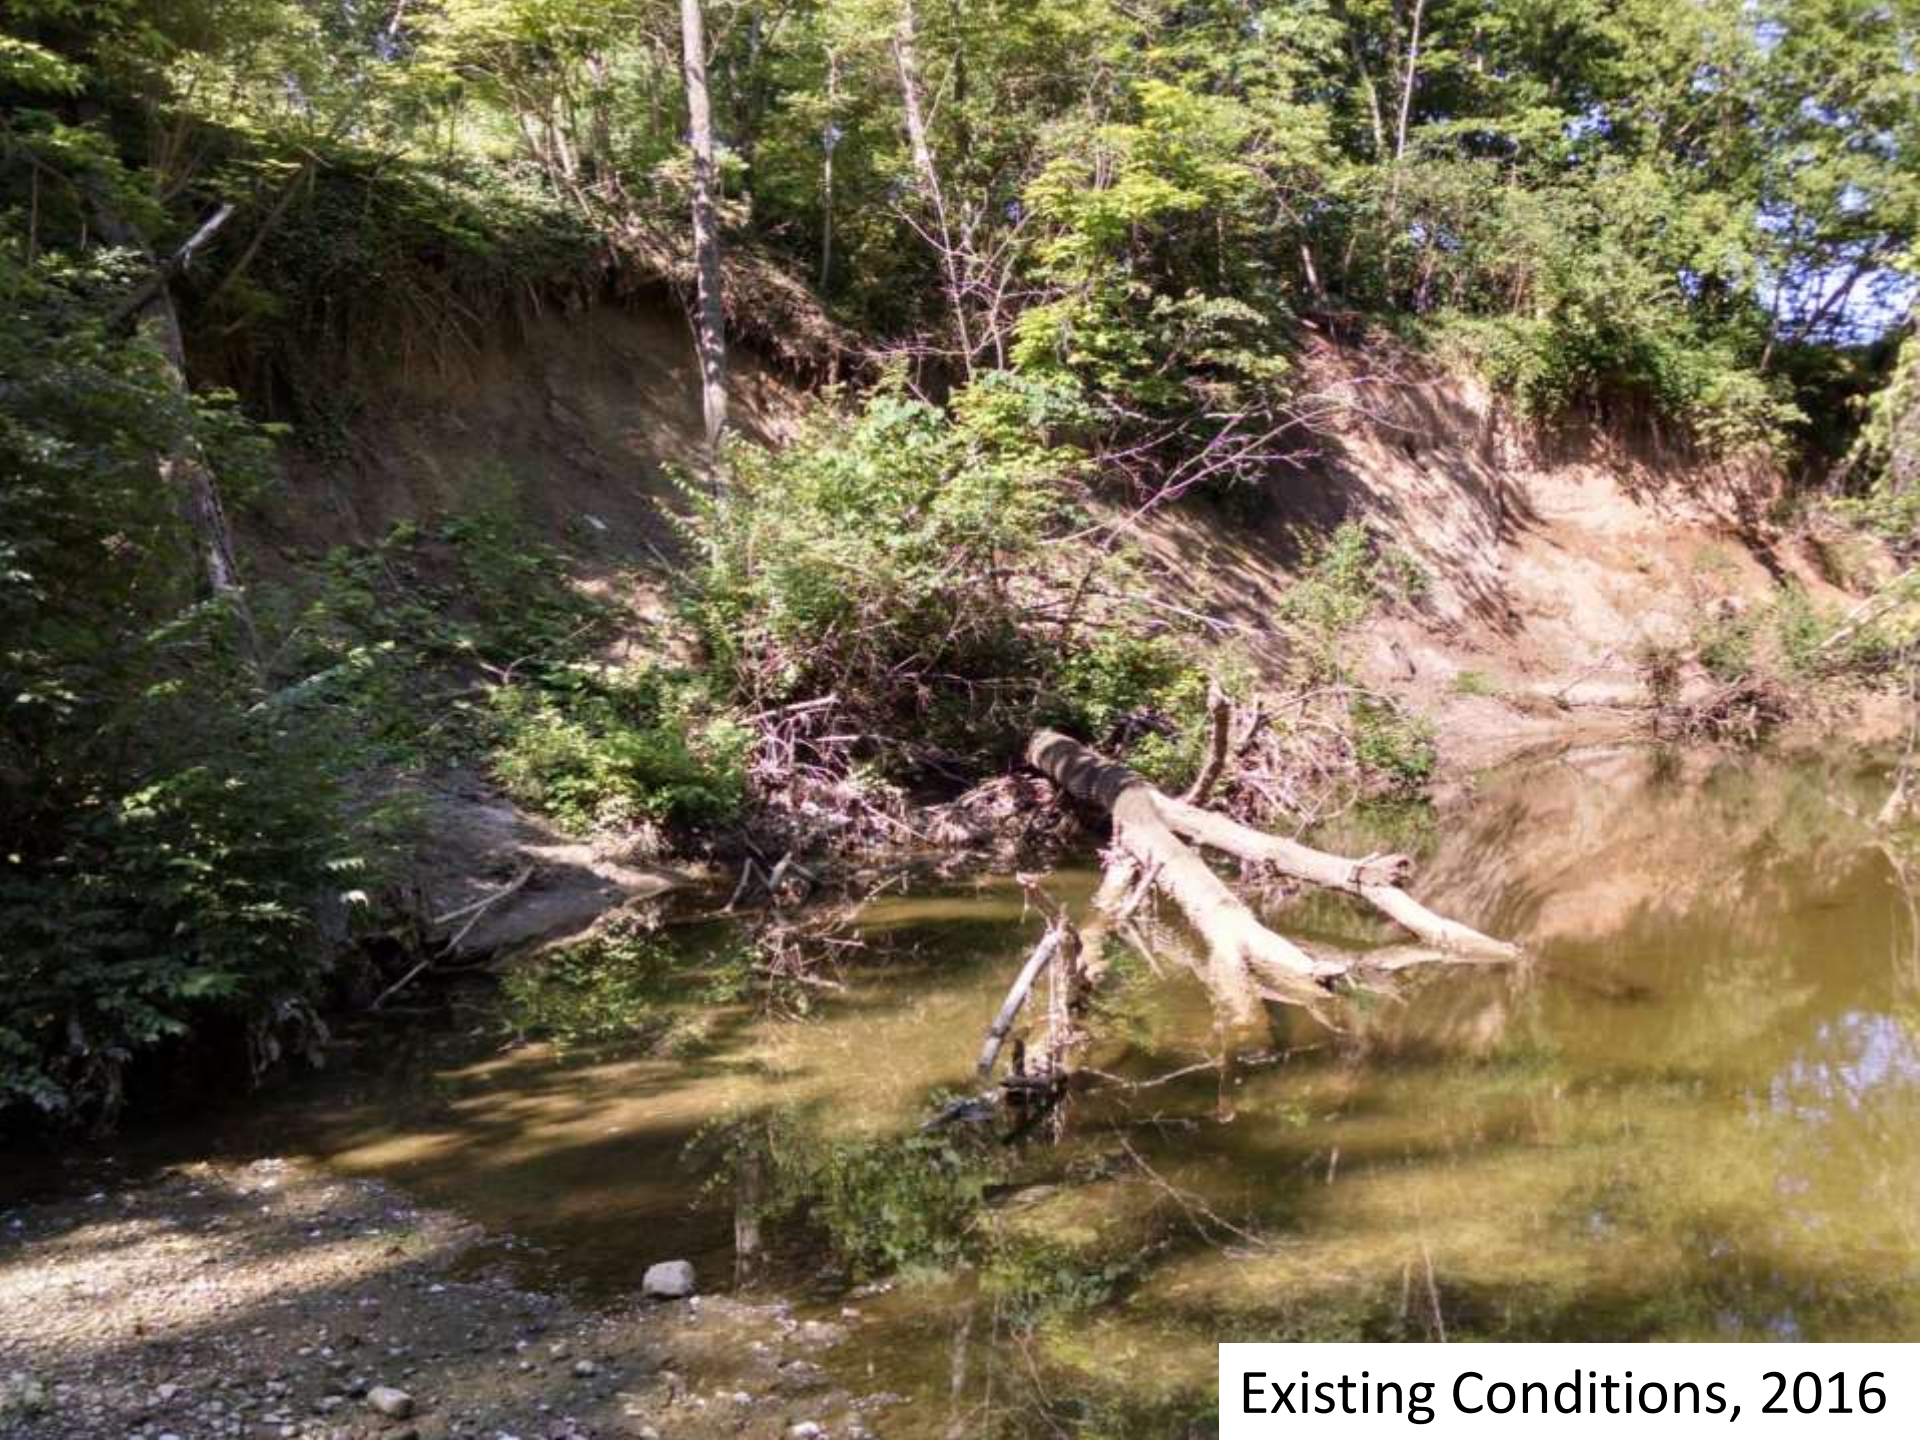
Existing Conditions, 2016

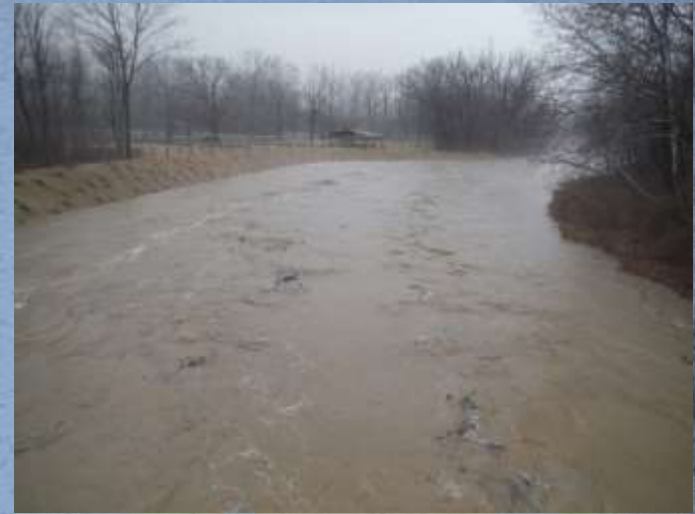
Dry Fork Creek, Site A - 1/3/2015 Flood

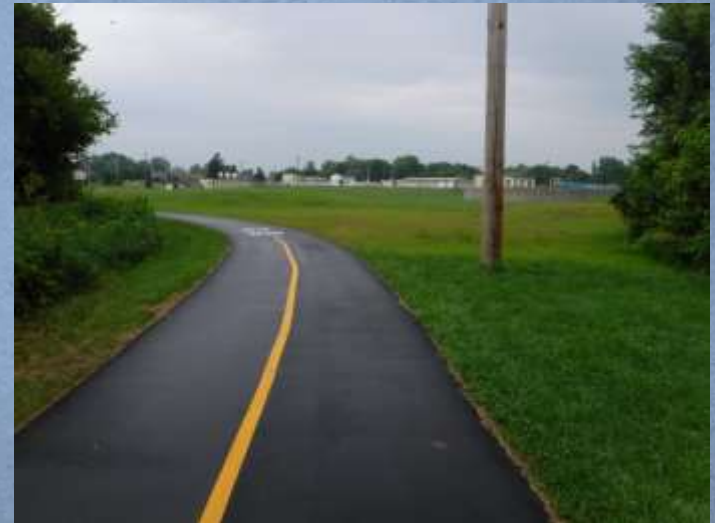
Gladly Run, bike path overlay
