Rehabilitation of Stone Arch Culverts Henry County US 24 and State Route 424

Mike Benton, P.E. – ODOT District 2
Matt Schroeder – Miller Bros. Construction

ODOT PID 88197 Scope

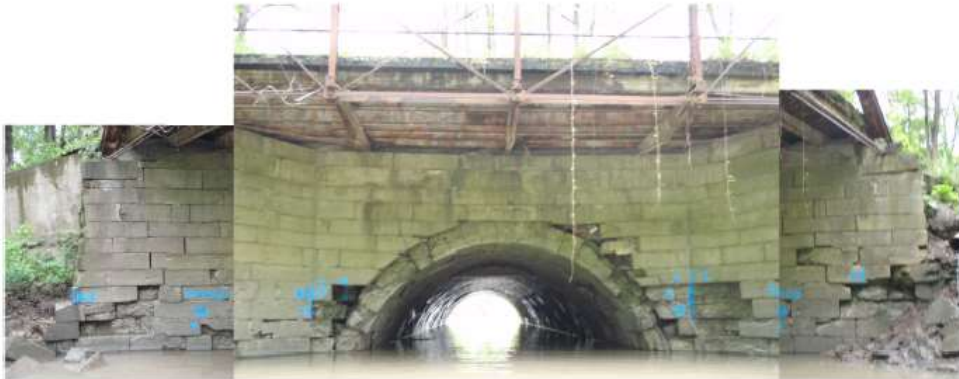
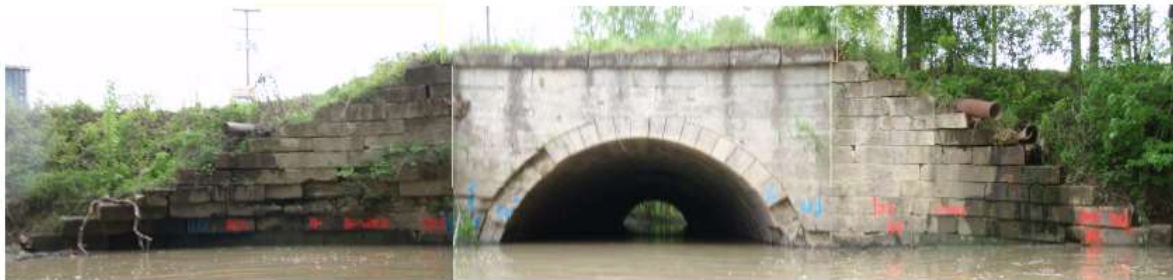
Revised Plan Sheet

Plans indicated the blocks were sitting on 2' of stone base. Once the work area was dewatered it was discovered that the entire structure (headwalls, wingwalls and arch) are sitting on large wooded timbers. At that point ODOT was notified of change of existing conditions and work was suspended until an alternate plan was developed. The existing timbers were tested and the results indicated that they were in good condition.

- (3) DISMANTLING THE EXISTING STONE ARCH HEADWALLS AND WINGWALLS - ALL EXISTING HEADWALL AND WINGWALL STONE BLOCKS ARE TO BE CAREFULLY DISMANTLED DOWN TO THE TIMBER MATTING AND STORED INSIDE THE DESIGNATED CONTRACTOR STAGING AREA. DETERIORATED OR DAMAGED STONE BLOCKS SHALL BE REPLACED WITH NEW LIMESTONE BLOCKS MEETING SPECIFICATION FOR MATERIALS SET FORTH IN THE GENERAL STRUCTURES NOTES ON SHEET 2/11.
- (4) CONSTRUCTION OF THE MULTI-PLATE ARCH - CONSTRUCTION OF THE MULTI-PLATE ARCH SHALL INCLUDE CONSTRUCTION OF CONCRETE FOOTINGS BEARING ON THE TIMBER MATS AS SHOWN ON PLAN SHEET 5A/11, ERECTION OF THE STEEL, MULTI- PLATE ARCH, INSTALLATION OF WEEPHOLES, AND GROUTING OF THE REMAINING GAP BETWEEN THE PROPOSED MULTI-PLATE ARCH AND THE EXISTING STONE ARCH.

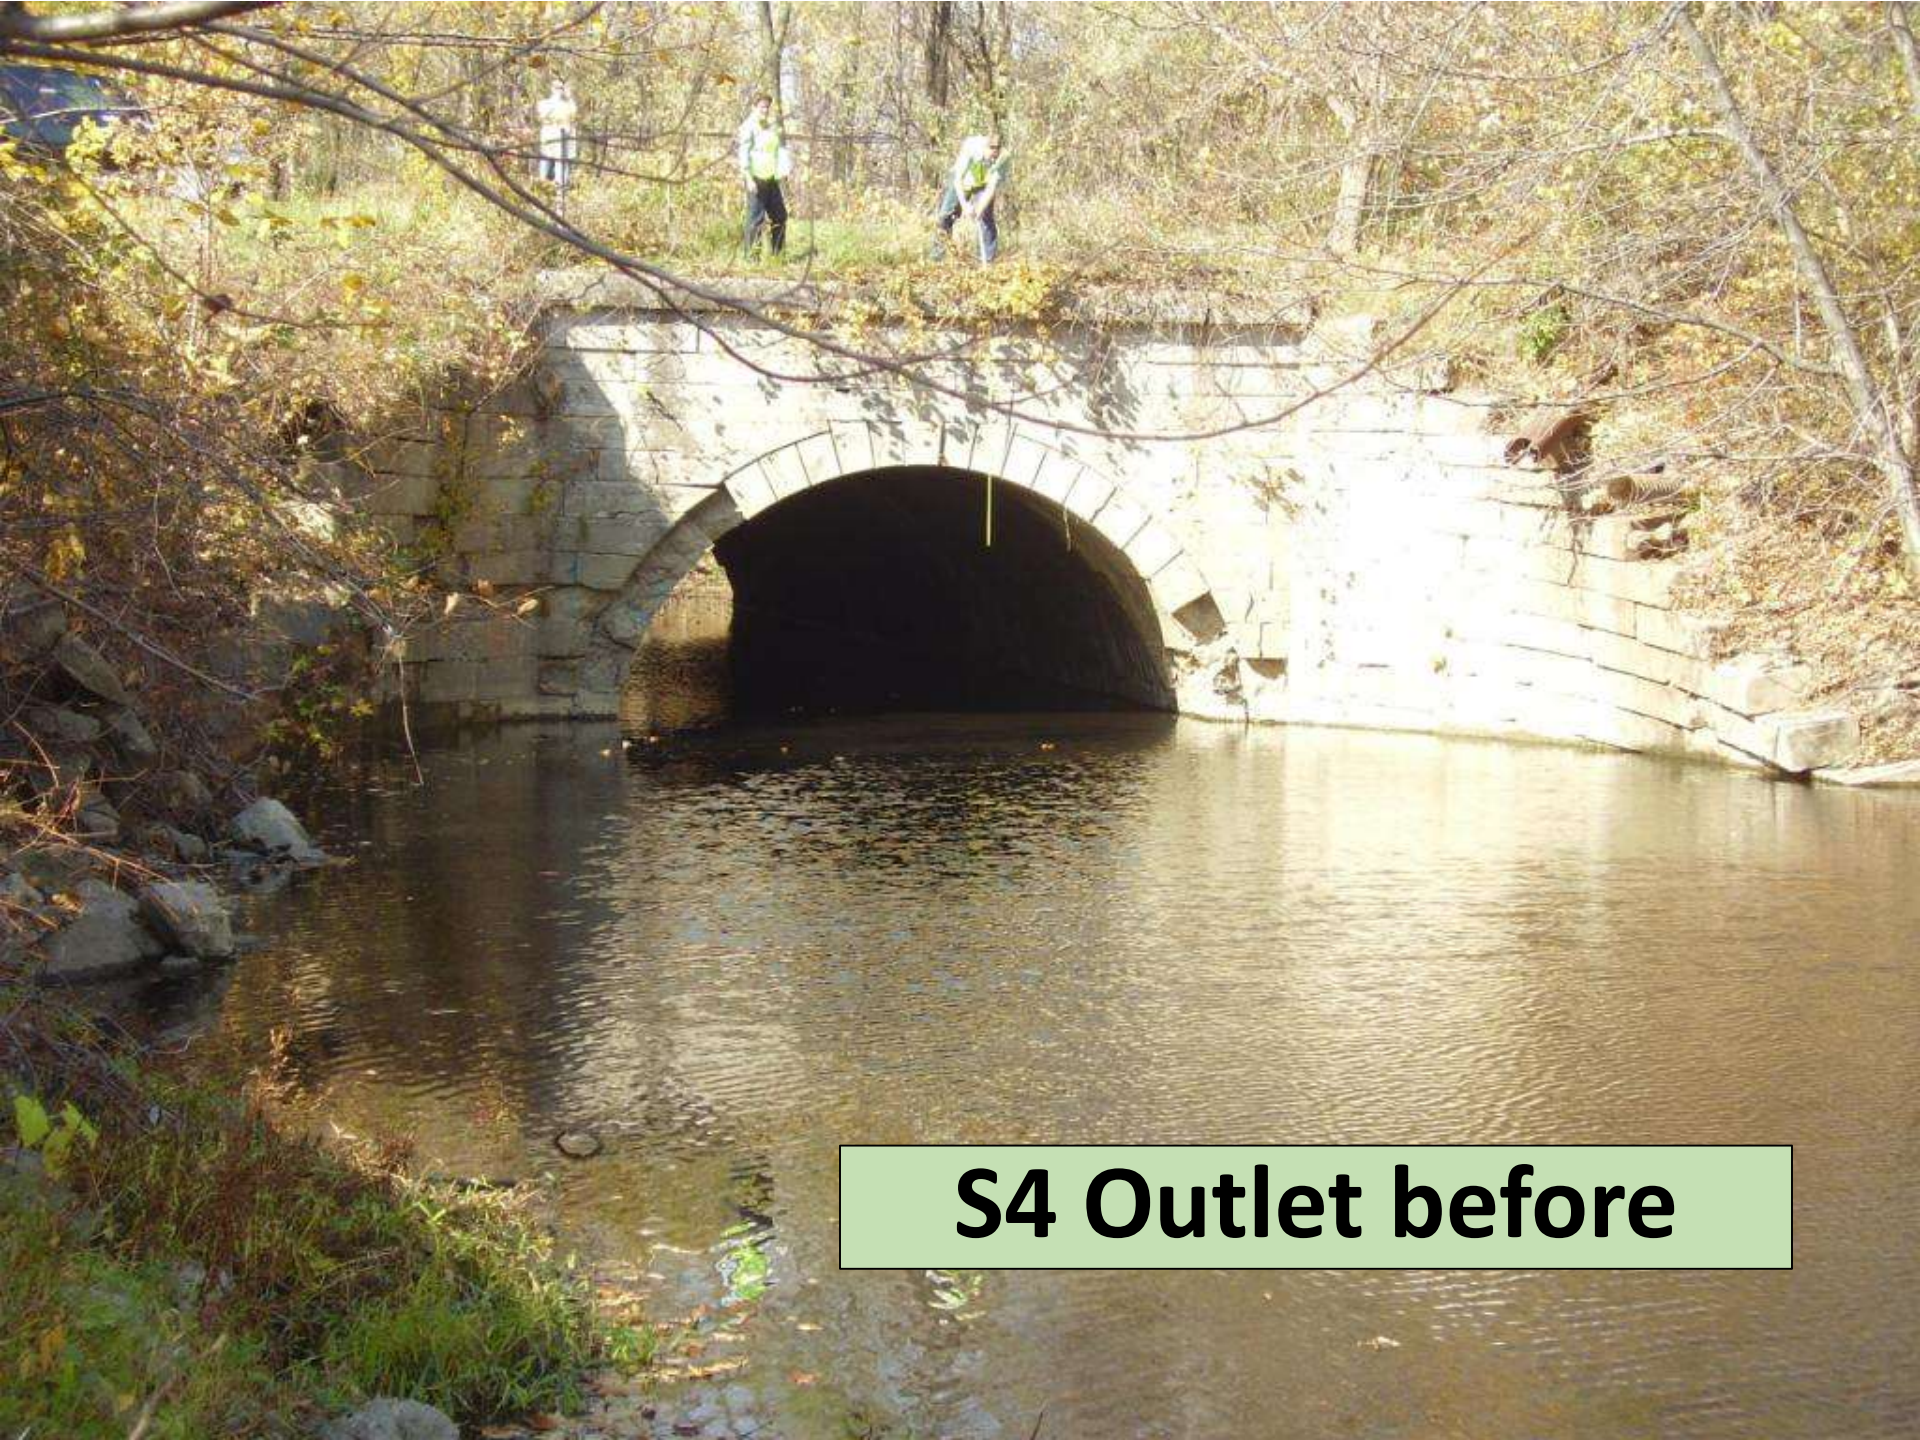
S4 Outlet before

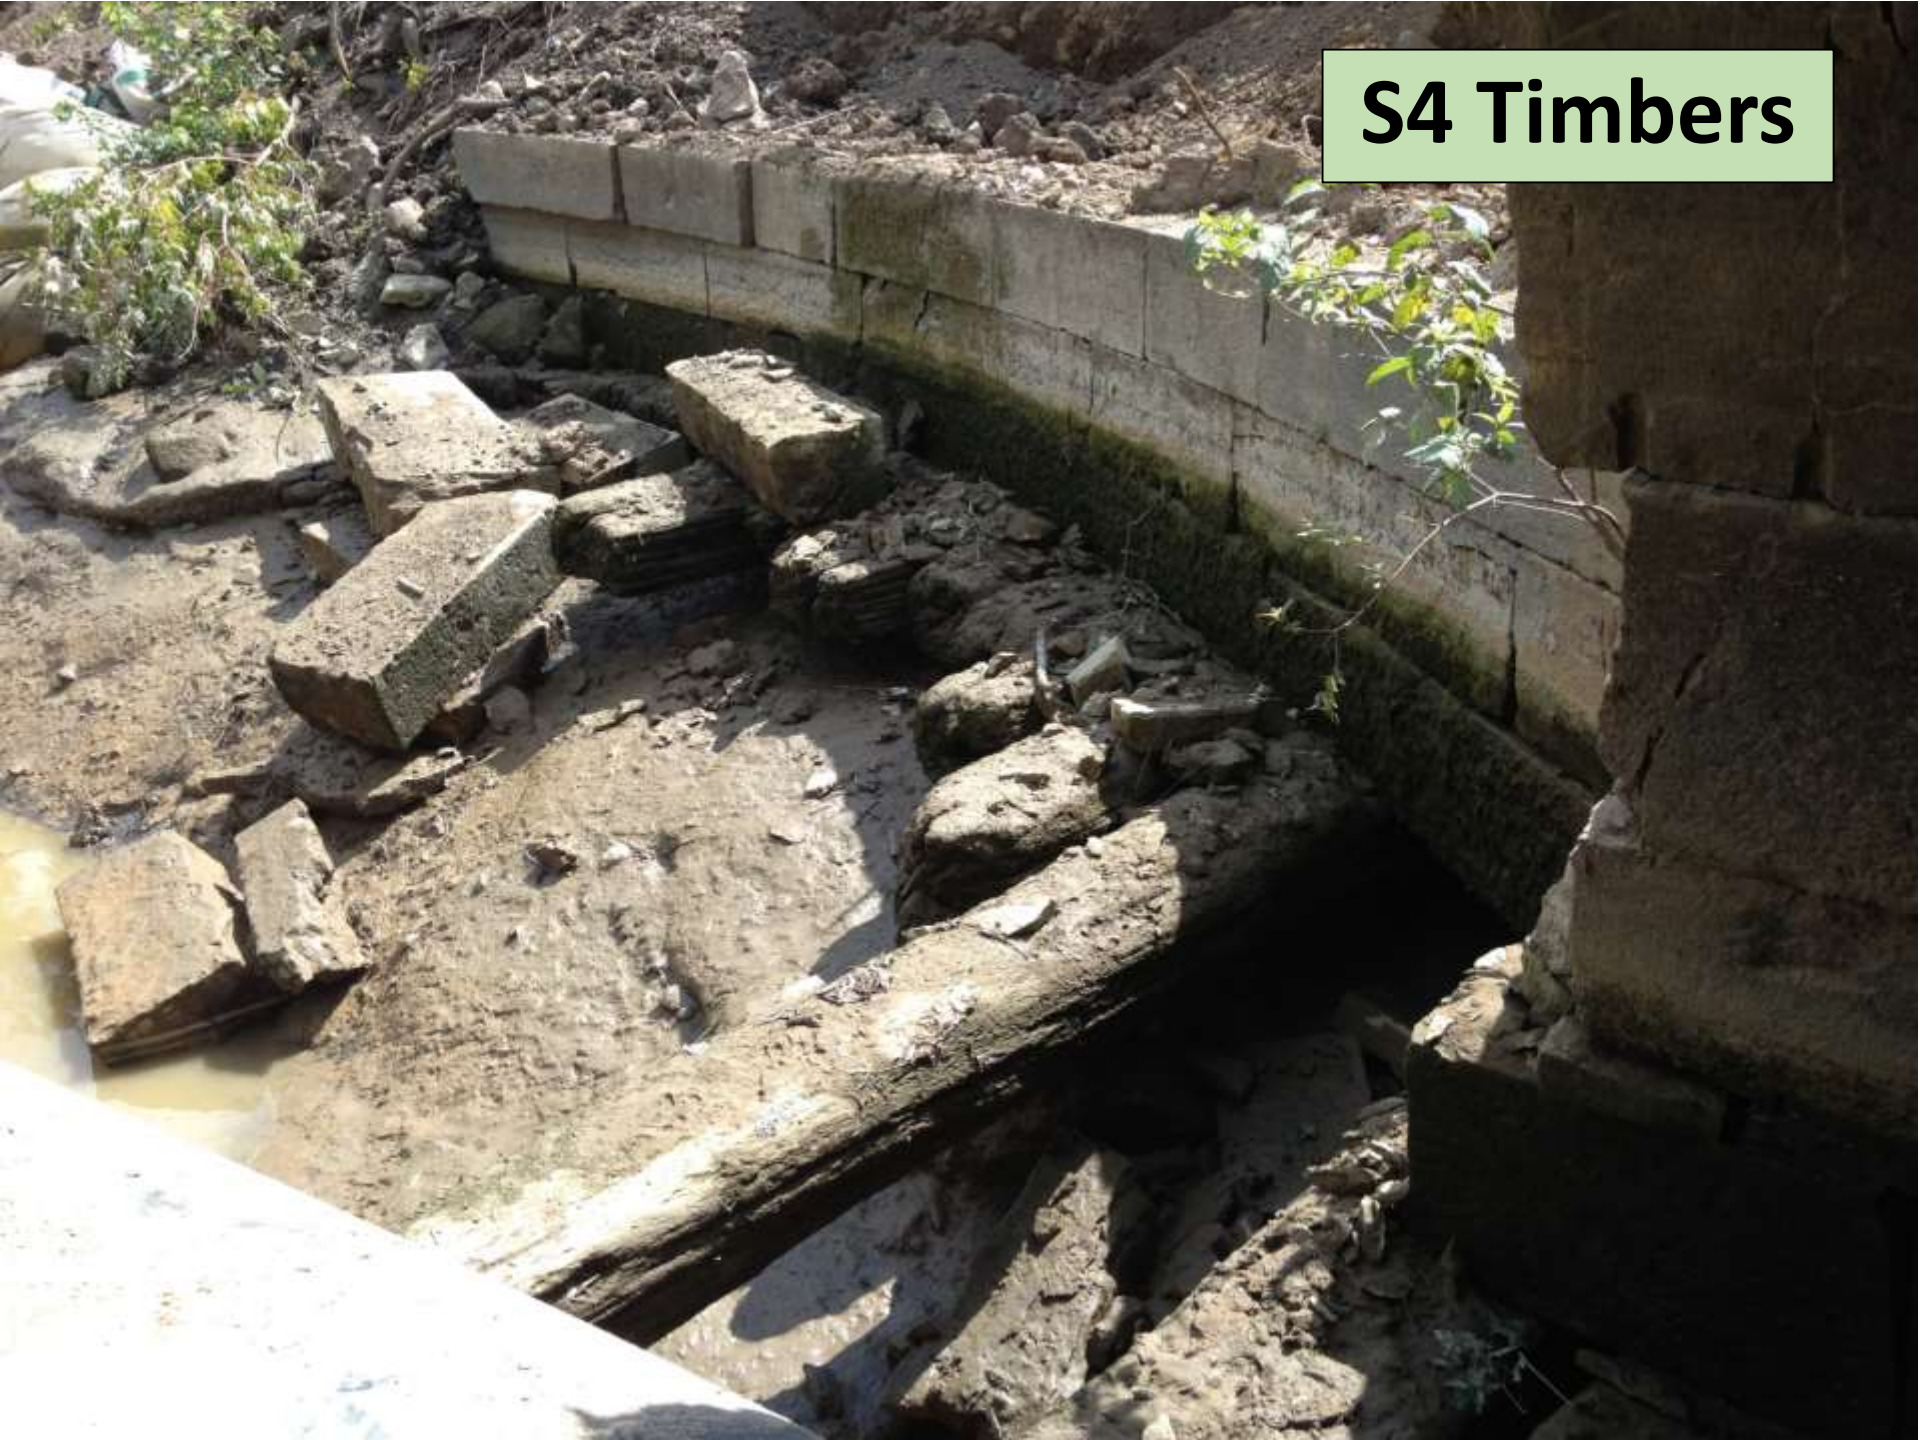
S4 Excavation

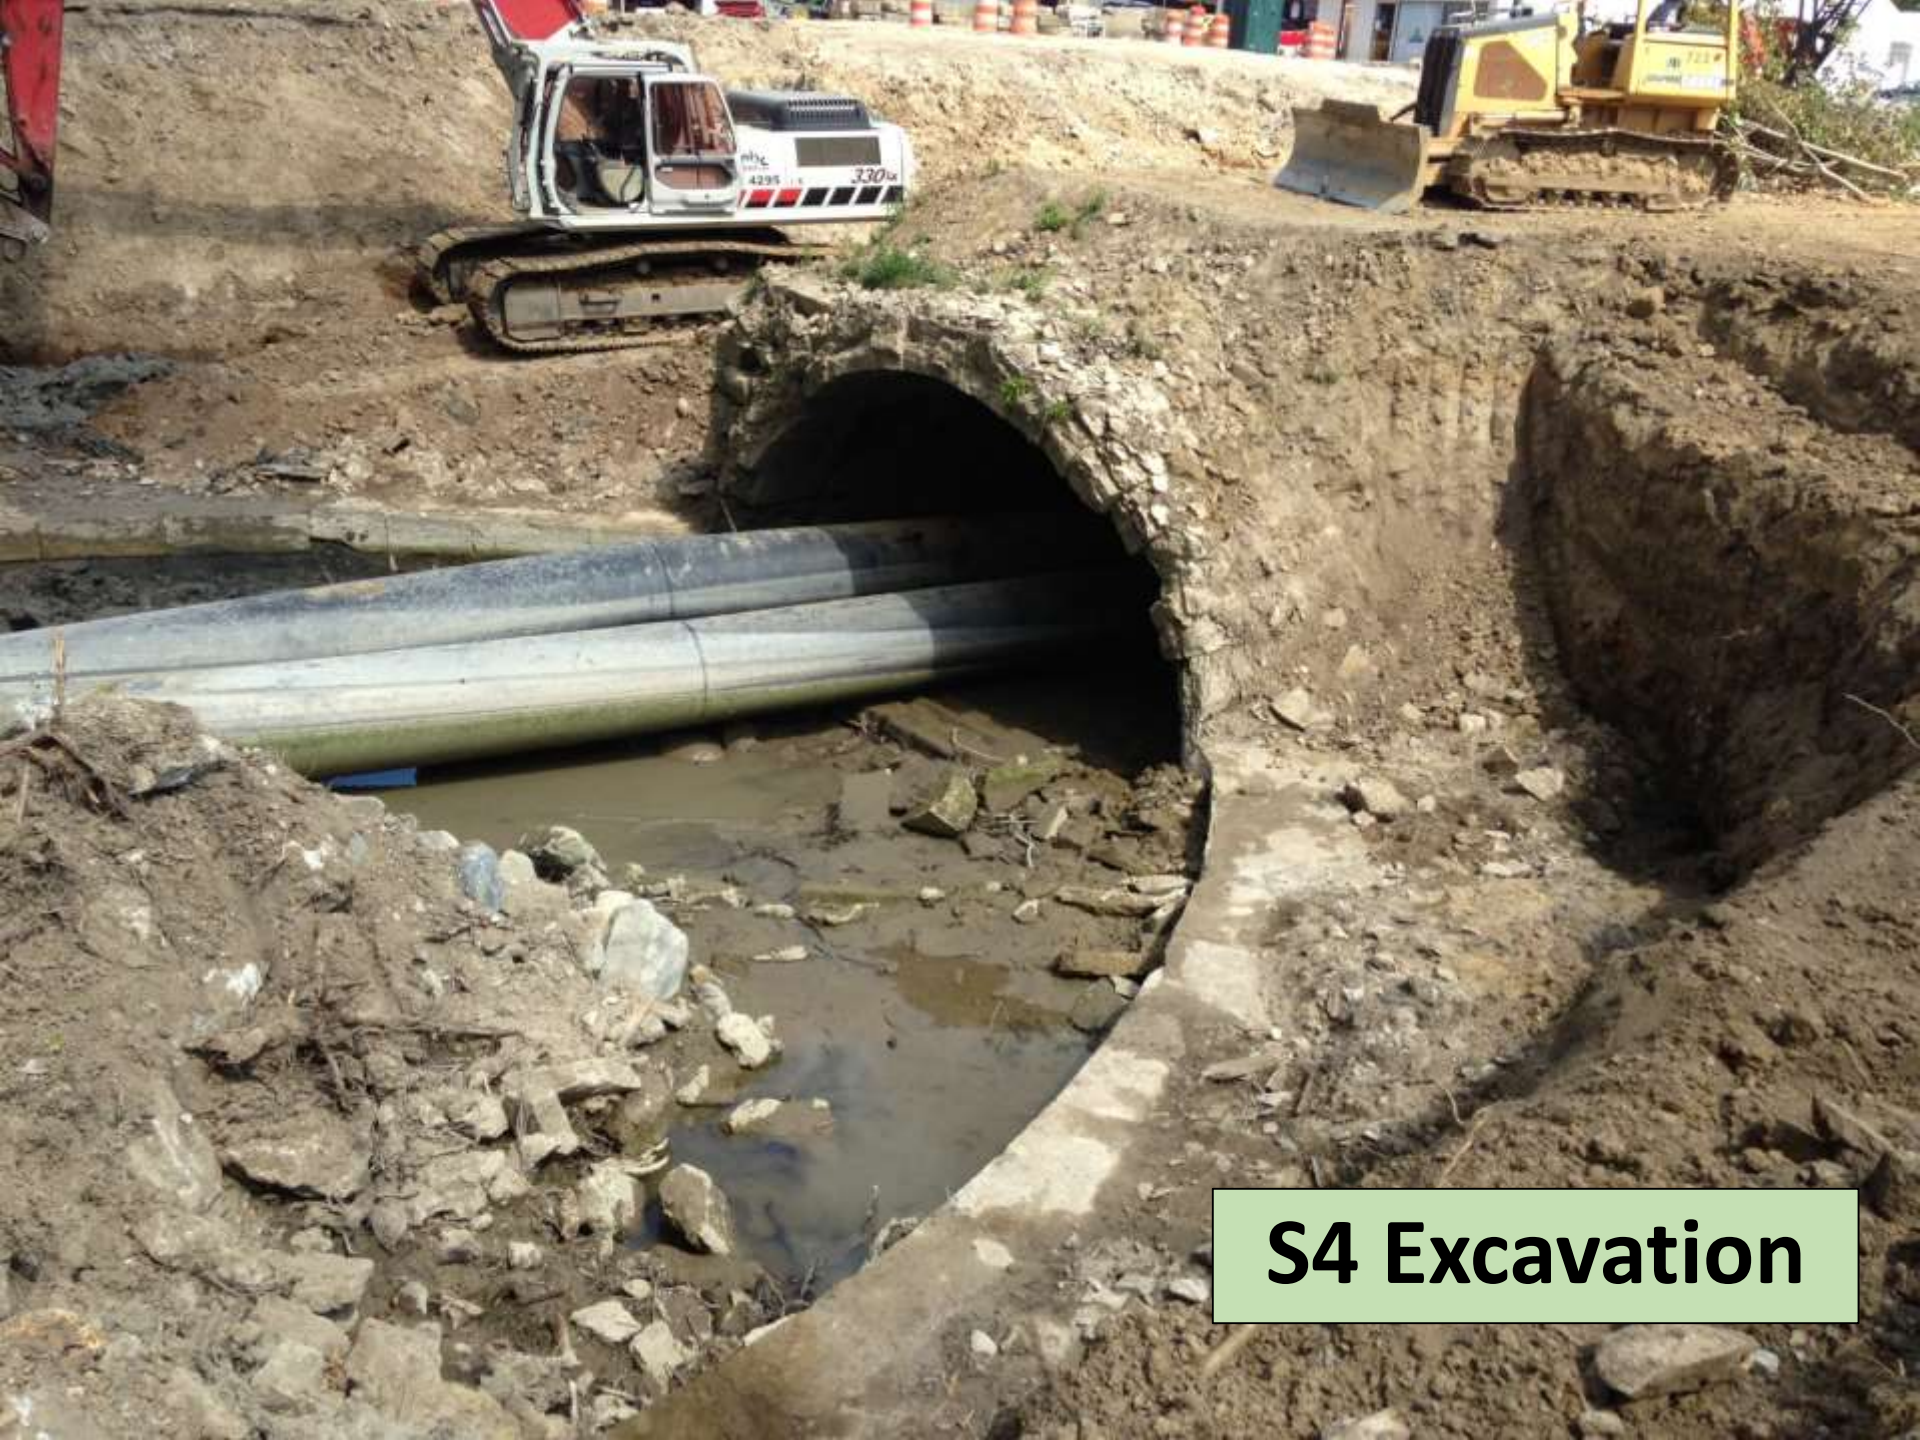
S4 CMP Liner installation

- Install 18'x7'8" CMP arch liner inside existing arch.
 - Liner sat on CIP footings placed on top of existing timbers.
 - Footings were doweled into existing blocks.
 - Liner was assembled outside the arch and pulled into place with steel cable block & tackle and dozer.
 - Void between the existing arch and liner was filled with LSM. Special procedure so as not to damage the liner
- Pour a new CIP arch ring to match the previous.
- Install wire MSE walls.
- Remove and reassemble headwalls & wingwalls.

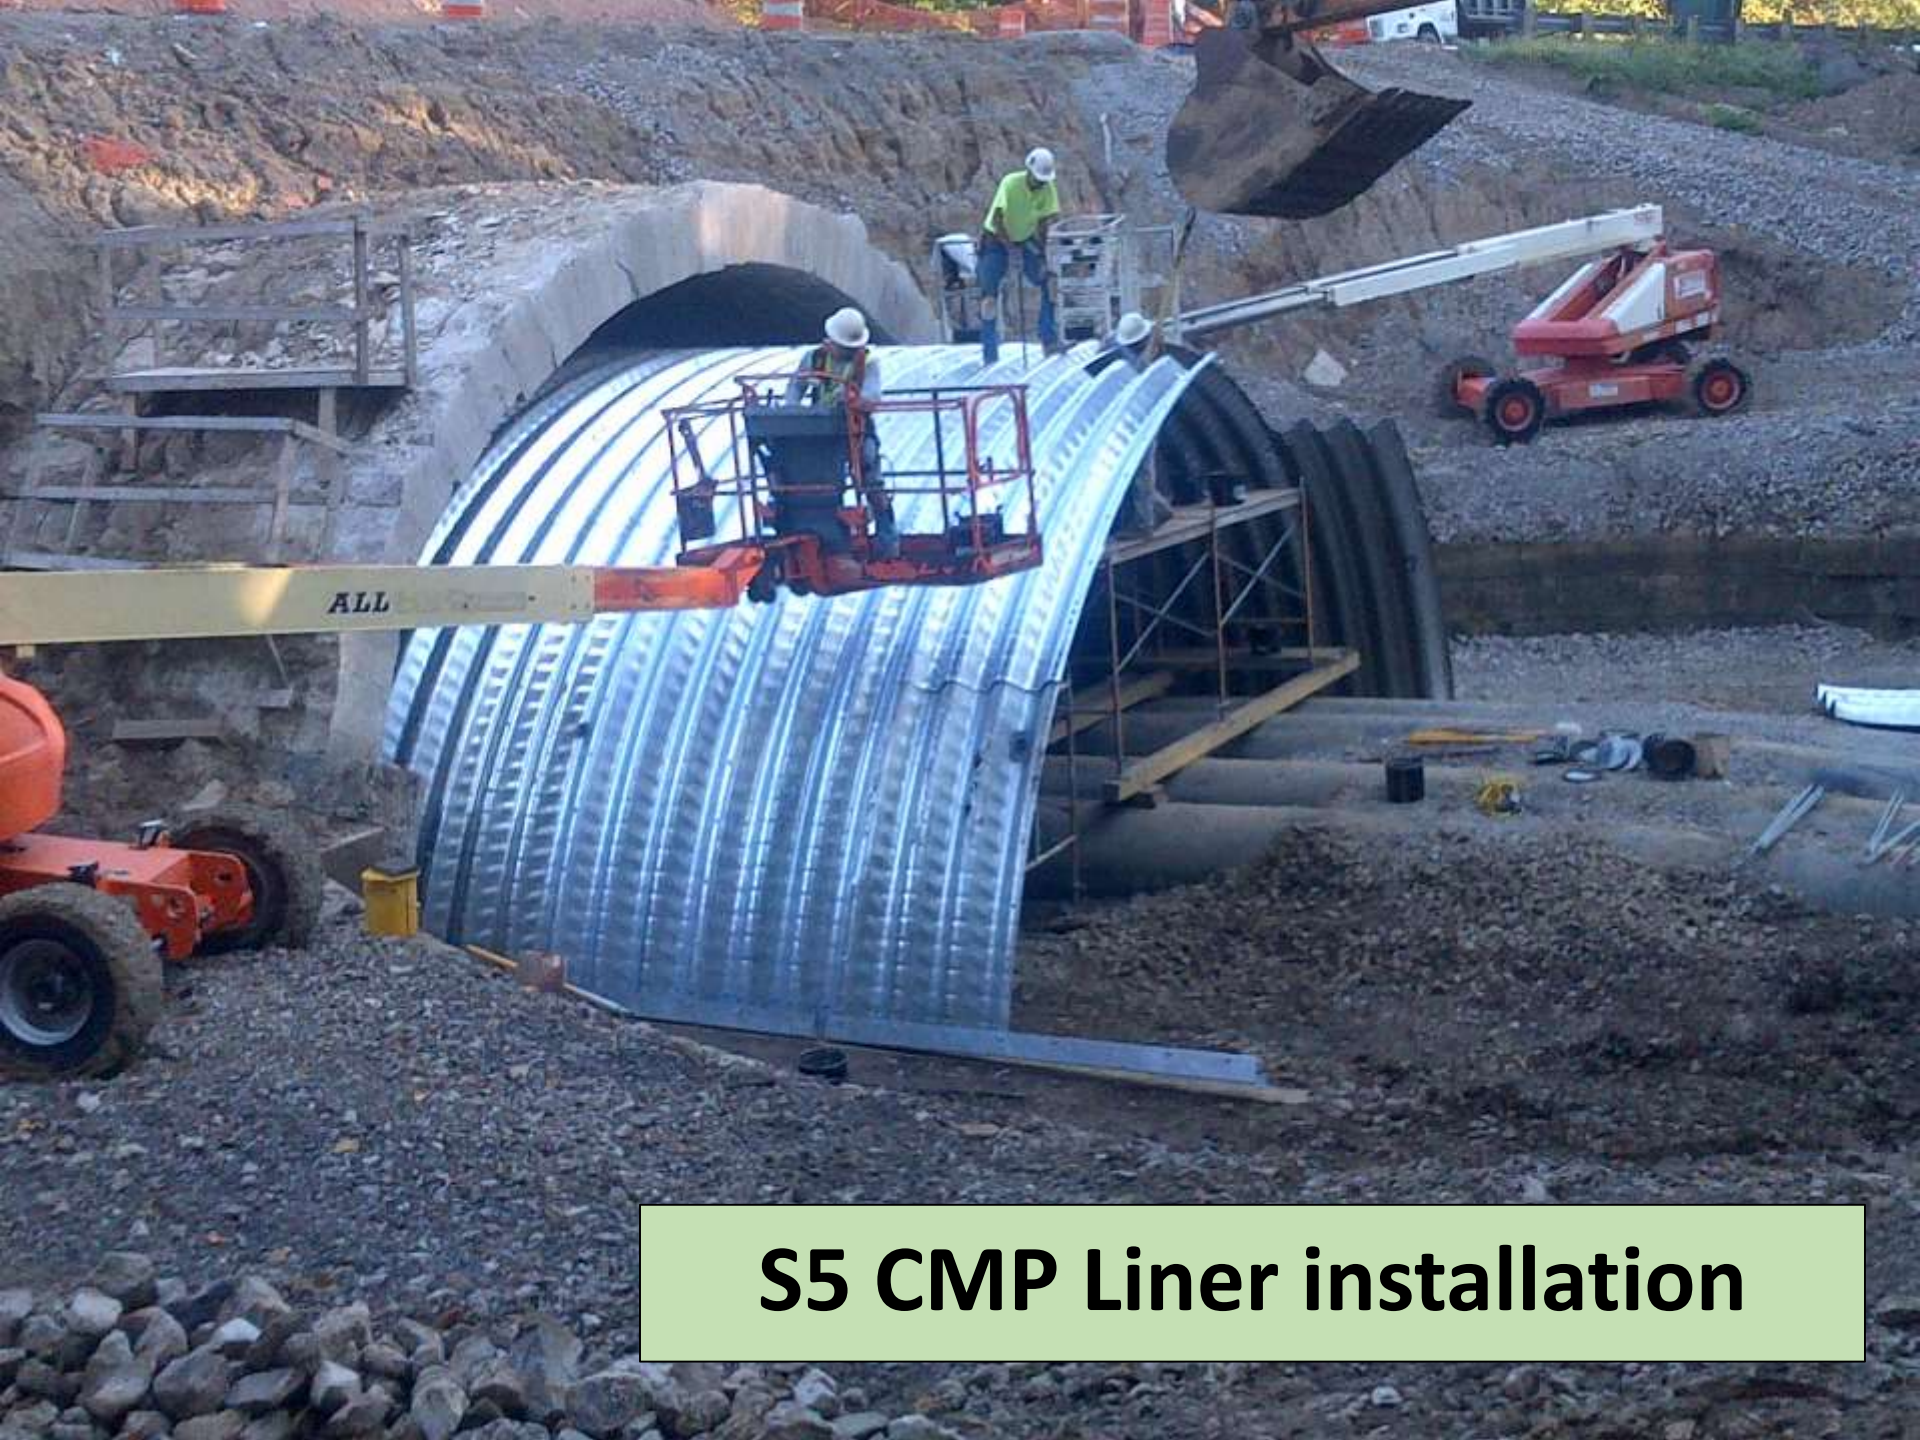
S5 CMP Liner installation

- Original Work Non-Performed; Re-added to contract due to success of S4 work
- Install 32'8"x13'3" CMP arch liner inside existing arch.
 - Liner sat on CIP footings placed on top of existing timbers.
 - Footings were doweled into existing blocks.
 - Liner was assembled outside the arch and pulled into place with steel cable block & tackle and dozer.
 - Void between the existing arch and liner was filled with LSM. Special procedure so as not to damage the liner
- Pour a new CIP arch ring to match the previous.
- Install wire MSE walls.
- Remove and reassemble headwalls & wingwalls.
