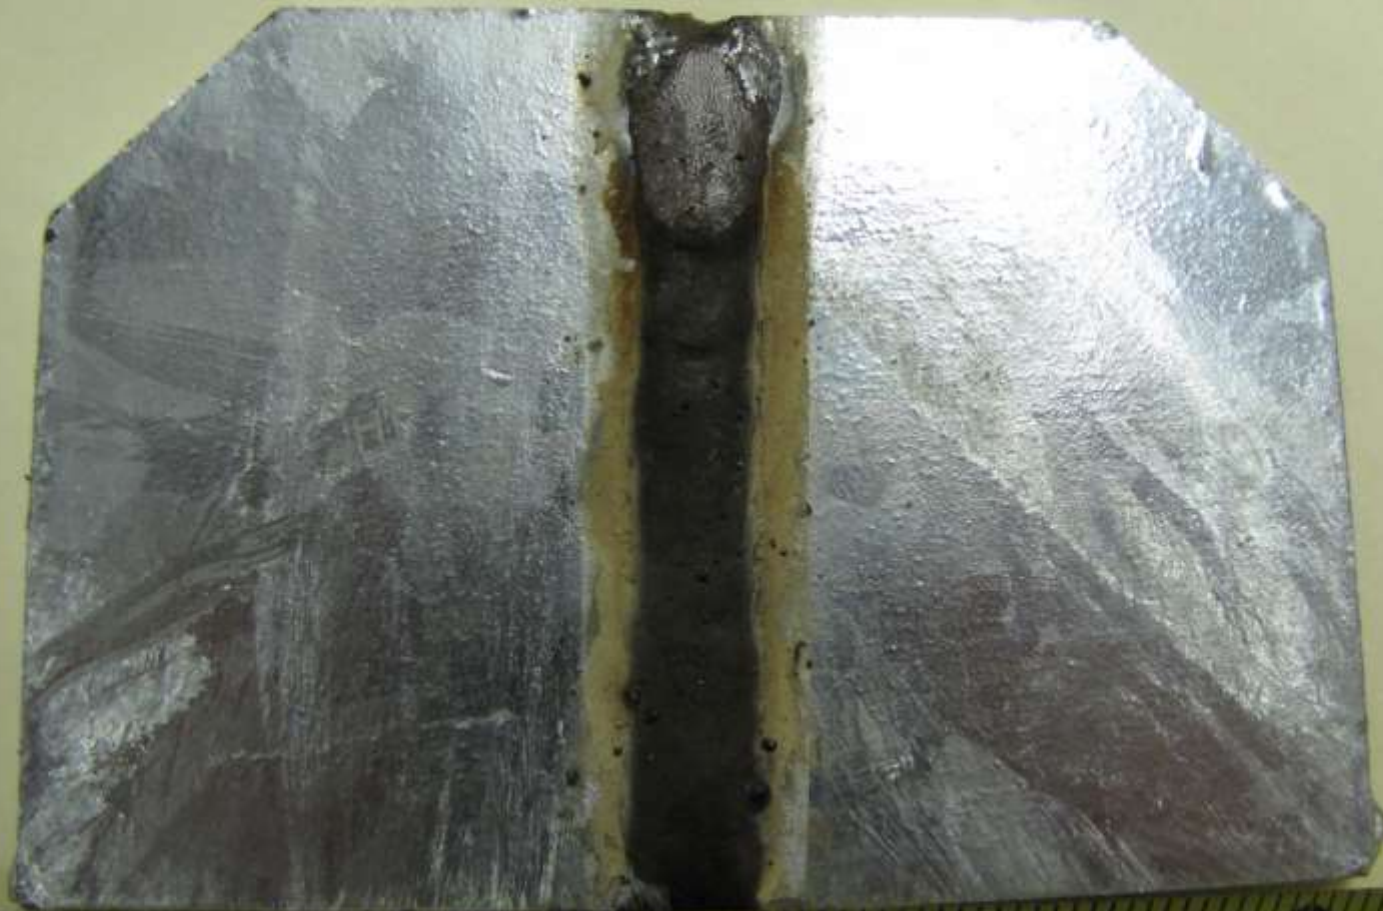
Preparation of Weld Area

“weld area should be free of Galvanizing, 1 to 4 inches back, both sides, top and bottom”

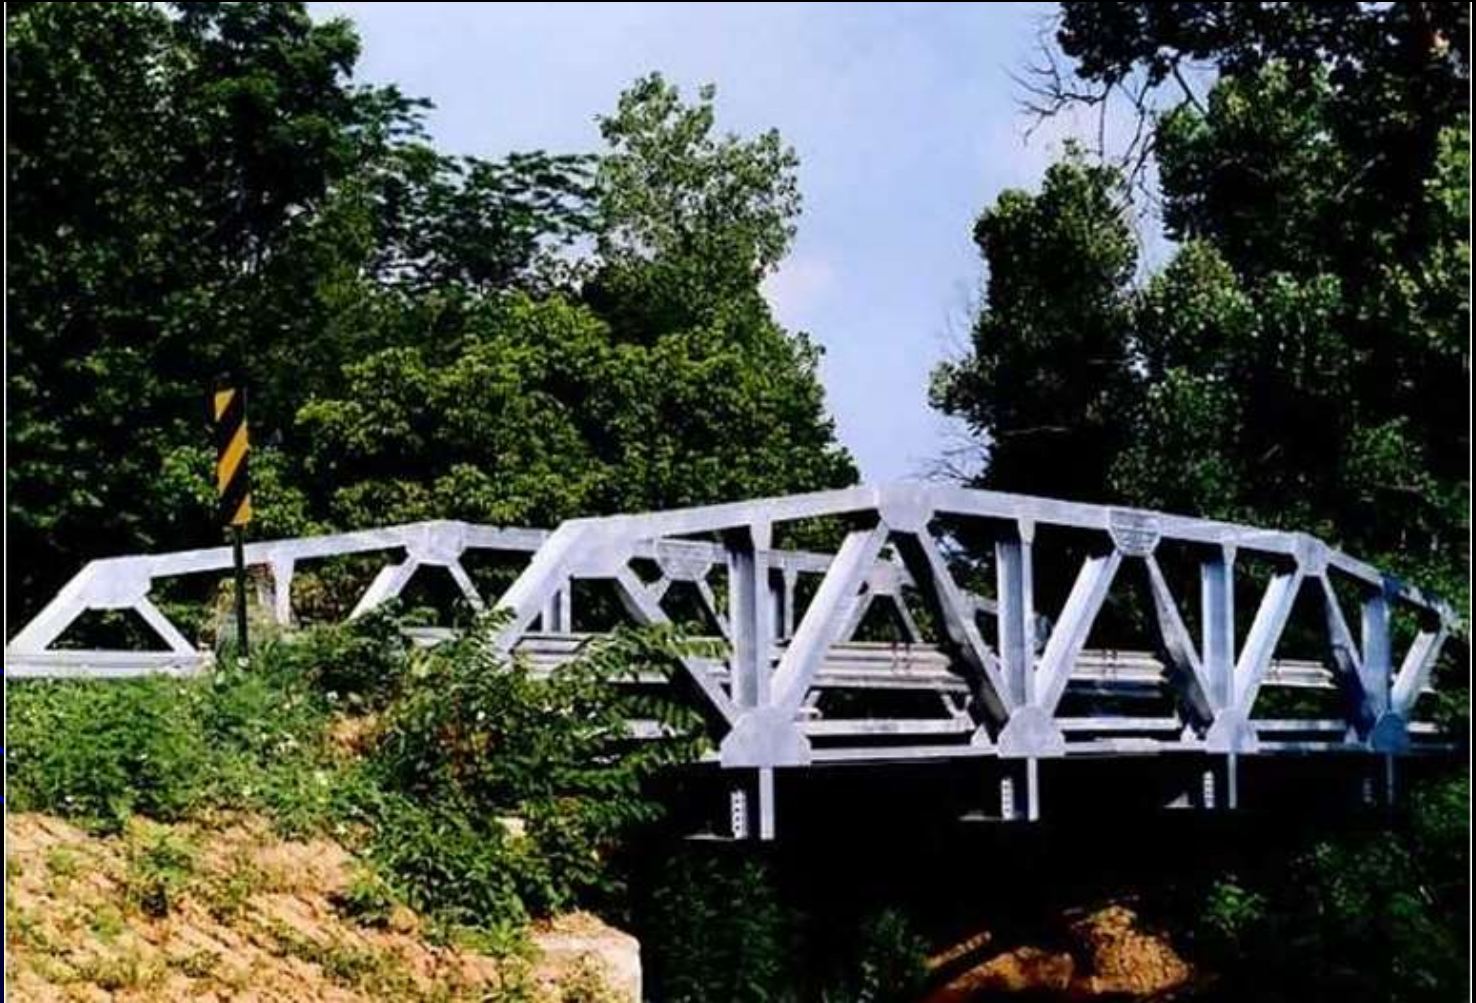
Ohio County Bridge

Cost Study of a truss 129 ft long x24 ft wide

5 gauge galvanized bridge floor

galvanized railing

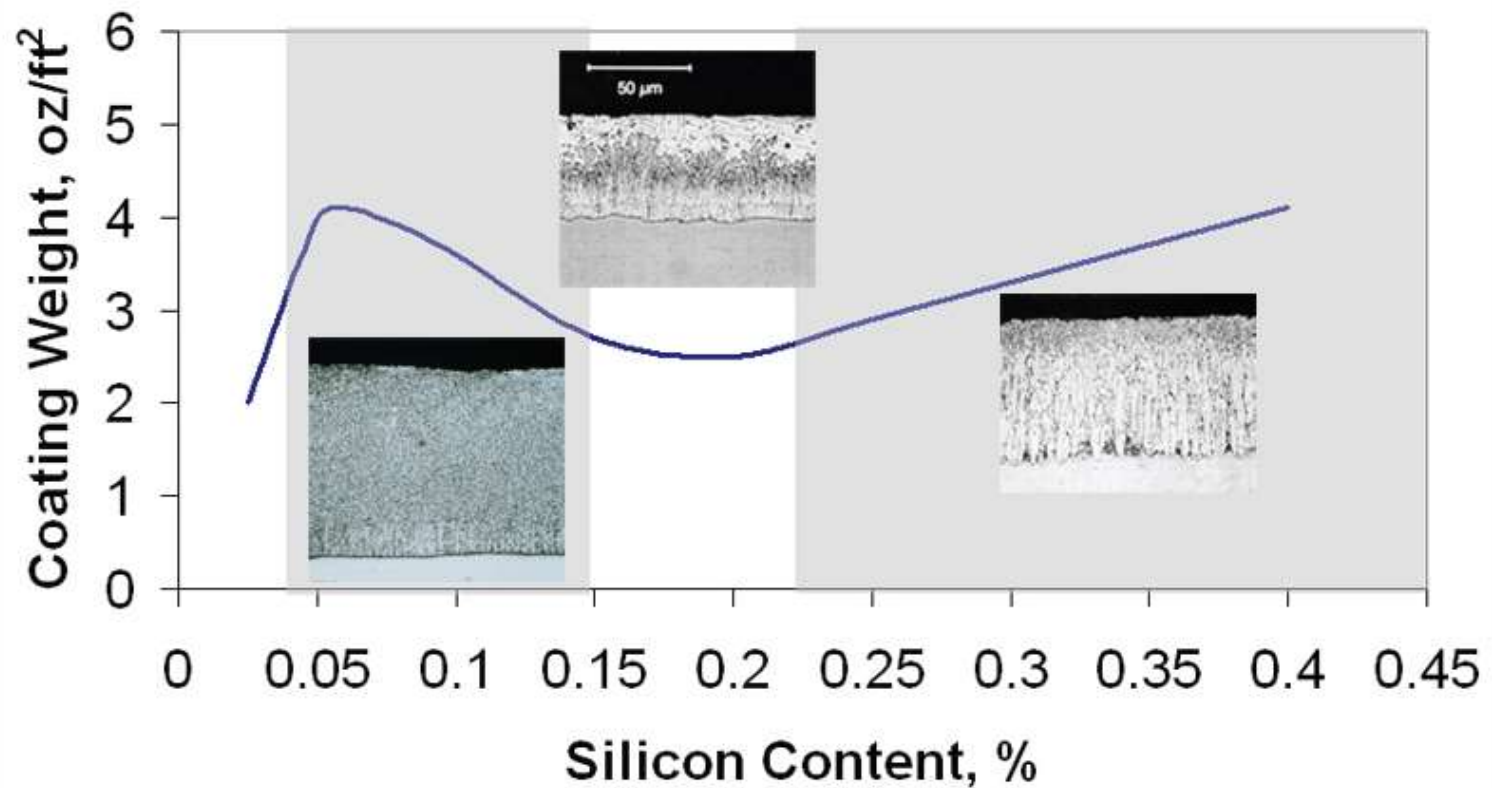
Sandelin Curve

Steel Chemistry

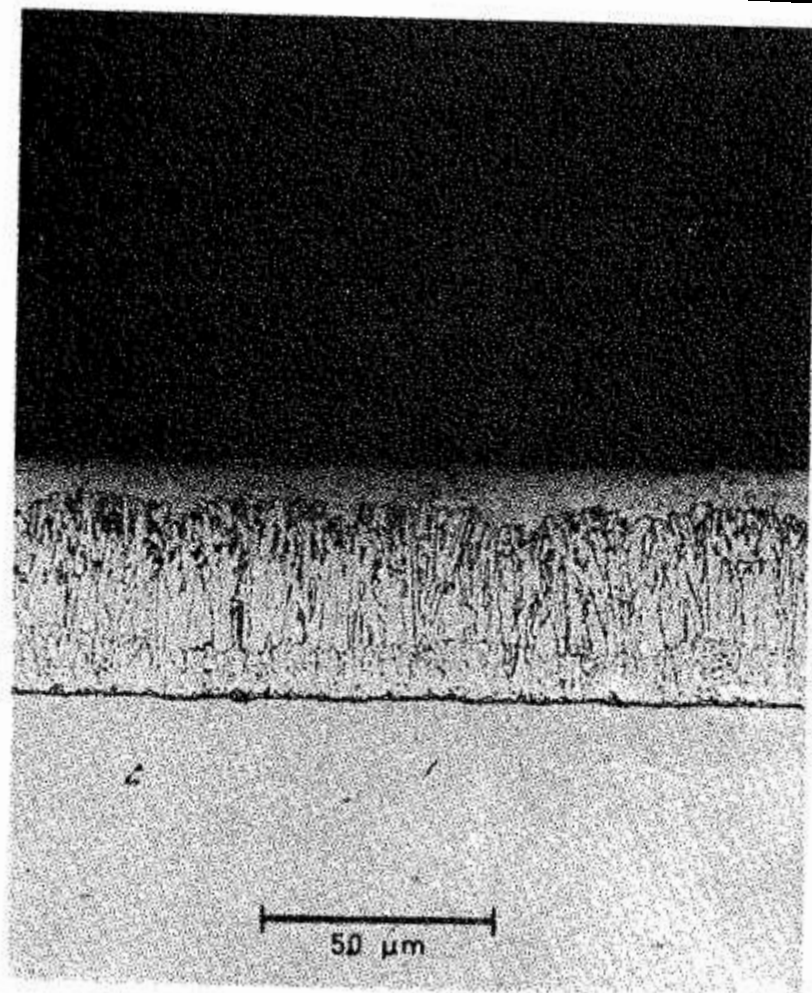
Irregular
Zinc-Iron
Alloy Layers

03% Si

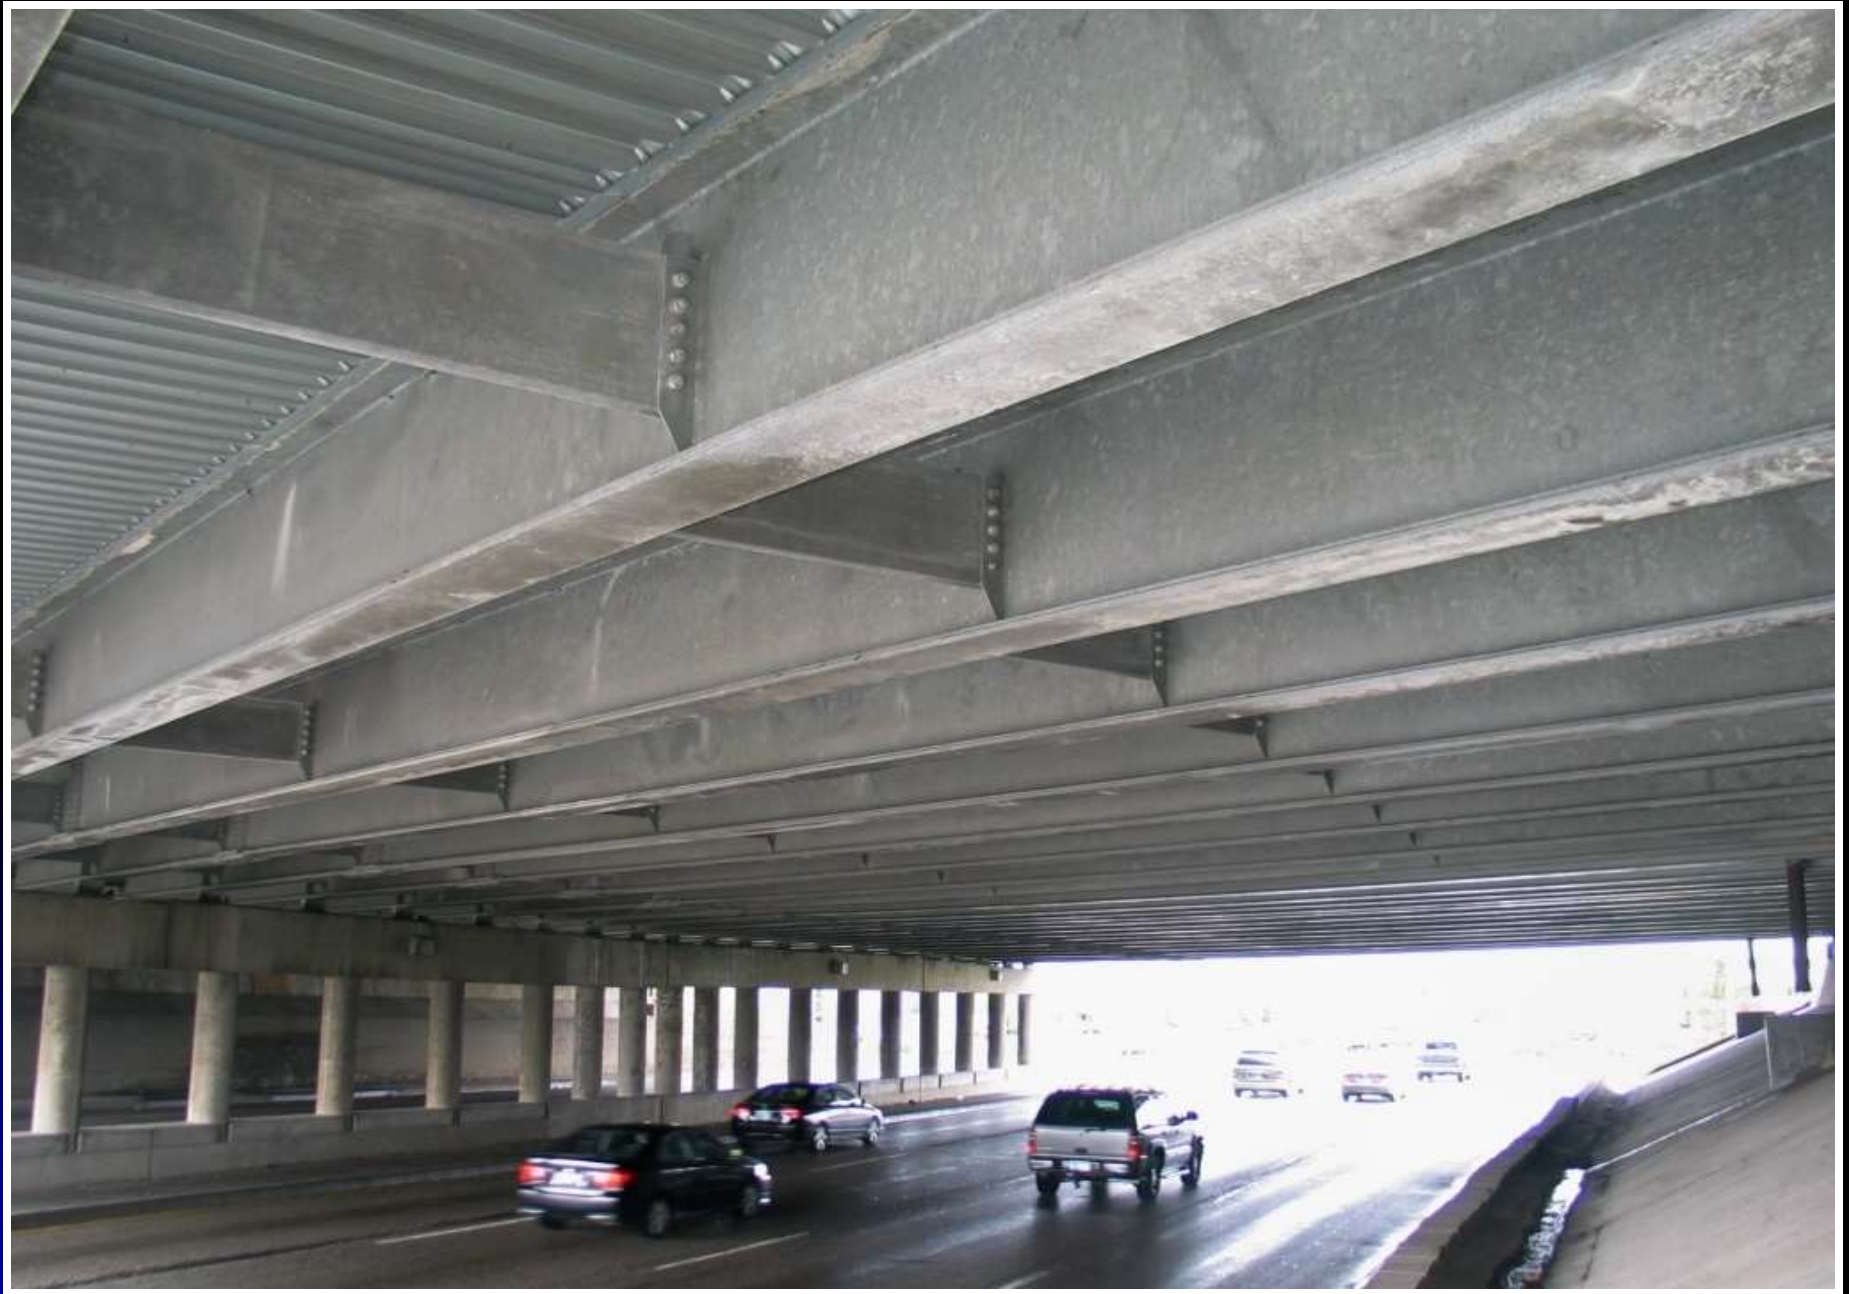
6.20 6.10 7.60
8.90 7.70

7.60 8.00 5.70
5.50 7.40

$\bar{X}=6.82$

Beam 1

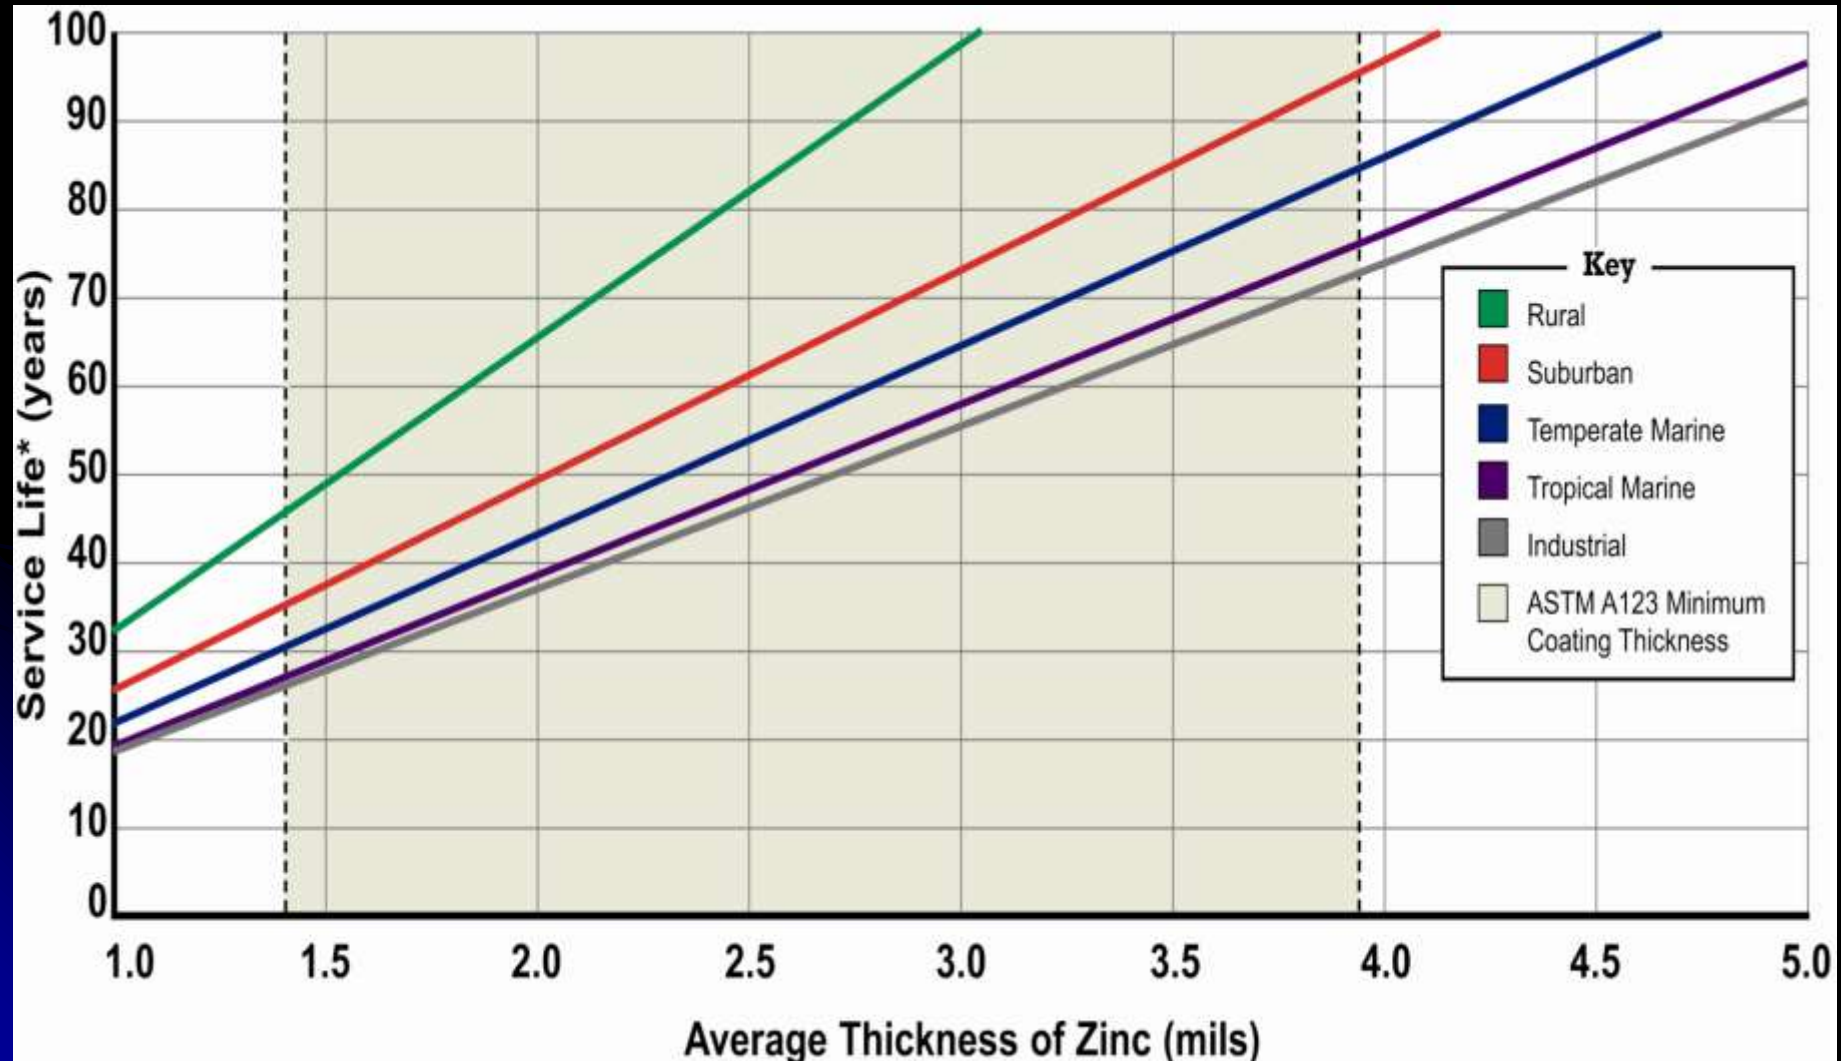
Estimated Service Life of HDG

*Service life is defined as the time to 5% rusting of the steel surface. 1 mil = 25.4 μ m = 0.56oz/ft²

Zinc Coating Life Predictor

- Anticipates service life
- Program performs calculations
 - Statistical methods
 - Neural network
 - technology
 - Worldwide corrosion database
- Atmospheric categories
 - Rural
 - Suburban
 - Temperate marine
 - Tropical marine
 - Industrial
