# National Bridge Inspection Standards & Bridge Maintenance Program Review

## Knox County

June 18, 2021

By: Mark Sherman, PE

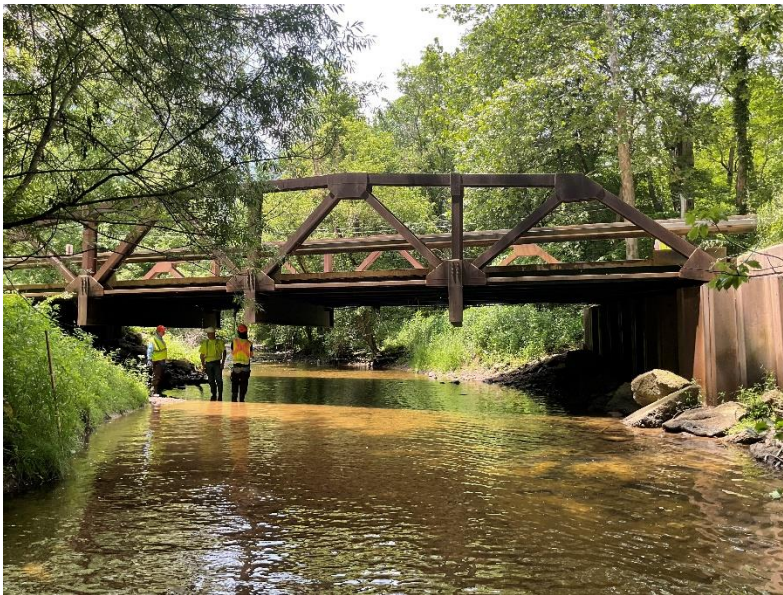
Pic taken during field review.

Channel Photos: Could find no channel photos in Assetwise ( need upstream and downstream photos like that below.
