Quality Assurance Review National Bridge Inspection Standards & Bridge Maintenance Program

Champaign County

August 18, 2022

By: Mark Sherman, PE CEAO Federal Bridge QA/QC Engineer

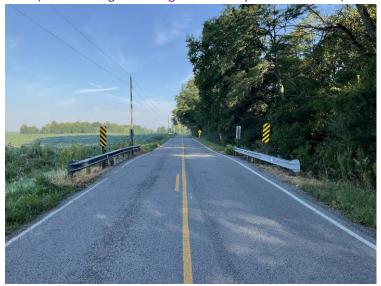
- Item 59 Superstructure.....6 (While the beam joints have leaked, it has been waterproofed and there is no salt residue and no delamination with every beam sounding solid. This could easily be a 7 for those reasons, even if the manual suggests otherwise.) The facia condition is a low 6 or even a 5, but that is not a governing factor for the overall condition rating of the superstructure. The 1 point over/under rule applies, so there is no need to change the rating, but both the deck and super need to match.
- Item 60 Substructure.......7 Agreed (This could go to a 6, if the delaminated areas make up a significant percentage of the abutment face from the facia inward, not the wingwalls. I quickly made a rough estimate of about 96 Sq. Ft. total, evenly split between abutments.)

Item 61 Channel.....7 Agreed Item 61.01 Scour.....7 Agreed Item 62 Culvert..... N

Item 36 Railing...... 0 0 0 0 Agreed (posts and anchorages missing) Item 72 Approach Alignment6 (Could be higher with good visibility and no curves.)

Comments: One of the oldest prestressed boxes in Ohio (1954) very good comments in Assetwise. Defect Photos: None in Assetwise, but good defect photos on file. Channel Photos: Great Channel Photos in Assetwise

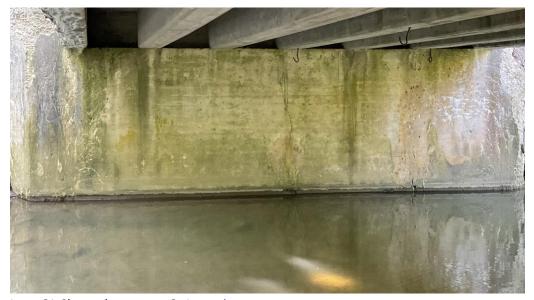
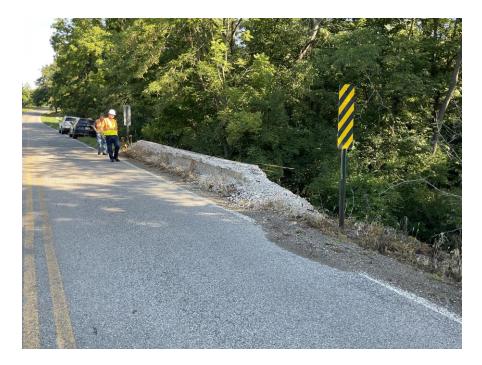
CHP-T0149-0019_(1131222) Concrete Tee-beams (check item 43? It is coded 103. Should be 104)

Item 59 Superstructure......5 Agreed (Facia beams are bad, but the interior beams are fair.)

Item 72 Approach Alignment8 Agreed

Comments: Very good comments in Assetwise.

Defect Photos: Good photos in bridge file, but could use a few broader angled shots to put the defects into the context of the larger member and bridge in general. That gives the needed extent and location added clarity.

(Follow up Comment: Safety Barrier installed within 4 weeks after the field review.)

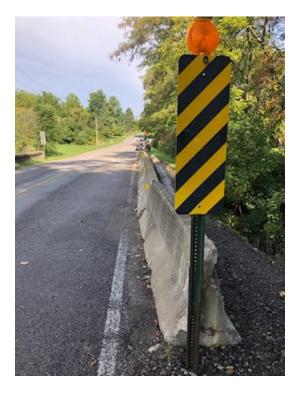
CHP-C0025-0152 (1130641)

Prestressed Box-beams

Item 58 Deck
Item 59 Superstructure 6 Agreed Joints have leaked in the past, but are dry now. Concrete areas at
the joints are distressed, but no loss of concrete yet.
Item 60 Substructure
Item 61 Channel
Item 61.01 Scour7 Agreed
Item 62 CulvertN Agreed
Item 36 Railing 1 0 0 0 Agreed
Item 72 Approach Alignment8 Agreed
Comments: Good Comments
Defect Photos: Good photos
Channel Photos: Great Channel Photos

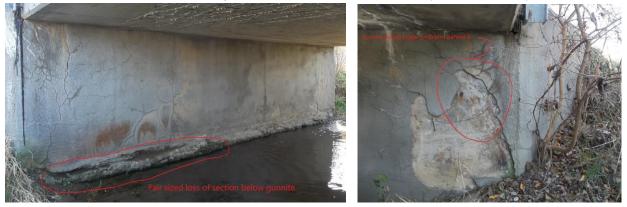
Concrete Slab

Item 58 Deck......8 Slab is the superstructure, so it has to agree with the superstructure rating. Item 59 Superstructure......6 Agreed

Item 62 Culvert.....N Agreed

Item 36 Railing...... 0 0 0 0 Agreed

Defect Photos: Great defect photos in bridge file, but should post some of them in Assetwise. **Channel Photos:** Need channel photos from both up and downstream in Assetwise. You have good ones from downstream. Upstream photo needs to have more visible.

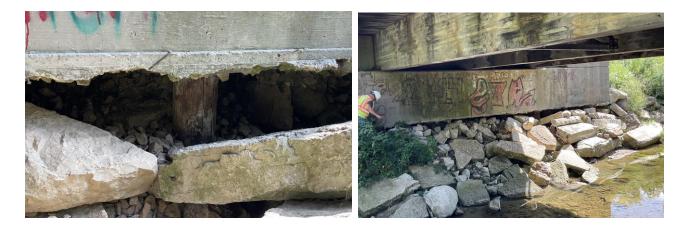
Item 58 Deck..... 7 Agreed

Item 59 Superstructure......7 Agreed

Item 61 Channel......8 Agreed

Item 61.01 Scour............7 According to the manual this should be a 4. Fortunately, it is an easy fix and does not warrant drastic measures. This should be fixed soon, to bring everything back up to a 7 or better. Comparing today's photos with the 2021 photos, it appears to be stable. The 2003 photos look like it might be just the initial stages of scour.

(Follow up Comments: Repairs installed shortly after the field review, bringing Scour back up to 7)
