**Quality Assurance Review  
National Bridge Inspection Standards &  
Bridge Maintenance Program**

**Hamilton County**

**April 19, 2022**

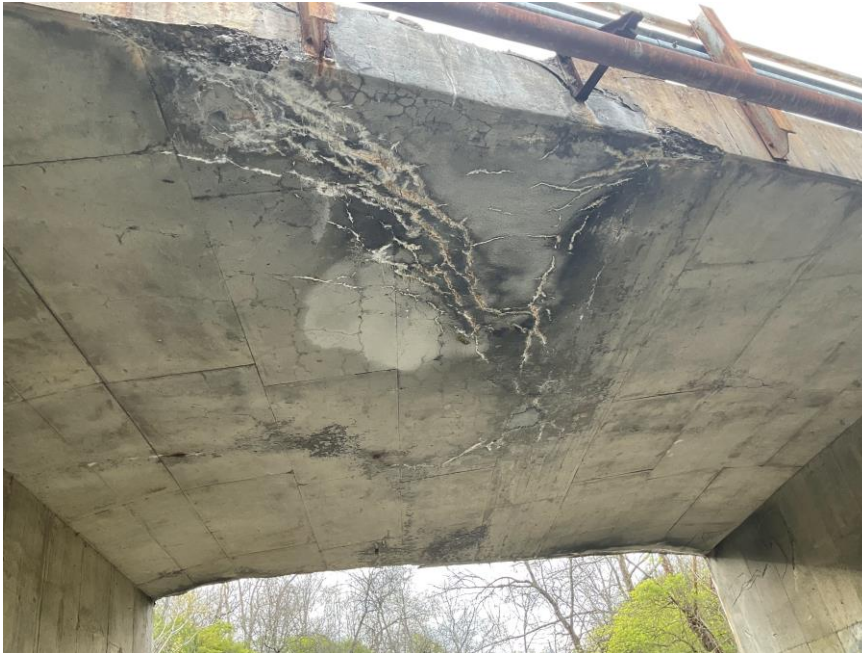
Defect Photos: Defect photos in Assetwise needed to show the extent. (A picture of the entire slab bottom would be great, like the one below.)

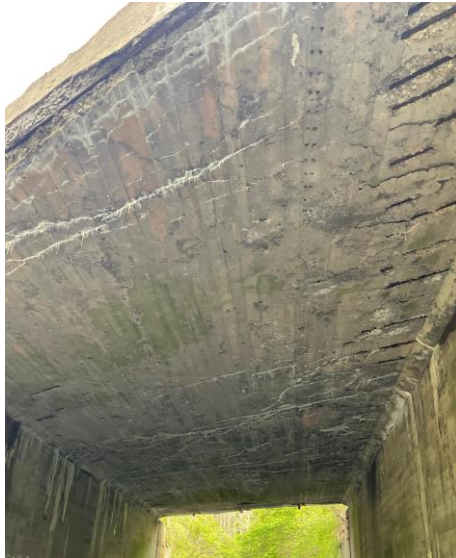
**HAM-C0358-0276\_(3132676) Concrete Frame**

- Item 58 Deck..... 7 Like the first bridge, it appears that there is no deck beyond the frame slab, so it has to be rated as the super is rated.
- Item 59 Superstructure.....5 Agreed Given the cracking, efflorescence and almost every bar exposed, this is rapidly approaching a 4 with the next inspection.

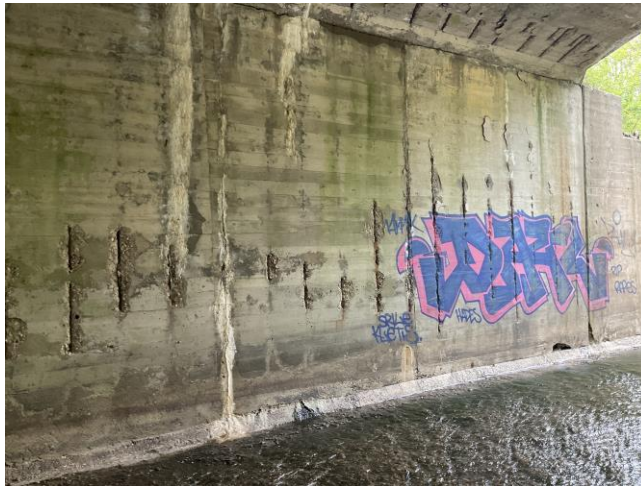
Item 60 Substructure.....5 Agreed

Defect Photos: A couple of good defect photos in Assetwise. Could use a view of the abutment spalling though, like the one above. If photos like this are in the bridge file, that is great and acceptable, but it would be nice to see one posted too.

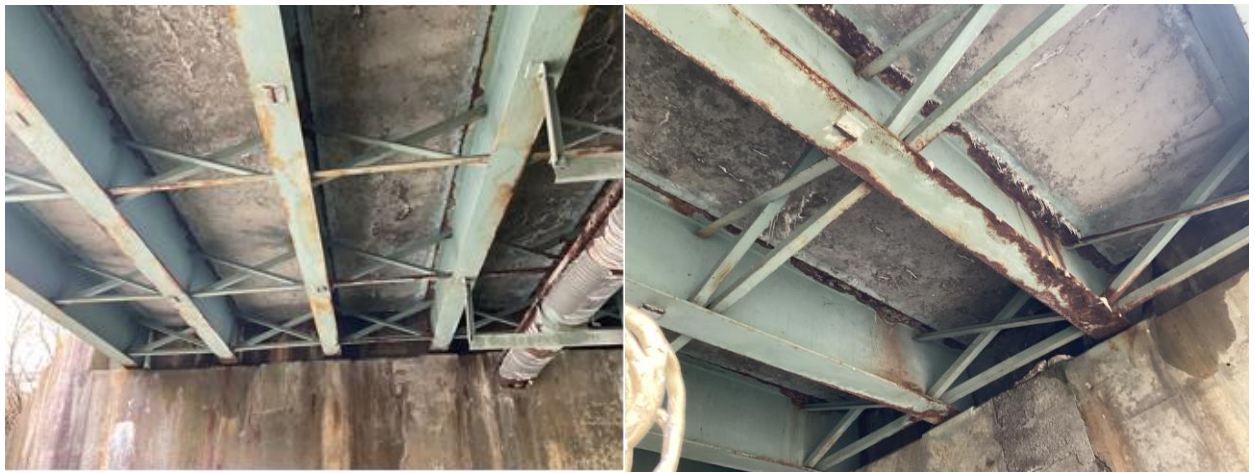
Defect Photos: Good Photos in general. Could use a closer one of the rusted portions of the beams. Plus, a good representative shot of the deck, like these.

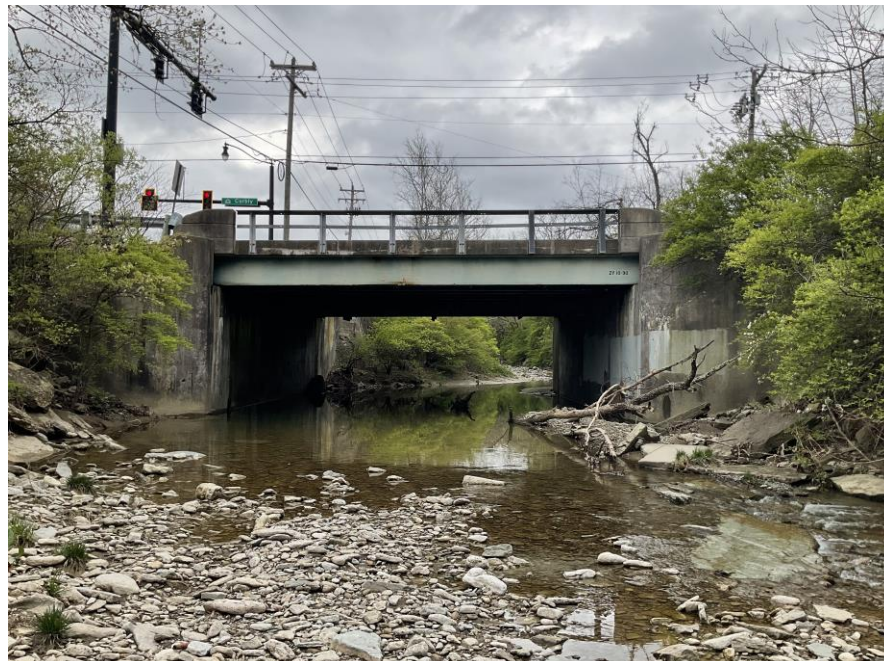
Channel Photos: Channel Photos need to look more like this one, where both abutments can be seen as well as the channel banks.

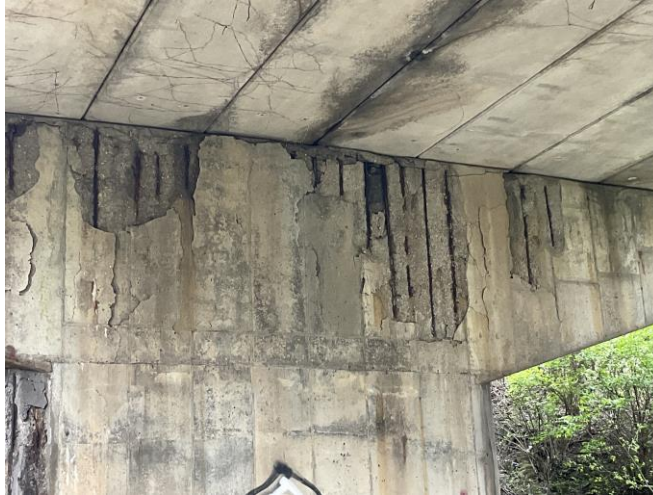
HAM-C0374-0277\_(3133699)

Item 60 Substructure..... 5 The abutments look good, one pier is problematic. This is a difficult one to assess because the overall area is not as impacted by the spalling. The stems are clean except the ends, but the hammerhead has extensive spalling on both sides. Since the hammer head experiences a variety of high stresses, and about 75% is spalled, I am leaning toward a 4 on this pier. While that still puts them within the 1-point rule, I would remeasure the spalled areas and re-evaluate the piers with the next inspection.

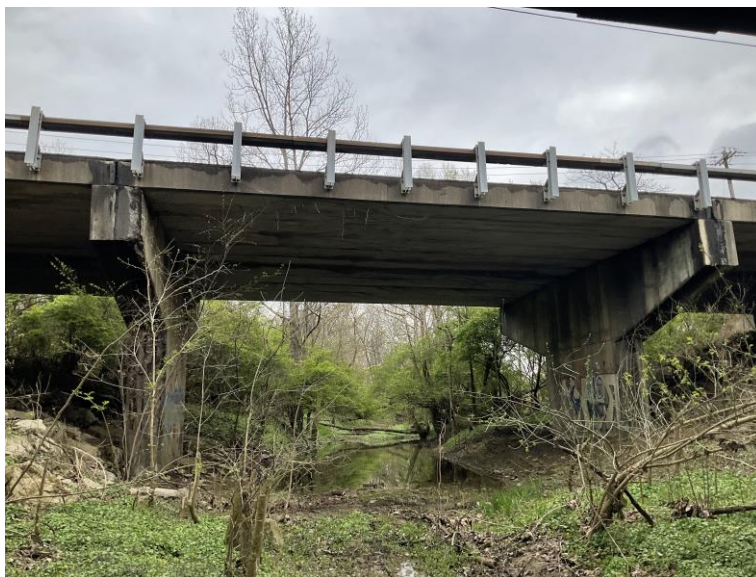
Channel Photos: Channel Photos in Assetwise are adequate for such a large bridge with a narrow channel

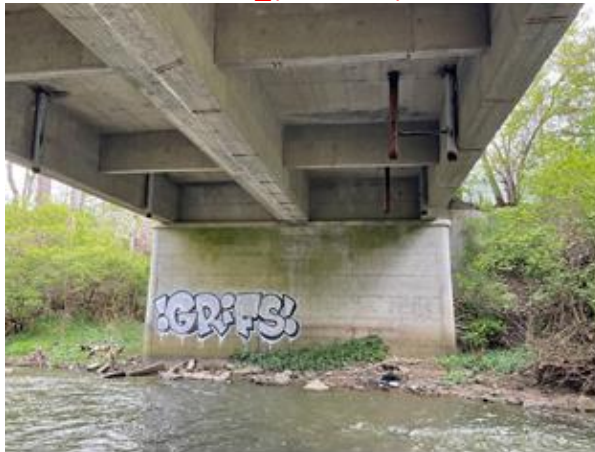
**HAM-RIDDL-0098WOO\_(3138208) Tee Beam**

The Tee Beam designation may not reflect the structural nature of this bridge, as this appears to be a Double Channel Section rather than a Tee. The plans show two separate sections in a channel shape, as the deck steel is not continuous over the center legs. While the design is unusual with the cantilevered end spans, it appears that was the intent. The concrete abutment face is only a facing in front of a very old masonry abutment that supported a narrow truss prior to this bridge and most likely could not support any loading when the bridge was replaced with a wider super. This has nothing to do with the condition, only my understanding of what I am observing.
