Quality Assurance Review
National Bridge Inspection Standards &
Bridge Maintenance Program
Lawrence County

March 28, 2022

By: Mark Sherman, PE
CEAO Federal Bridge QA/QC Engineer

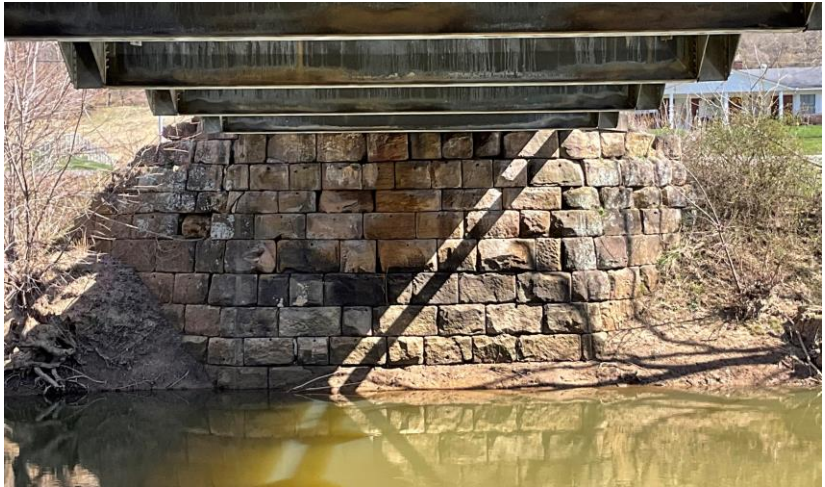
Item 59 Superstructure.....**5** *Inspection comments are thorough, but damage appears to be superficial. Slightly bent gusset appears to be as erected and not due to over-stressing. Same with other defects observed. I would give it a 6 in spite of the observed deformities, and based on Manual guidance. But the county is within the one-point acceptability, so 5 it is.* Agreed

Item 60 Substructure.....**5** Agreed Stones need Tuck-pointed at some point in the future.
No movement detected.

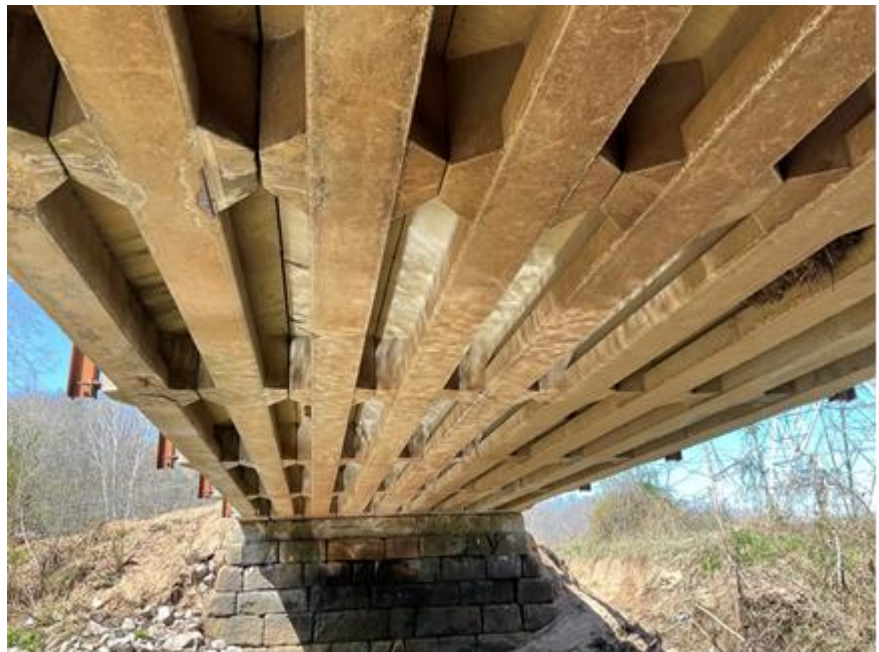
Item 59 Superstructure.....5 Agreed Over all the beams look to be in good condition. There is some efflorescence and minor delamination, but no exposed rebar. With 9 rows of beams spaced at about 3 feet, there is plenty of redundancy. The lower flanges sounded solid when struck with my sounding rod. The only spalling is on the fascia beam, lower flange. I would rate this superstructure closer to a 6 or better.

Item 60 Substructure.....5 Agreed Some stone joints in the abutments need tuck-pointed.
 Item 61 Channel.....7 Agreed
 Item 61.01 Scour.....7 Agreed
 Item 62 Culvert.....N
 Item 36 Railing..... 0 0 0 0 Agreed
 Item 72 Approach Alignment 4 Agreed
 Comments: Excellent comments.
 Defect Photos: No defect photos in Assetwise, they exist in office bridge files.
 Channel Photos: Good Channel Photos in Assetwise

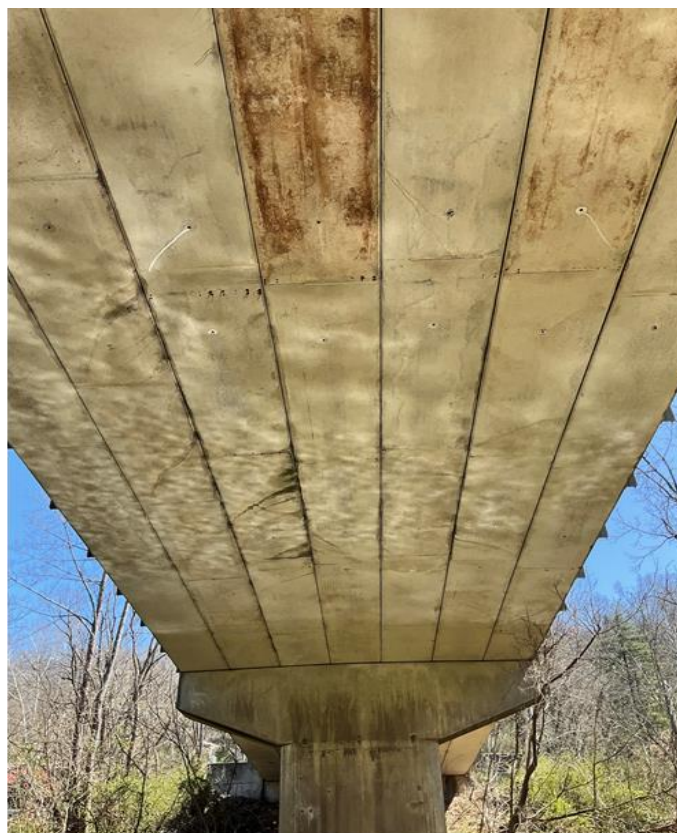
LAW-C0104-0001_(4445031)

Prestressed Box-beams Continuous

Item 58 Deck..... 5 Agreed (See Superstructure comment)
 Item 59 Superstructure.....5 Agreed *While there were some strands exposed at the abutments and near midspan, the areas are few and isolated. Based of the criteria in the manual, I would have to rate this one at least a 6. However, the beams are too high to sound and require a snoopers for arms-length inspection. I am basing my evaluation on a distant visual, but it is hard to argue with the level of detail presented in the report and the previous snoopers evaluation findings. Therefore, I can only defer to the County Engineer’s judgement on this one. Snooper will be scheduled for 2023 inspection.*

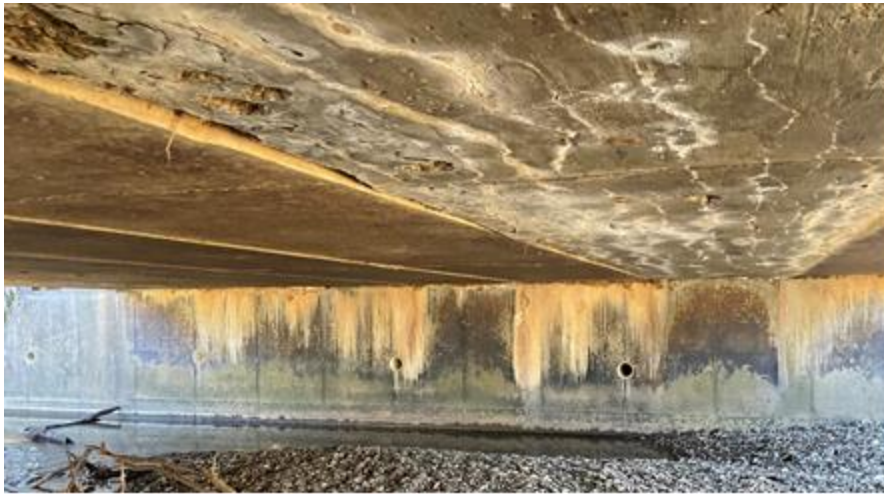
Item 59 Superstructure.....4 See tables for 2010 and 2014 below. Well documented defects; There is a single beam in the wheel track is going bad. The rest are not nearly that bad. Looks like a bad batch of concrete at the pre-caster's shop.

Item 60 Substructure.....6 *Agreed Heavy efflorescence coming from end joint is too much to get a good sounding. Could possibly rate Higher than a 5, but I have to go with comments and the engineer's consistency.*

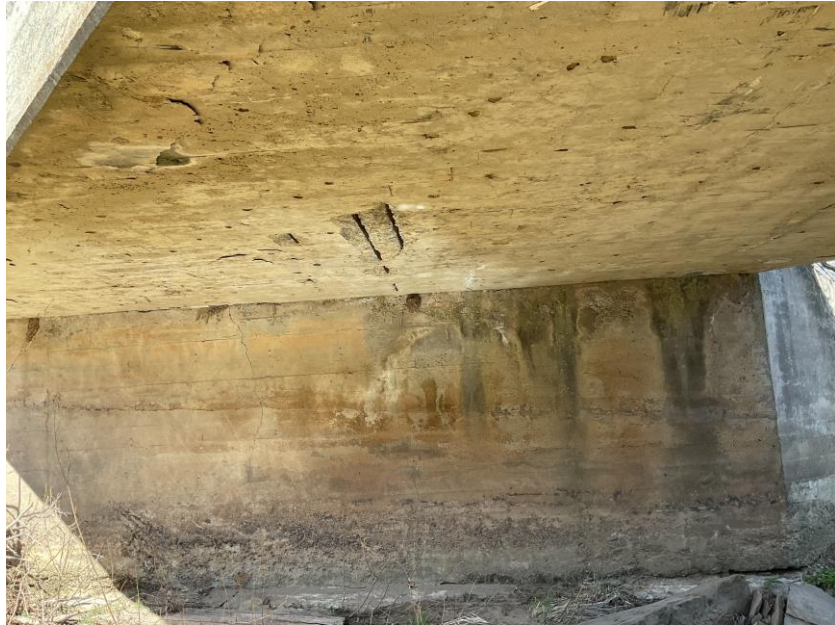
Item 59 Superstructure.....4 *Agreed Unusual design, as the main reinforcement rebars are oriented normal to the abutments and not on the nearly 40 degree skew. The 1935 concrete is very*

tough, but there are many spalls. The condition has not changed much from year to year.

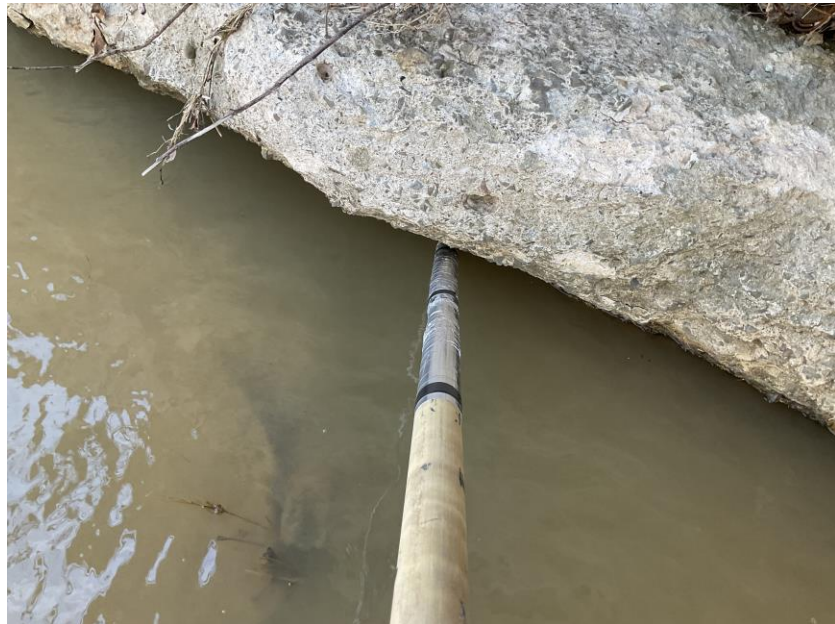
Item 61.01 Scour.....6 It appears that scour has advanced deeper since the previous inspection report. My probe went about 2 feet under abutment apron. I would give this a rating of 5 or 4.

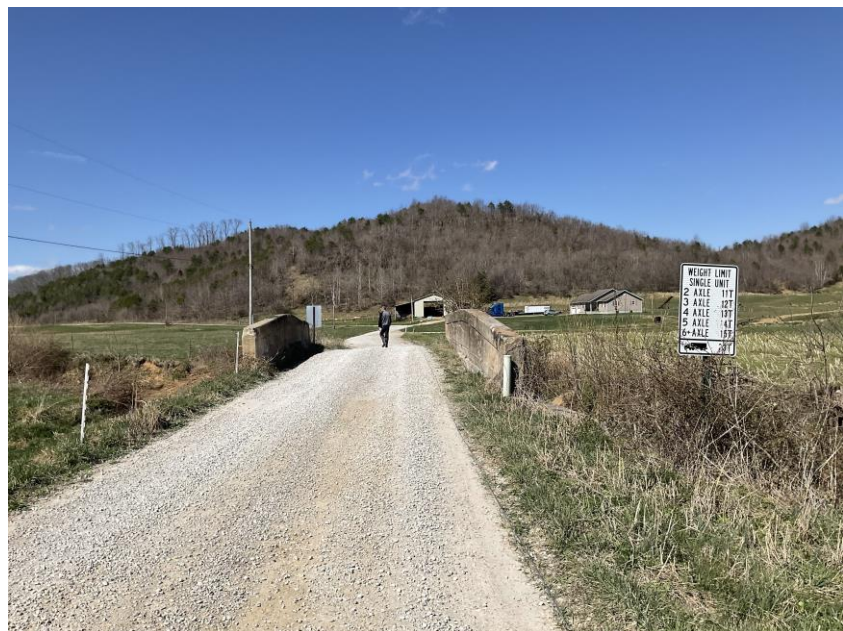
Item 72 Approach Alignment 5 Could be a 6. Bridge in narrow and raised, but not enough to slow traffic down at all, especially since it is an unpaved road.

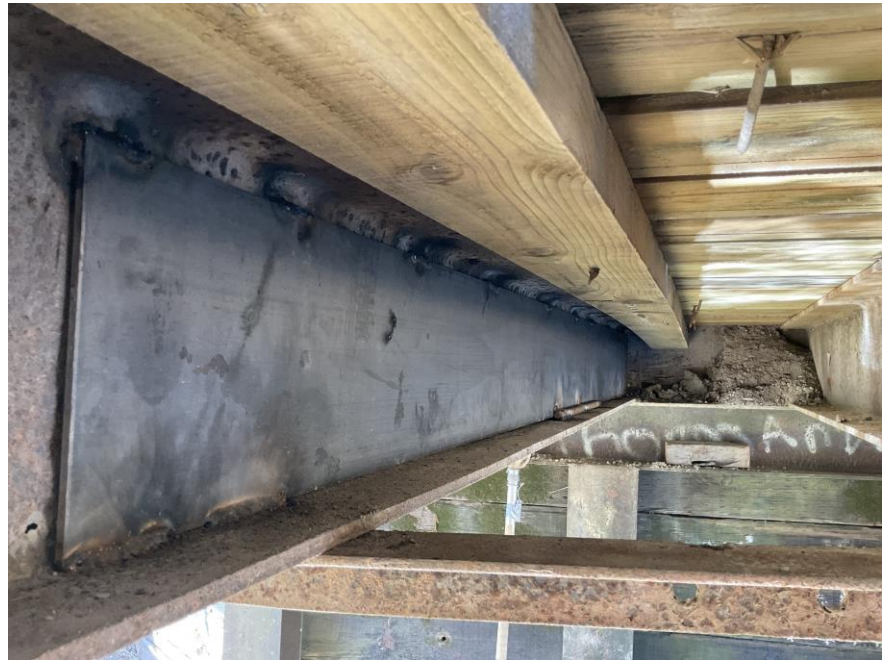
Item 58 Deck..... 4 Agreed (Timber) Lots of replaced floor sections and gaps between deck boards.

Item 59 Superstructure..... 4 Agreed Section loss in beams has been mitigated, but not enough to warrant a higher rating. Plus the angle of the welding at the top of the plate is difficult to determine the effectiveness/integrity of the weld.

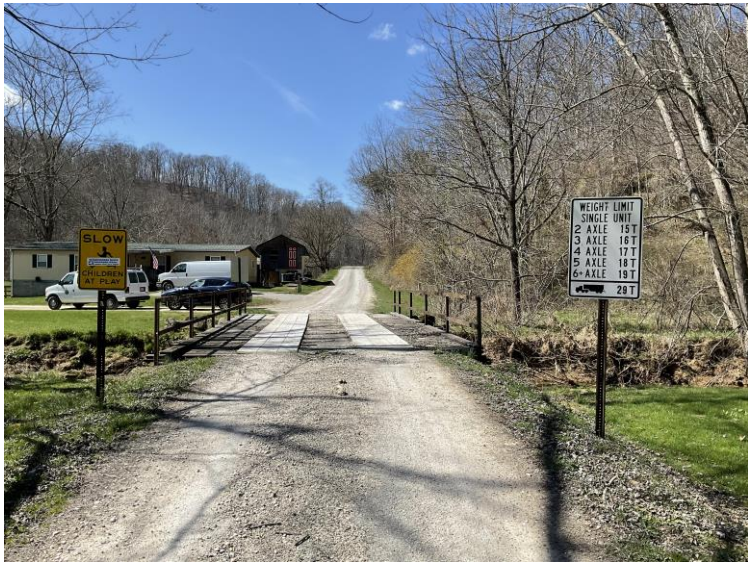
Item 72 Approach Alignment 5 Agreed, but I would go one higher (perhaps a 6), the minor misalignment is not slowing anyone down.
